# World Housing Encyclopedia

## HOUSING REPORT

### Unreinforced clay brick masonry house

<b>Report#</b>	24
<b>Last Updated</b>	
<b>Country</b>	Indonesia
<b>Author(s)</b>	Sugeng WIJANTO,
<b>Reviewers</b>	Ravi Sinha ,

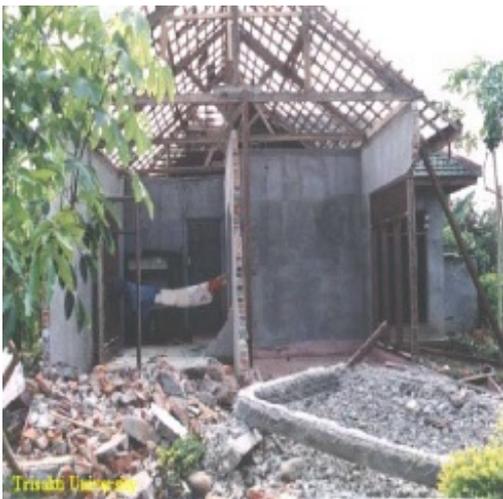
Typical damage features on non-engineered buildings : 1. Failure on corners of the walls and the openings like doors and windows. 2. Roof structure was usually sliding off from its base 3. Diagonal cracks on the clay-brick walls 4. Failure in connection between: - foundation and walls, - walls and walls, - walls and roof structure. 5. low construction quality (the quality of building material and labor).

***A photograph illustrating Typical Earthquake Damage (June 4, 2000 Bengkulu Earthquake)***

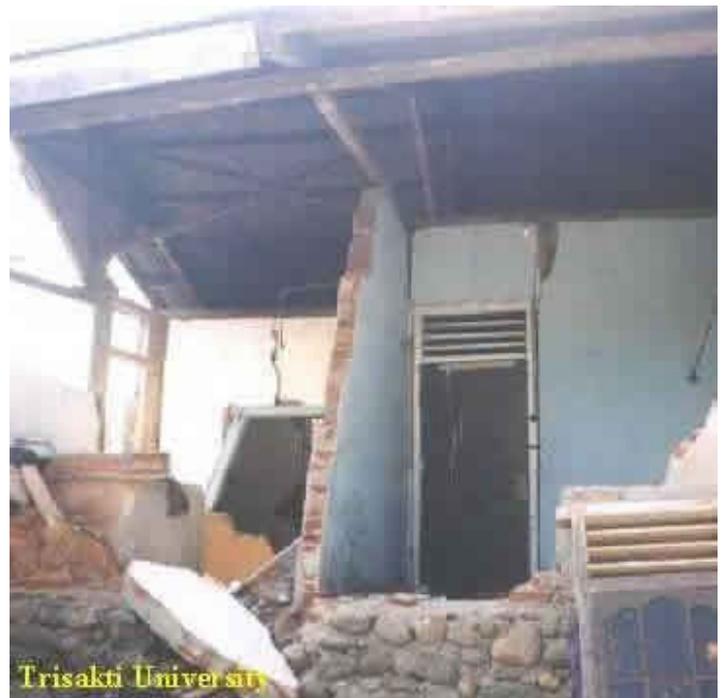
***Typical Earthquake Damage (June 4, 2000 Bengkulu Earthquake)***

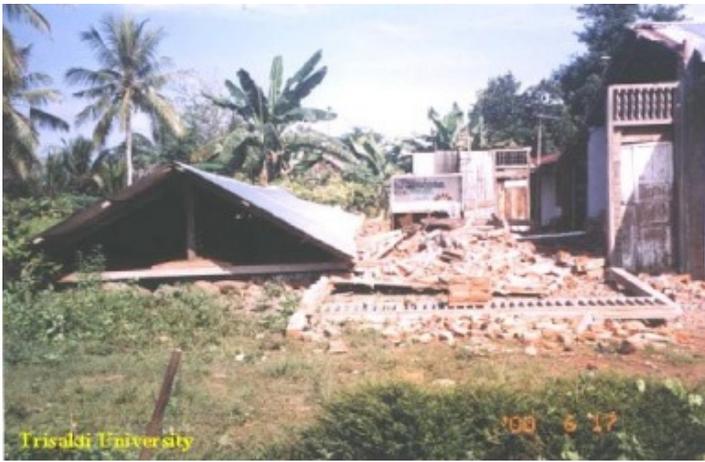
***Unreinforced Brick Masonry Building totally collapsed in the June 4, 2000 Bengkulu Earthquake)***

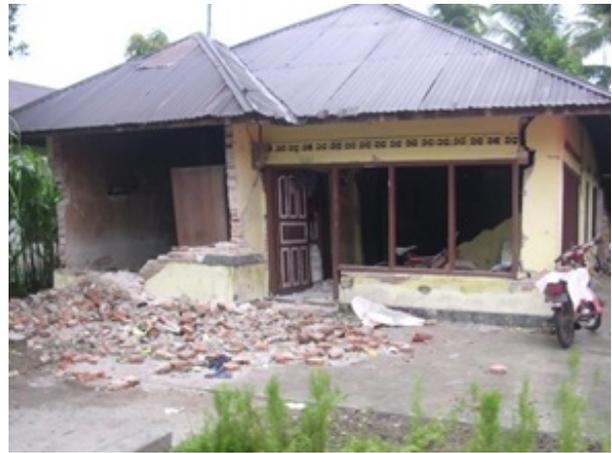
Sumatra, depth 87 kilometers epicenter. It was affecting an area with a population of about 1.2M people, including 900,000 in Padang and 80,000 in Pariaman. Padang is the capital of West Sumatra, situated on the coast of the Indian Ocean between the Sumatra fault and the Sunda Trench fault. Single storey houses, which were built using unreinforced clay bricks as their bearing walls, suffered severe damages.

***Unreinforced brick masonry house with both in-plane and out of plane wall failures\_Padang Earthquake.***

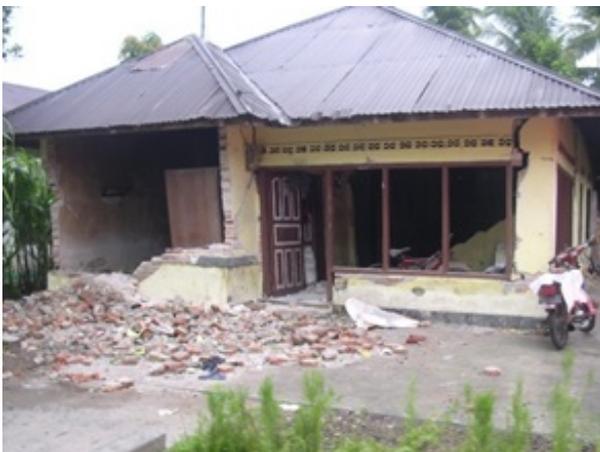
***Unreinforced brick masonry house with both in-plane and out of plane wall failures\_Padang Earthquake.***

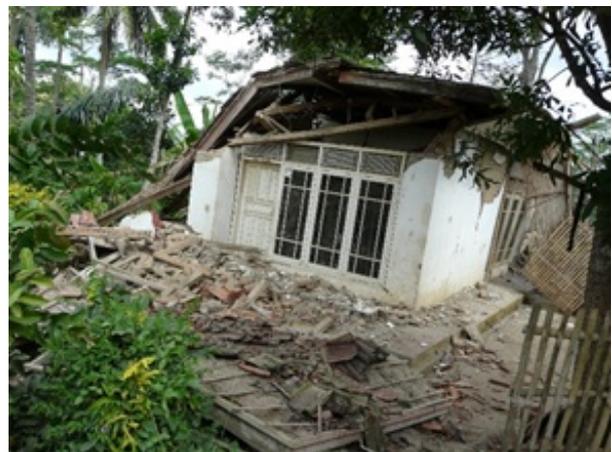
On Wednesday, September 2, 2009, at 2:55:00 pm (07:55:00 am UTC), a tectonic earthquake with a magnitude of 7.3 on the Richter Scale struck the south part of West Java. Based on the report of the Indonesia Meteorology & Geophysics Agency, the epicenter of the earthquake was at 142 km South-West of Tasikmalaya (8.24°E, 107.32°E) and its focus was found at a depth of 30 km below the sea level. The quake happened at the intersection between the Eurasian and Australian tectonic plates. It was followed by some smaller aftershocks. Nearer to the epicentrum, the residents of four districts in the south part of West Java, namely Tasikmalaya, Garut, Cianjur, and Cilacap were terrified by the shocks, which reached the intensity of V to VI MMI Scale. The inhabitants went out right away from their dwellings. More than 67,000 houses were reported as badly damaged while about 150,000 of dwelling units experienced light to medium impairment. Based on the latest report, there were 80 people died, 47 missing villagers, and 1142 injured inhabitants. Single storey houses, which were built using unreinforced clay bricks as their bearing walls, suffered severe damages.

***Unreinforced brick masonry house with both in-plane and out of plane wall failures\_Tasikmalaya Earthquake.***

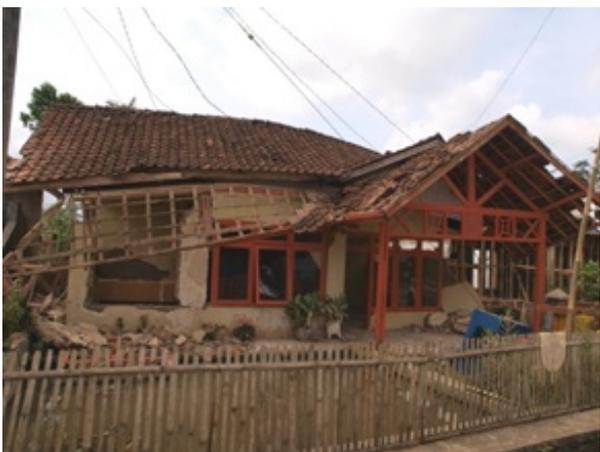
***Unreinforced brick masonry house with both in-plane and out of plane wall failures\_Tasikmalaya Earthquake.***

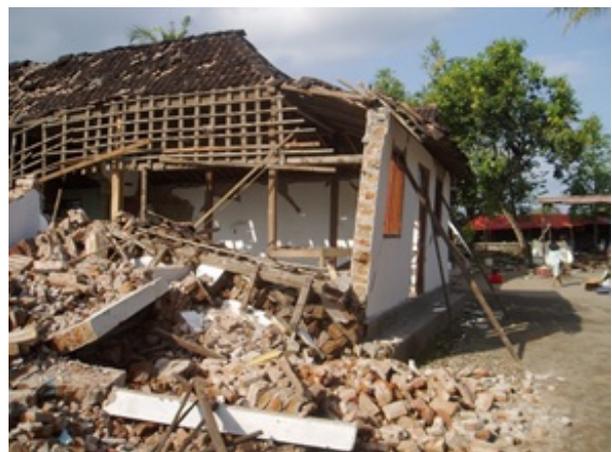
On May 27, 2006 at 5:54 am local time, a Mw 6.3 earthquake struck the island of Java, Indonesia, about 20 km from Yogyakarta. According to the U.S. Geological Survey, the epicenter of the earthquake was on-shore at latitude 7.962 and longitude 110.458, with a fairly shallow focal depth ( 10 km). The affected area is a densely populated mix of urban and rural communities on the southern slope of Mount Merapi, an active volcano. The latest casualty figures stand at 5,176 killed and over 40,000 injured. The total amount of damage and loss caused by this earthquake is estimated at US \$3.1 billion (CGI 2006). Most heavily damaged are single storey houses, which were built using unreinforced clay bricks as their bearing walls.

***Unreinforced brick masonry house with both in-plane and out of plane wall failures\_Yogyakarta Earthquake.***

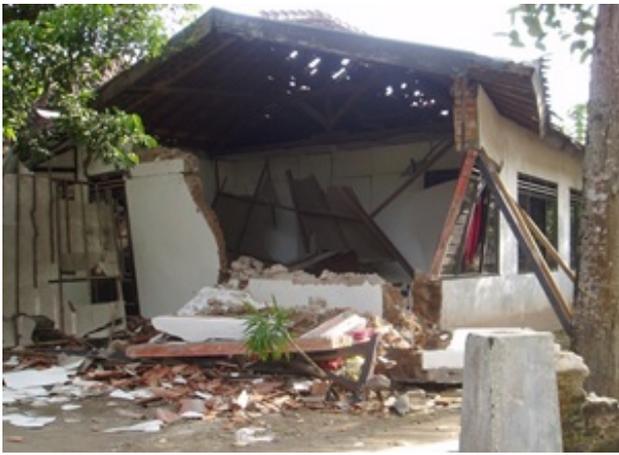
***Unreinforced brick masonry house with both in-plane and out of plane wall failures\_Yogyakarta Earthquake.***
