# World Housing Encyclopedia

## HOUSING REPORT

### **Reinforced concrete frame building with masonry infills**

<b>Report#</b>	64
<b>Last Updated</b>	
<b>Country</b>	Turkey
<b>Author(s)</b>	Polat Gulkan, Mark Aschheim, Robin Spence,
<b>Reviewers</b>	Craig D. Comartin,

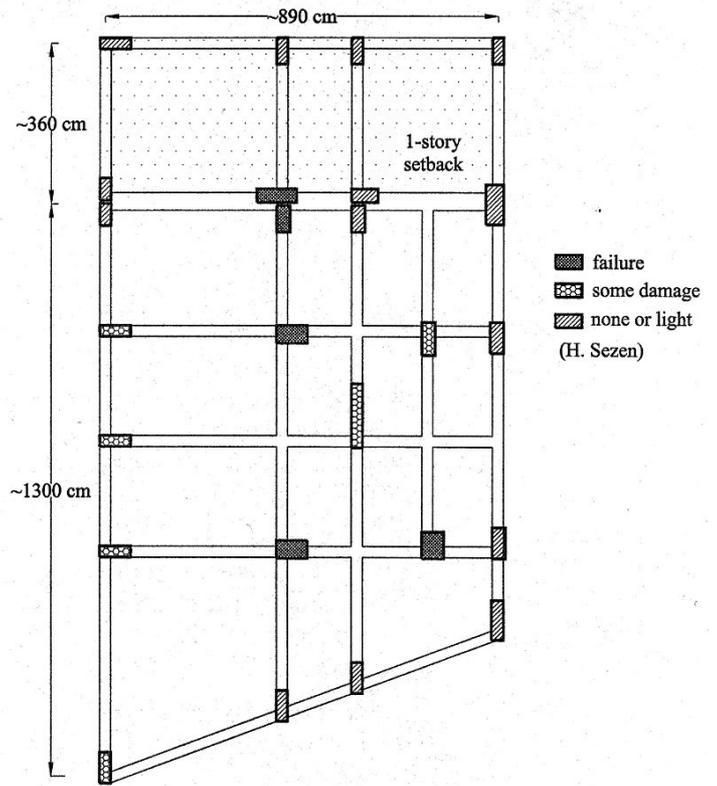
**Typical Plan Illustrating Damaged Columns in Lowest Floor of a Five-Story Building in Adapazari (EERI 2000)**

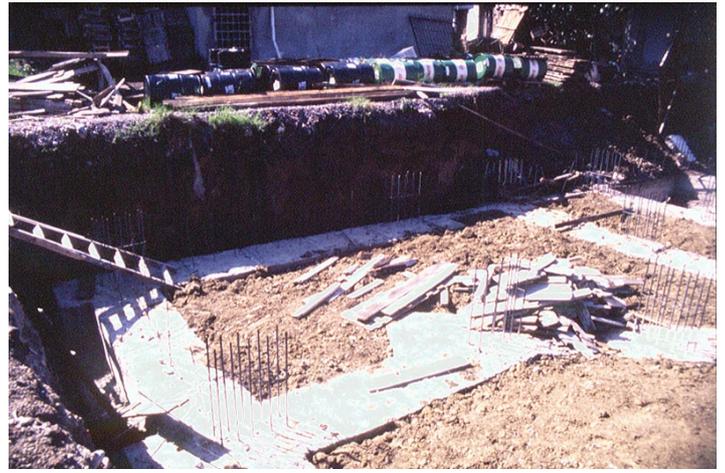
□ ***Critical Structural Details - Irregular Column Orientations and Layout (EERI 2000)***

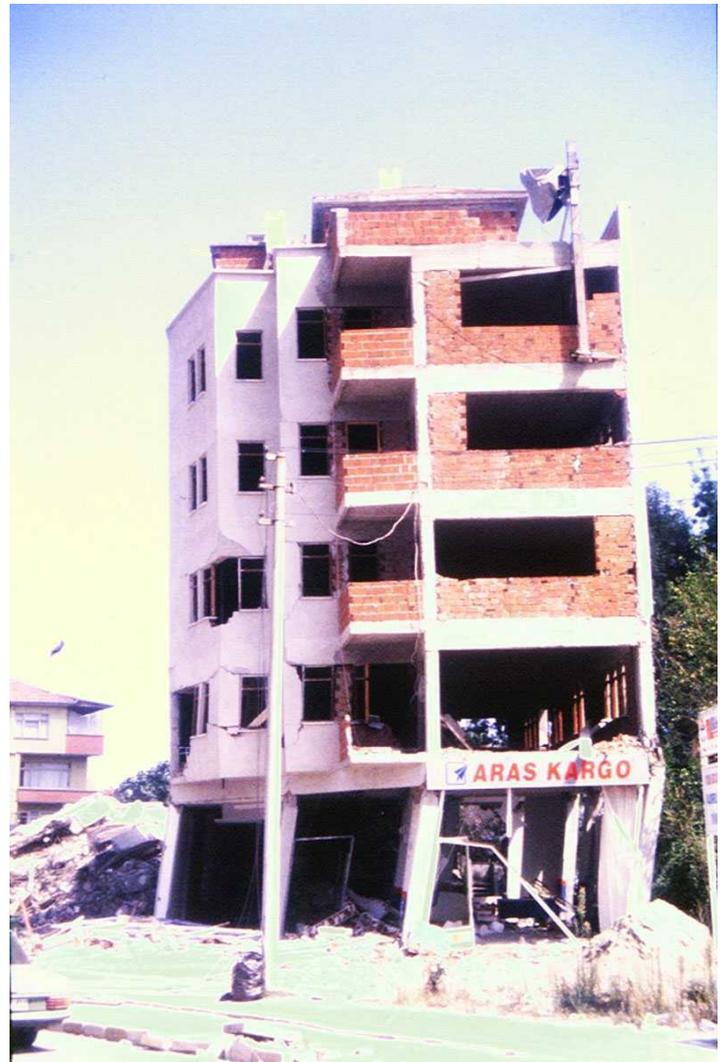
**Key Seismic Deficiencies - A Weak-Story Mechanism Developed at the First Floor (the case of the lowest floor used for commercial purposes and lacking the stiffness provided by the infill at the upper floors (EERI 2000))**

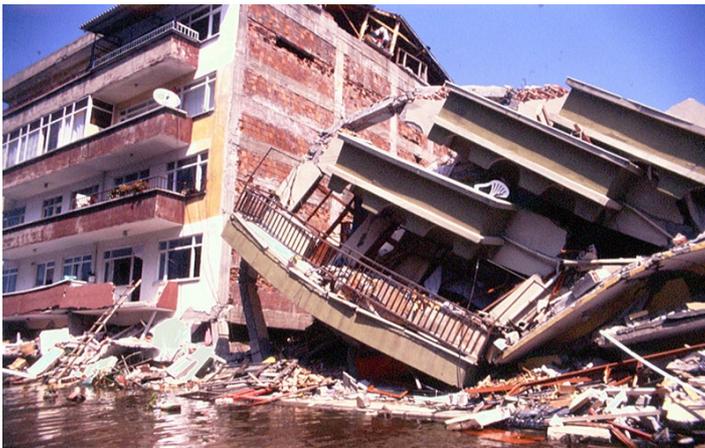
**Typical Earthquake Damage - Multiple-Story Collapse in a Six-story building at Golcuk (EERI 2000)**

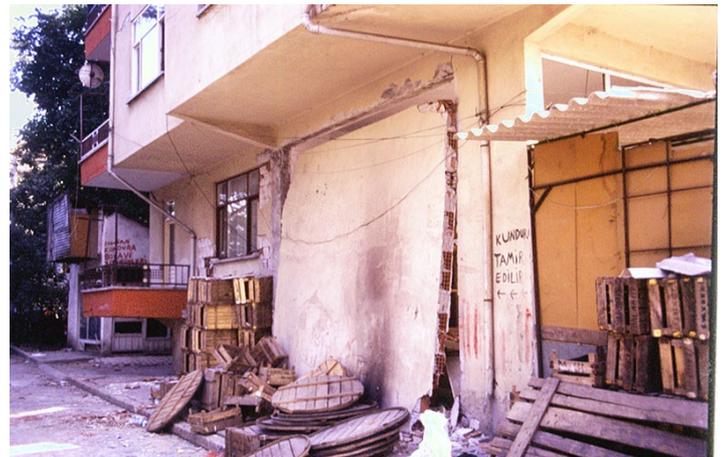
**Typical Earthquake Damage - Hollow Clay Tile Wall "popped" out from a Six-Story Building in Golcuk (EERI 2000)**

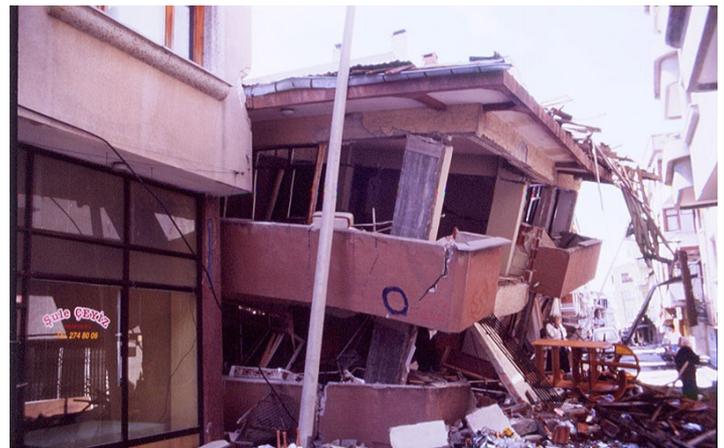
**Typical Earthquake Damage - Pullout of Column Reinforcement in a Low-Rise Building in Adapazari (EERI 2000)**

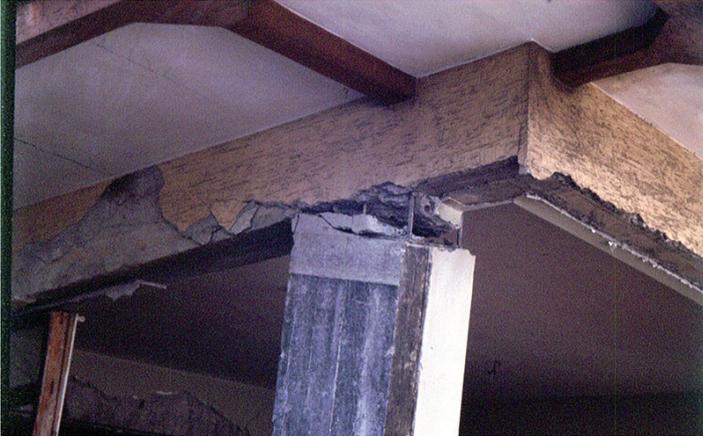
**Typical Earthquake Damage - Close Up of Uppermost Corner Column Joint in the Building Shown on the Previous Figure (EERI 2000)**

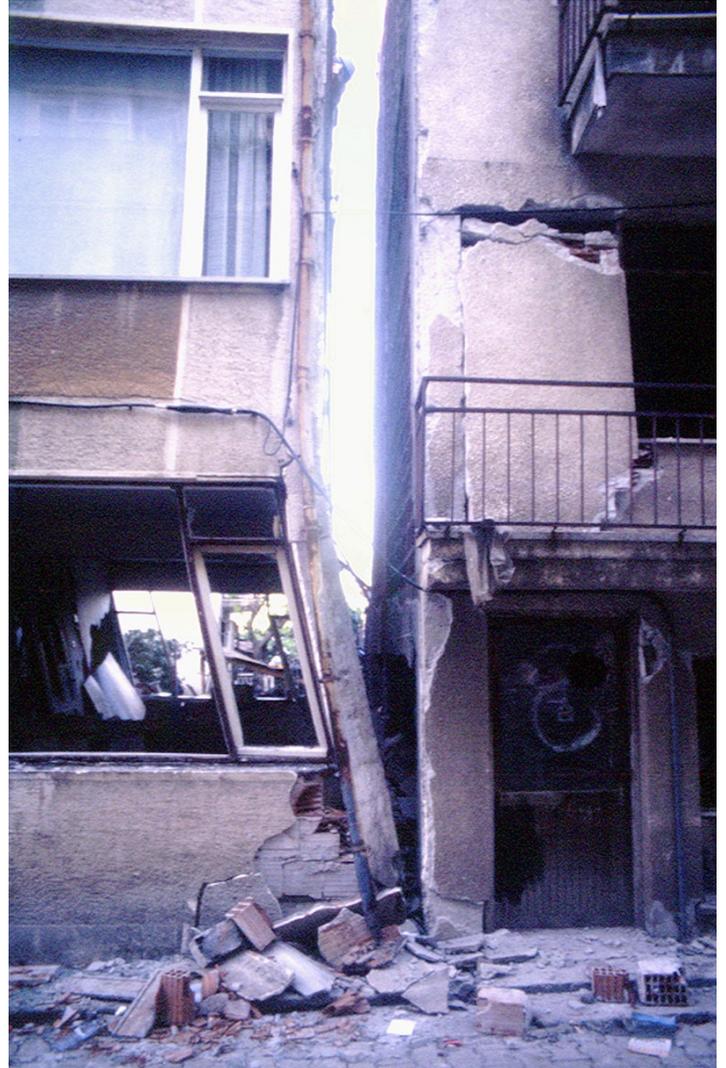
**Typical Earthquake Damage: Weak-story Mechanism Developed in the Building at the left (note columns oriented to increase the glazing area). The columns at the front of the building at the right are oriented perpendicular to those of the building.**

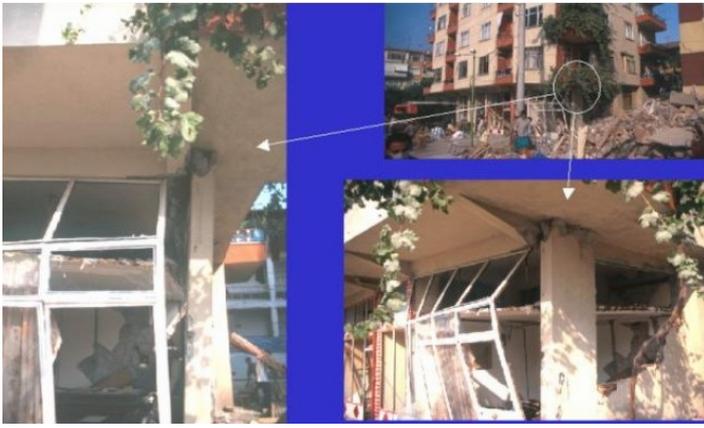
***Typical Earthquake Damage: Weak-Story Mechanism Developed in the Bottom Story***

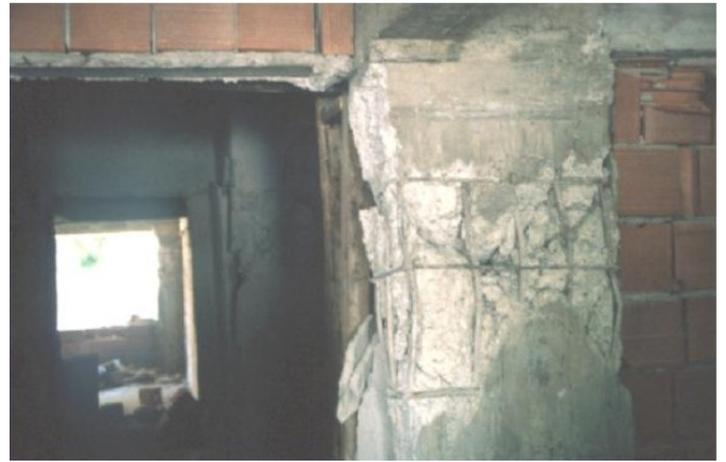
***Typical Earthquake Damage - Column Failure***

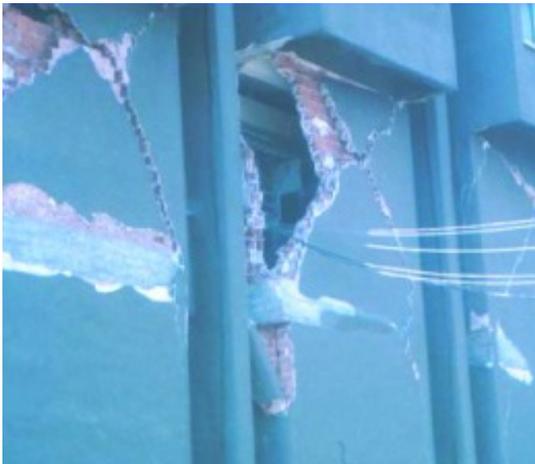
***Typical Earthquake Damage - Pier Failure***

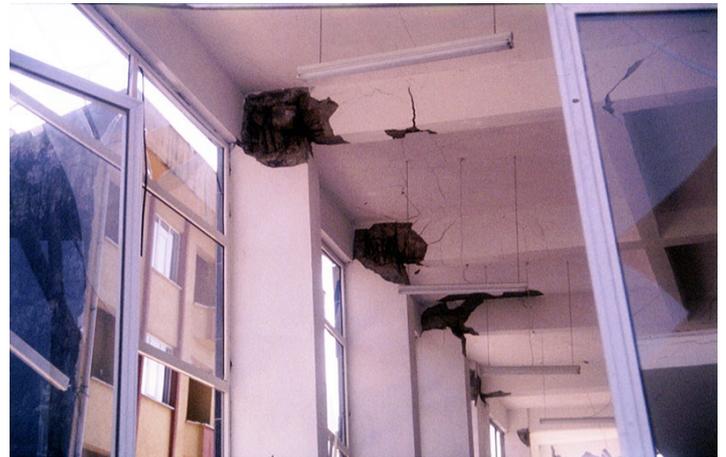
***Typical Earthquake Damage - Diagonal Cracking of Infill Often Preceded the Out-of-Plane Failure (EERI 2000)***

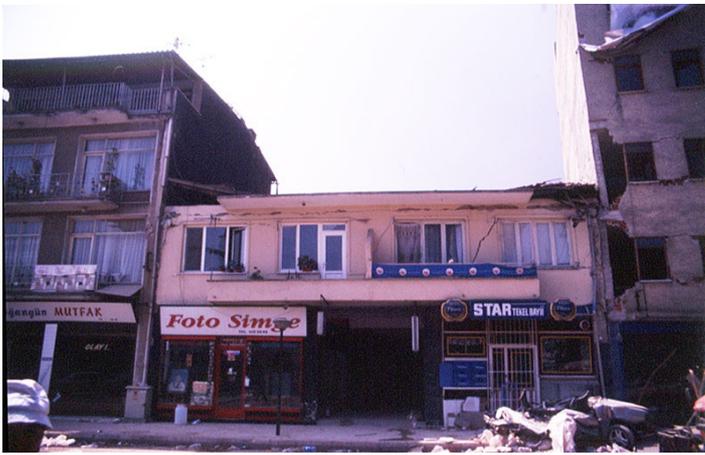
**Typical Earthquake Damage to Beam-Column Joints of an Irregular building in Adapazarı Maintaining Gravity Load Support (EERI 2000)**

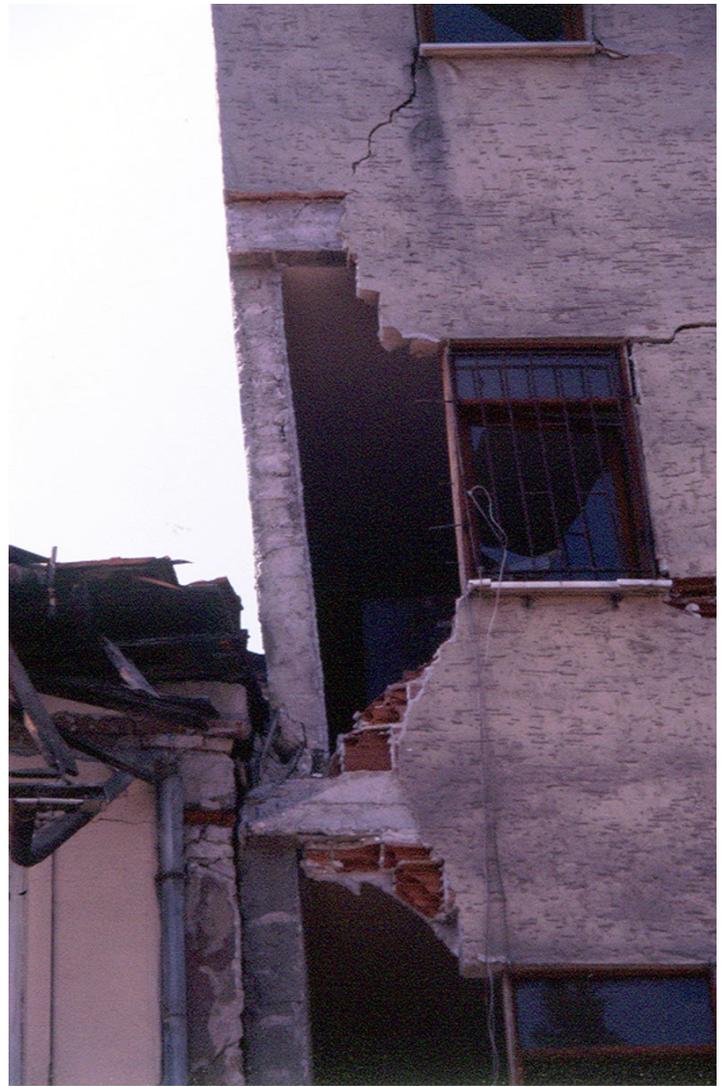
**Typical Earthquake Damage - Pounding Between a Six-Story Building and a Two-Story Building in Golcuk, Causing Damage to the Column of the Six-Story Building (EERI 2000)**

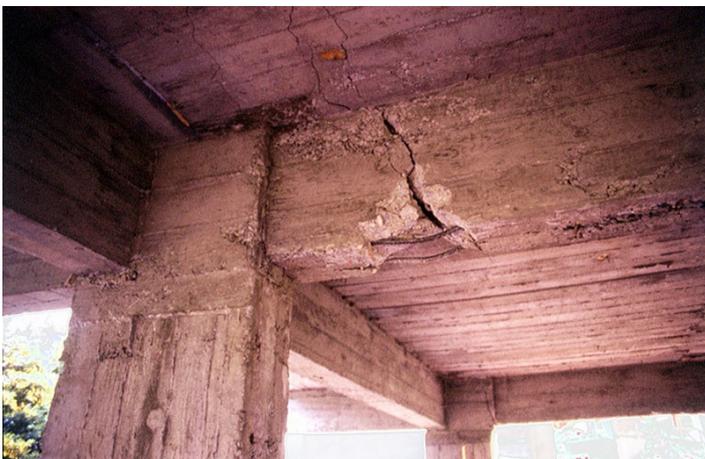
**Typical Earthquake Damage Due to Pounding Effect (detail of a six-story building shown on the previous figure) (EERI 2000)**

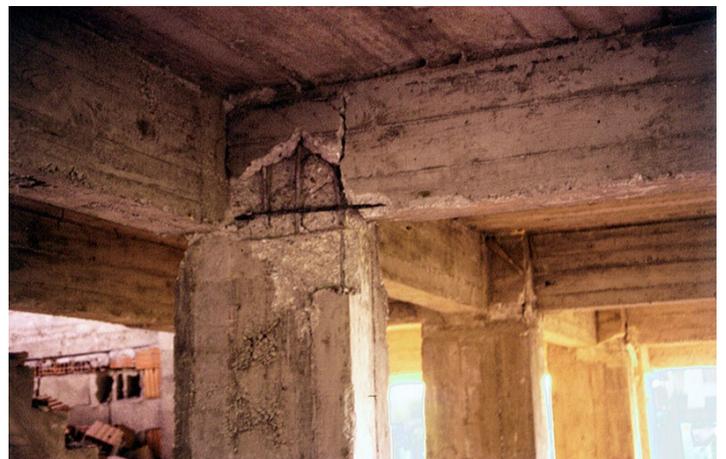
**Typical Earthquake Damage - Building Under Construction, Revealing Location of Central Bent-Up Longitudinal Beam Bar, Infrequent Stirrups, and Beams**

## ***Framing Eccentrically Into Columns (EERI 2000)***

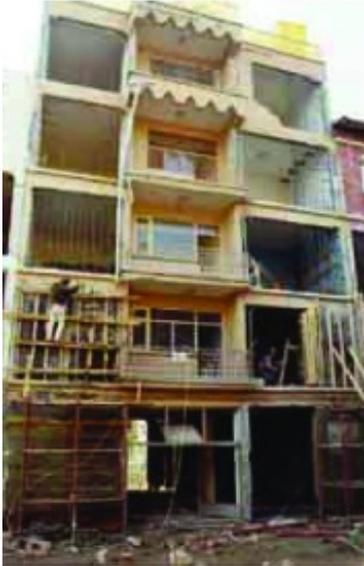
***Typical Earthquake Damage to a Building Under Construction, Revealing Eccentric Beam-Column Framing, Beam Longitudinal Bars Located Outside the Column Cage, and Infrequent Transverse Hoops (EERI 2000)***
