HOUSING REPORT

Adobe / Earthen House : Mud walls

Report#	134
Last Updated	
Country	Honduras
Author(s)	Matthew A. French, ,
Reviewers	Andrew W. Charleson,

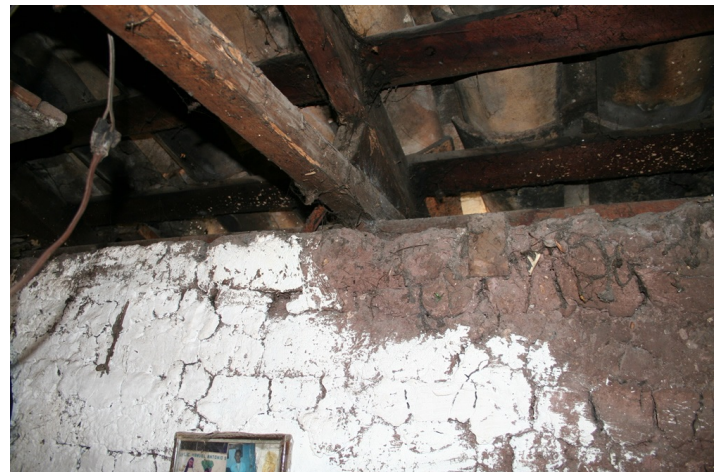
Roof framing and wall connection.

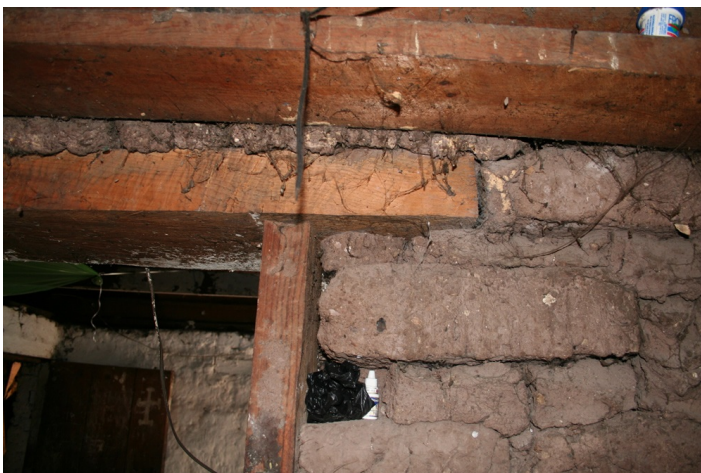
Lintel and wall connection.

construction type	
Seismic deficiency in walls	The adobe walls have little tension resistance under seismic loads. The lintels above the doors and windows are not adequately connected back to the walls resulting in exit points being blocked by their fall, and leading to progressive roof collapse.
Earthquake-resilient features in walls	
Seismic deficiency in frames	
Earthquake-resilient features in frame	
Seismic deficiency in roof and floors	The roof is poorly connected to the walls and these poor connections suggest that the roof cannot be counted on to act as a rigid diaphragm, but does act as a timber bond beam.
Earthquake resilient features in roof and floors	
Seismic deficiency in foundation	
Earthquake-resilient features in foundation

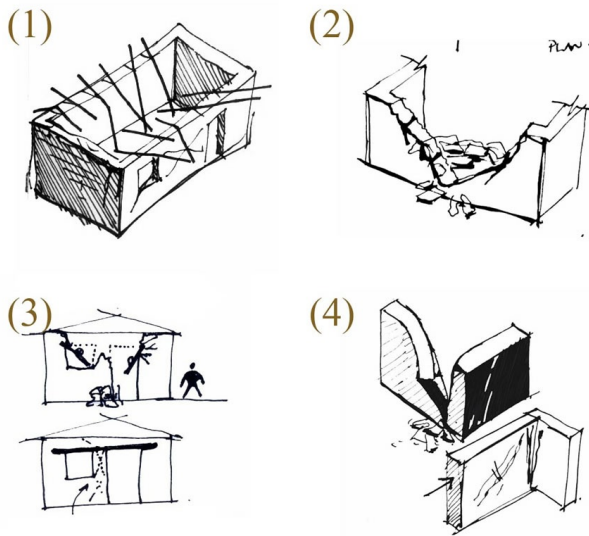
(1) Typically the roof collapses inwards due to reduced wall support and poor connections. The probability of this damage pattern occurring is increased when heavy roofing materials such as earth are used. (2) Wall collapse under face loads is a common e

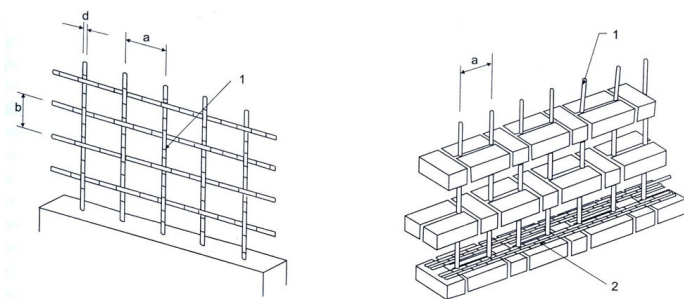
(a) Pattern of mesh in walls of constructions (a) and (c)

(b) Pattern in adobe wall

(c) Pattern in adobe walls, (note preformed notches in adobe for receiving cane)

- 1 - Cane or bamboo
- 2 - Crushed cane or split bamboo every four layers of adobe
- a - Spacing of canes, 400 mm maximum
- d - Diameter of cane or bamboo about 20 mm

Reinforcement system utilising bamboo. IAEE Guidelines 2004, p.73.

Structural Deficiency	Seismic Strengthening
Walls: Adobe has limited tension resistance. Inadequate connections to return walls, poor lintel embedment, and lack of face load strength for long walls reduces strength.	1. Bamboo: Several researchers have been involved with using internal horizontal and vertical bamboo, in a similar fashion to reinforced concrete masonry walls. 2. Timber ring beam: This helps to hold the walls together and facilitate transfer of loads from the roof to the walls. 3. 'Improved Adobe' has long been promoted to make adobe buildings more robust under seismic activity. The 'system' does not utilise another material, but focuses on the design and planning of adobe buildings by limiting opening sizes, plan dimensions, wall lengths and heights, and roof weight
Roof: Heavy clay tile roofs increase vulnerability	Galvanised sheet metal is now common and helps reduces high loads. For thermal and

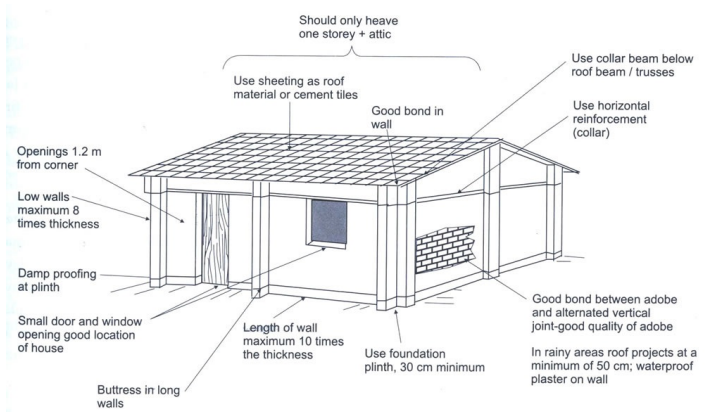
'Improved Adobe' features which make adobe more earthquake resistant. IAEE Guidelines 2004, p.75.
