World Housing Encyclopedia

HOUSING REPORT

Adobe with sawn timber roof framing and corrugated iron sheeting

Report#	136
Last Updated	
Country	Guatemala
Author(s)	Matthew A. French, ,
Reviewers	Andrew W. Charleson,

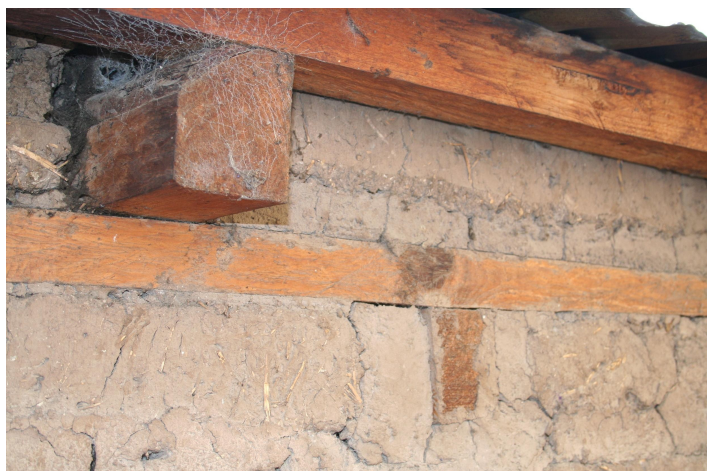
Connection of roof framing to wall incorporating a timber ring beam.

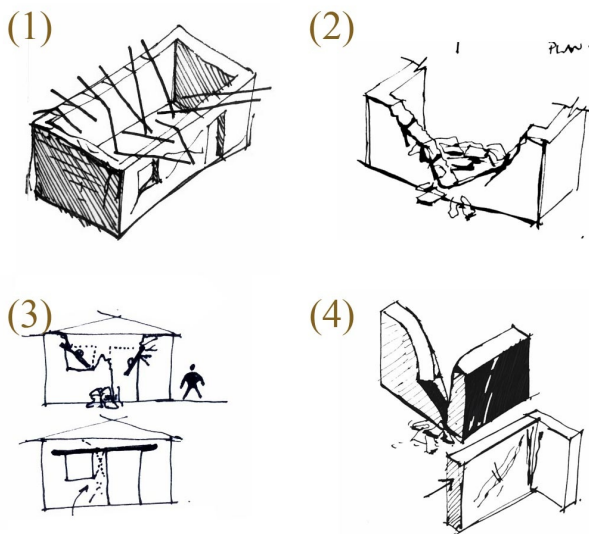
(1) Typically the roof collapses inwards due to reduced wall support and poor connections. The probability of this damage pattern occurring is increased when heavy roofing materials such as earth are used. (2) Wall collapse under face loads is a common ea
