World Housing Encyclopedia

HOUSING REPORT

Unburnt brick wall building with pitched roof (nyumba ya zidina)

Report#	46
Last Updated	
Country	Malawi
Author(s)	Sassu, M., Ngoma,I,
Reviewers	Manuel A. Lopez M. ,

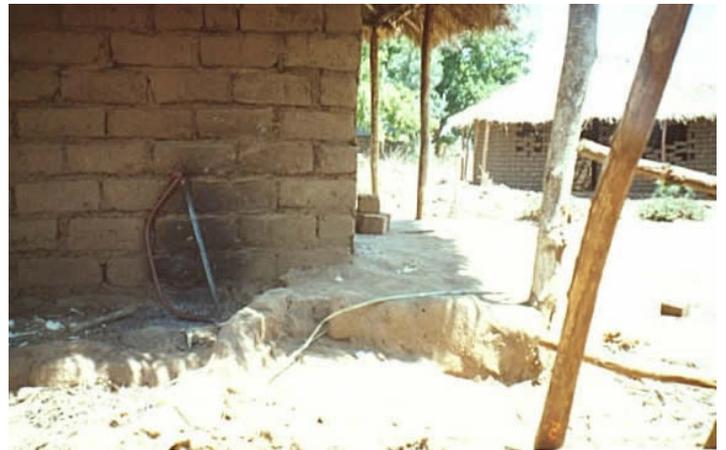
An illustration of key seismic features and/or deficiencies

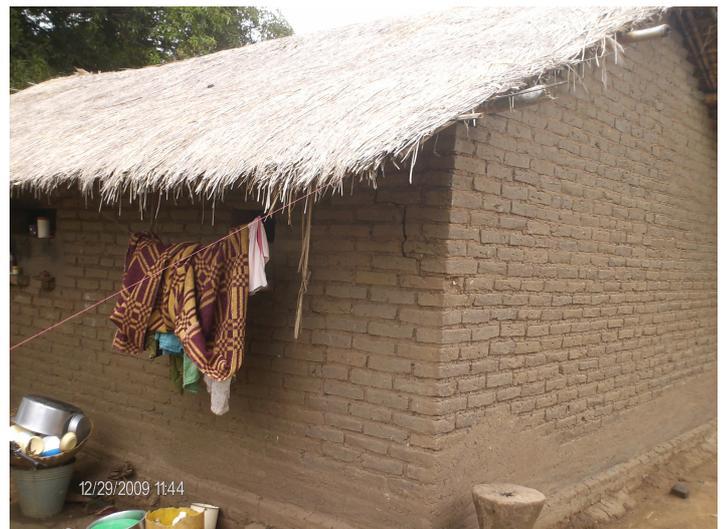
Karonga earthquake damaged house

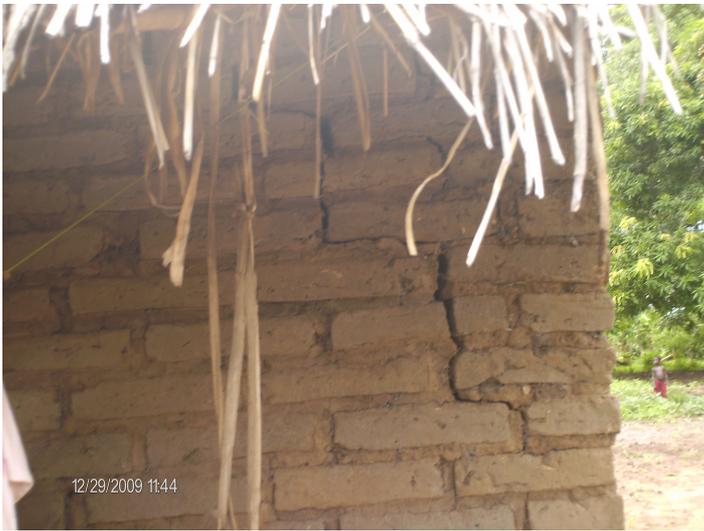
Karonga earthquake damaged house

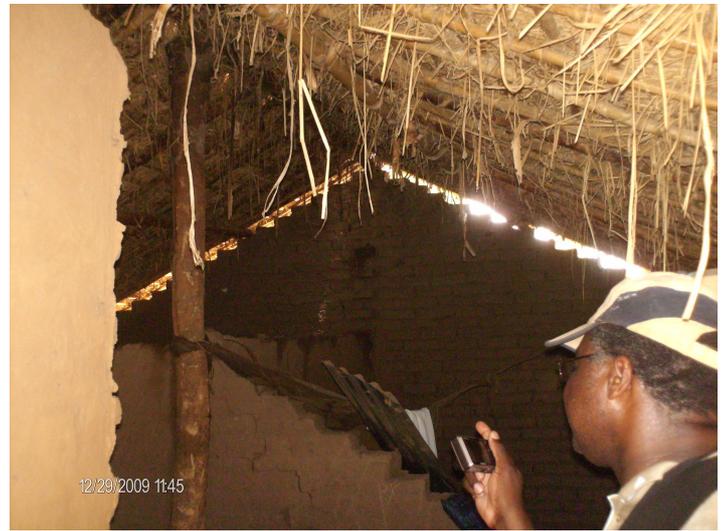
Karonga earthquake damaged house
