World Housing Encyclopedia

HOUSING REPORT

Reinforced clay/concrete block masonry building

Report#	5
Last Updated	
Country	Chile
Author(s)	Ofelia Moroni, Cristian Gomez, Maximiliano Astroza,
Reviewers	Sergio Alcocer,

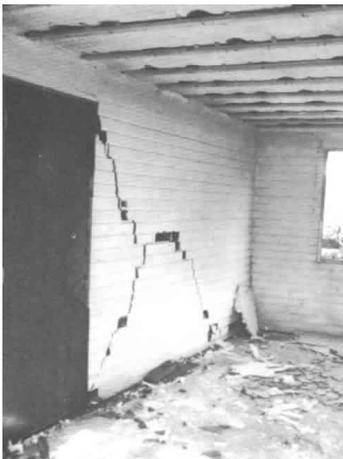
Shear fails in reinforced masonry walls.

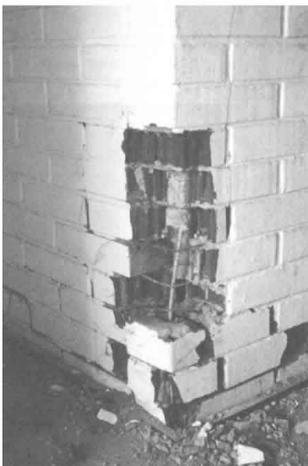
Compression fail in reinforced masonry wall.

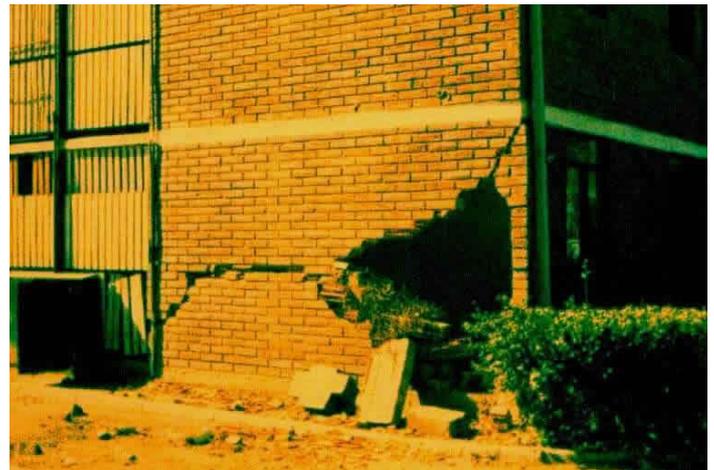
Failure of masonry walls in March 3, 1985 Lolleo earthquake

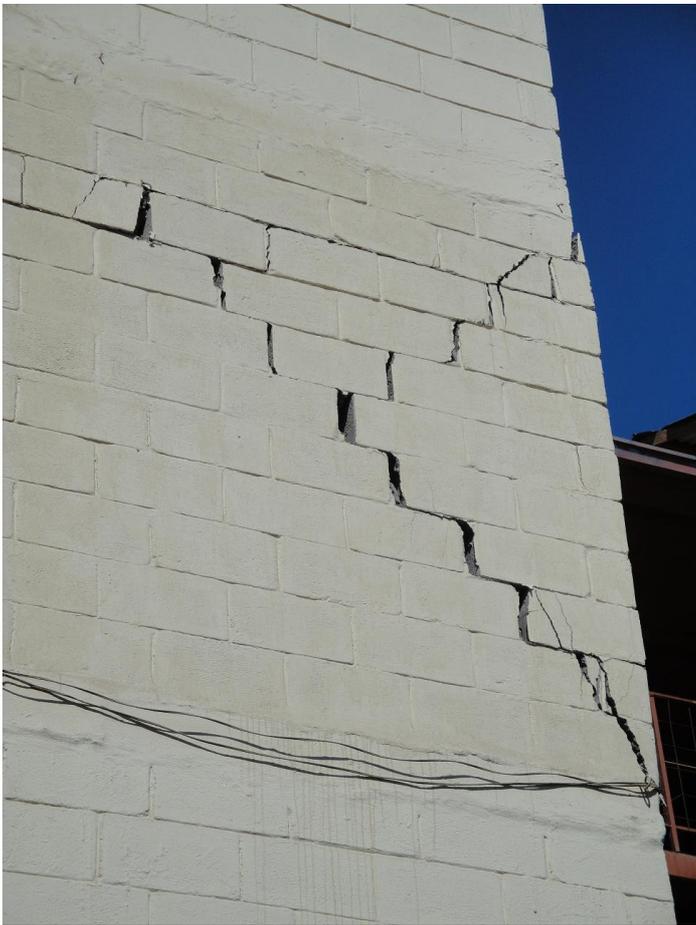
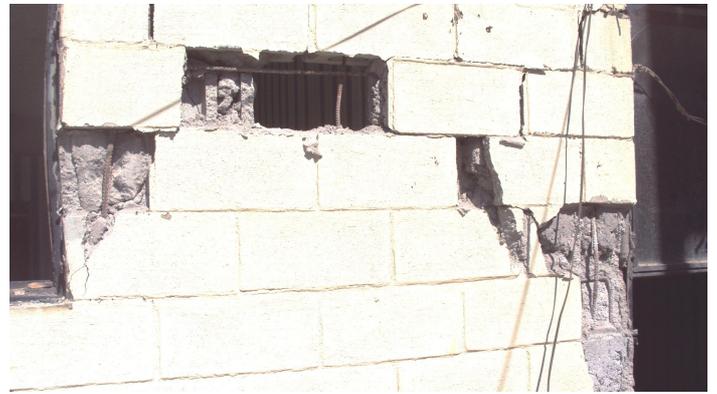
***Villa Cordillera, Rancagua, VI region,
4 story-building***

After the 1985 earthquake the Ministry of Housing appointed an especial committee to review the seismic effects on social dwellings. About 12.000 units were reinforced masonry type and 44% of them had some type of damage. A 100% of the 3 or more story buildings (2800 units) were severely damaged. The following characteristic damage patterns were observed:- shear cracks in walls, spandrels part of the walls and window piers- vertical cracks at the wall bottom due to compression failure- horizontal cracks at the joints between masonry walls and reinforced concrete floors or foundation- cracks in window piers and walls due to out-of-the-plane action. Some damage occurred in houses located in Illapel during 1997 earthquake due to differential settlement in a sloped terrain. Heavy damage occurred in reinforced masonry houses located in Pozo Almonte during 2005 earthquake, probably because the wall density in one direction was quite low and the construction quality was very poor (Astroza et al, 2005). During 2010 earthquake, a substandard quality of masonry construction was observed in some severely damaged buildings in Rancagua, although the seismic intensity in that location was moderate (Nunez, 2010).

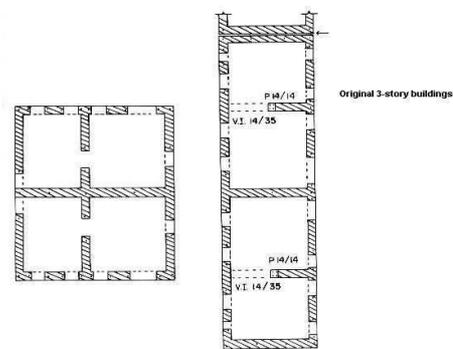
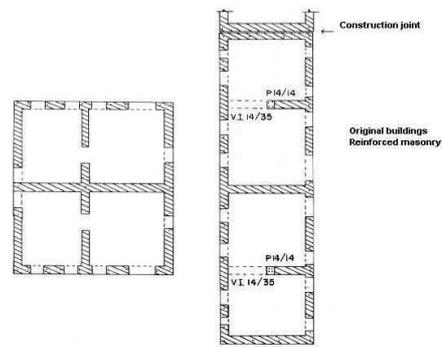
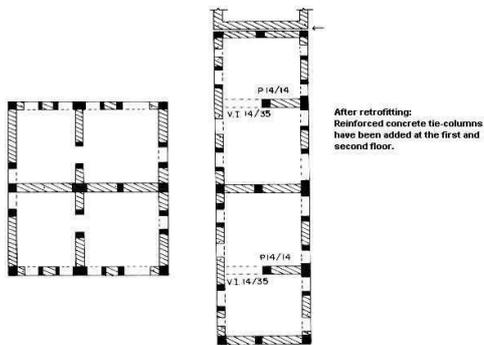
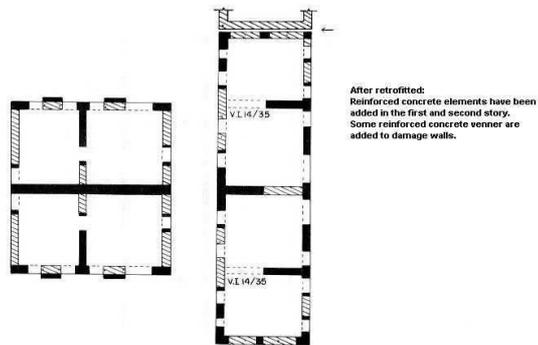
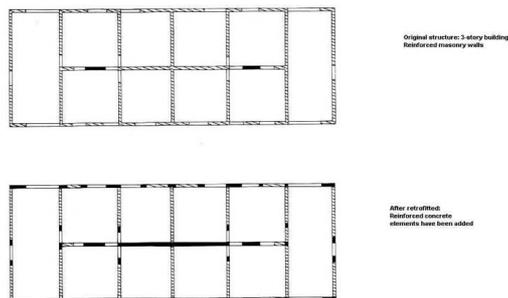
Lack of appropriate reinforcement	Addition of new tie-columns

Additional comments on seismic strengthening provisions	The strengthening procedure consist in confining the masonry wall with reinforced concrete tie-column and tie-beam. This may cost up to 20% of the original cost. With this procedure ductility is also improved. When only some bricks have been damaged, they have been replaced; the same occurs when cracks appeared in the mortar joints.
Has seismic strengthening described in the above table been performed?	The seismic strengthening described in the above table was performed after 1985 earthquake in some "conjuntos". After 2010 earthquake, most of severe damage buildings were demolished.
Was the work done as a mitigation effort on an undamaged building or as a repair following earthquake damages?	As it was pointed out in Section 6, after the 1985 earthquake a committee chaired by Prof. Rodrigo Flores was appointed by the Ministry of Housing in order to review the damaged buildings, to prepare restoration projects and supervise its execution.
