# **A TUTORIAL: Improving the Seismic Performance of Stone Masonry Buildings**

**Jitendra Bothara • Svetlana Brzev**

**Publication Number WHE-2011-01**

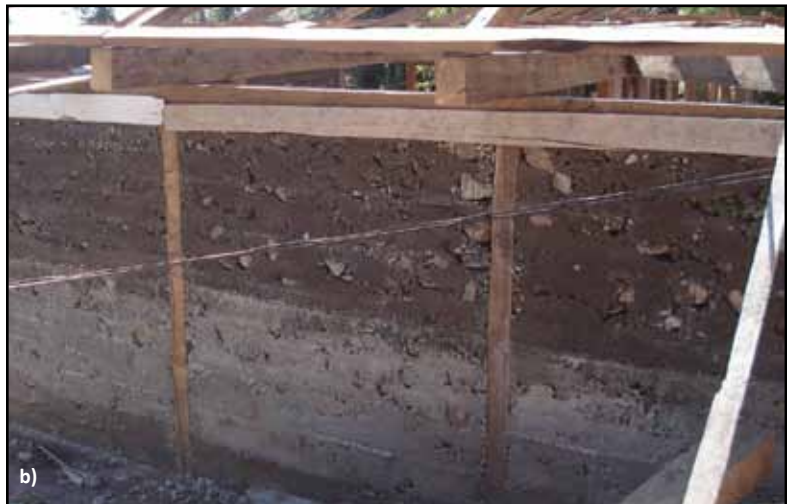
**Figure 1.16** Concrete wall construction using stone rubble: a) an ancient Roman concrete wall, and b) in-situ concrete construction with stone rubble in Pakistan (photos: T. Schacher)

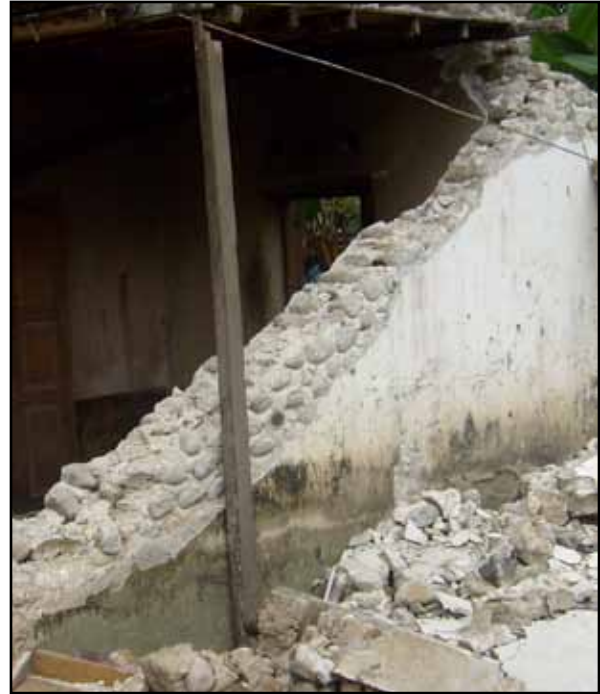
**Figure 1.19** Round stone boulders used for traditional stone masonry construction in Padang, Indonesia (photo: J. Bothara)

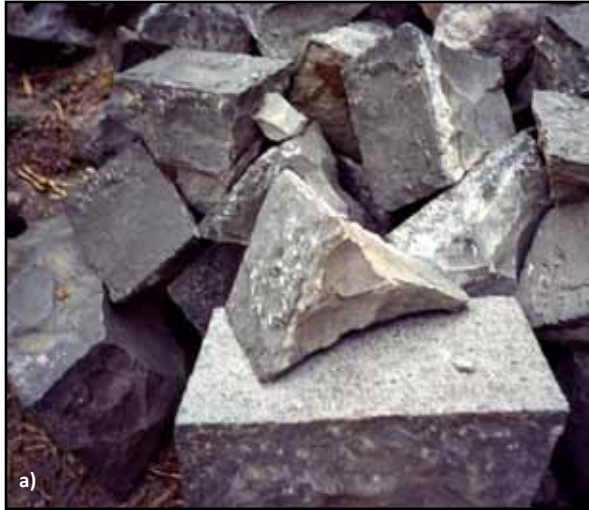
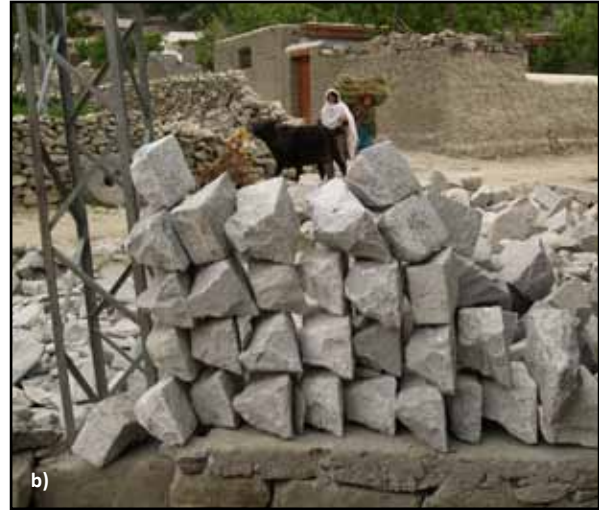
**Figure 1.21** Semi-dressed stones ready for wall construction: a) wedged stones in Maharashtra, India (photo: S. Brzev), and b) shaped stones in Pakistan (photo: T. Schacher)

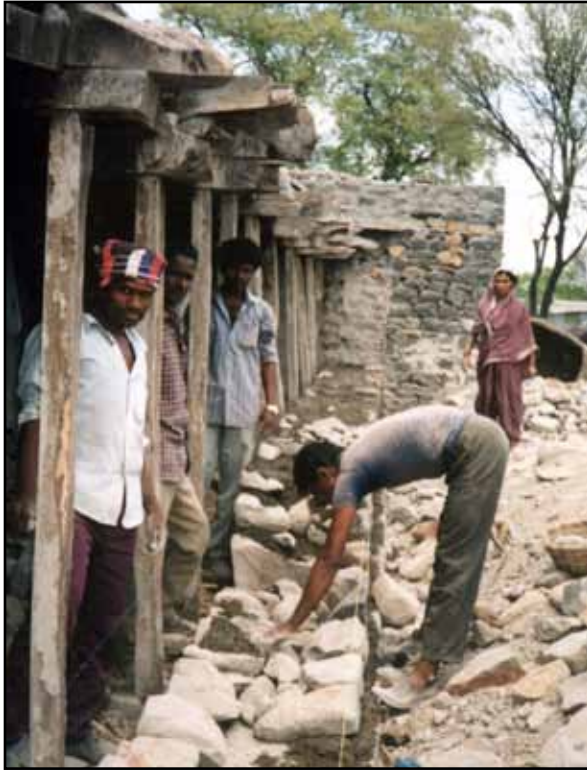
**Figure 1.23** Construction of an uncoursed random rubble stone wall in Maharashtra, India (photo: S. Brzev)

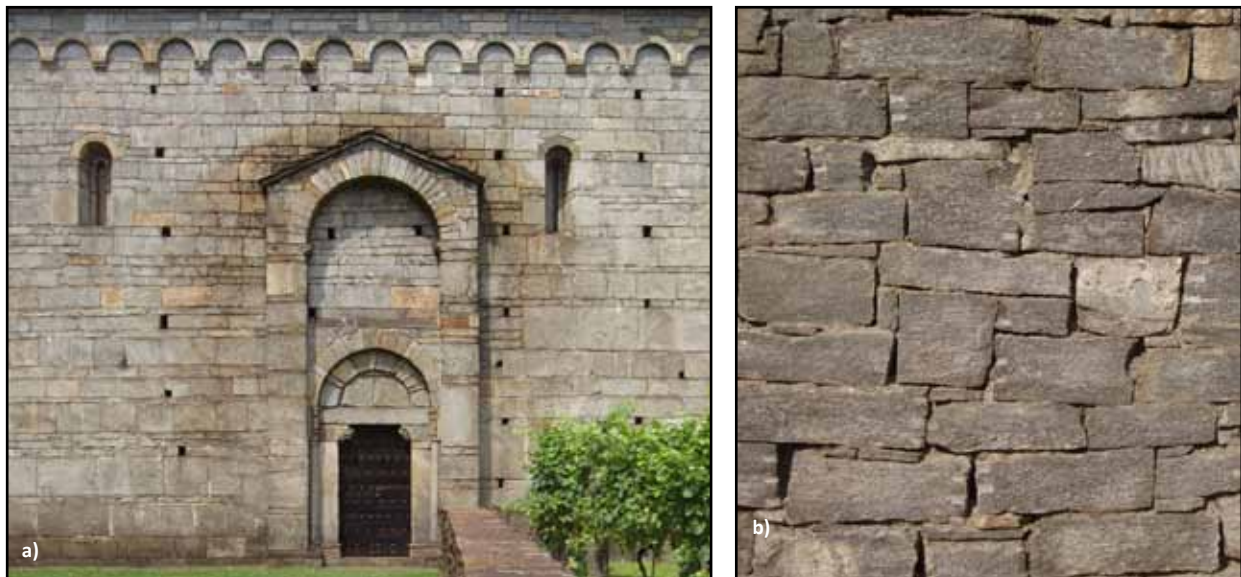
**Figure 1.32** Dressed stone masonry construction in Southern Switzerland: a) a typical building in Giornico, and b) a detail of the exterior (photos: T. Schacher)

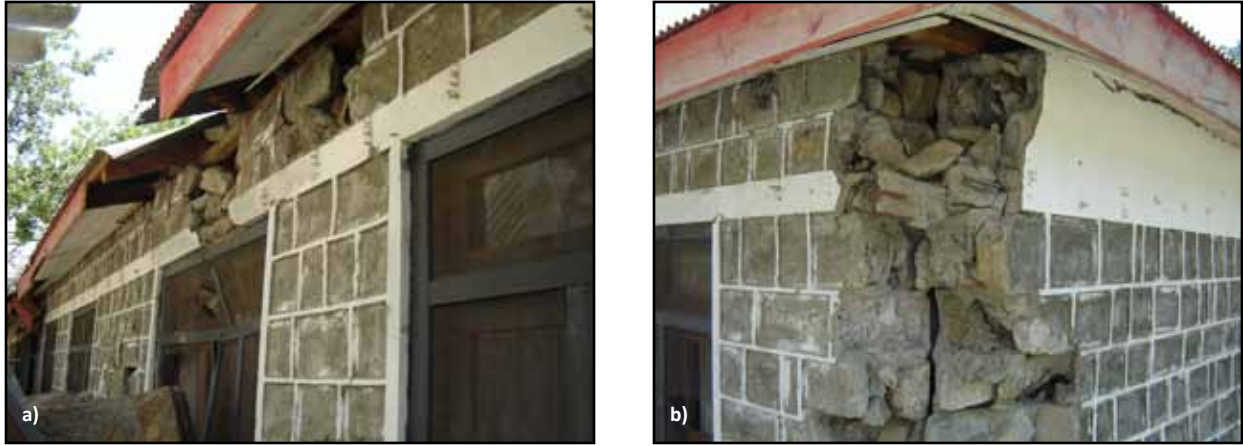
**Figure 2.11** A stone masonry building with an RC lintel band that survived the 2005 Kashmir earthquake in Pakistan: a) the building suffered only moderate damage in the top portion, and b) separation at the wall intersection took place in spite of the band (note inadequate anchorage of the band reinforcement) (photos: Builders Without Borders)

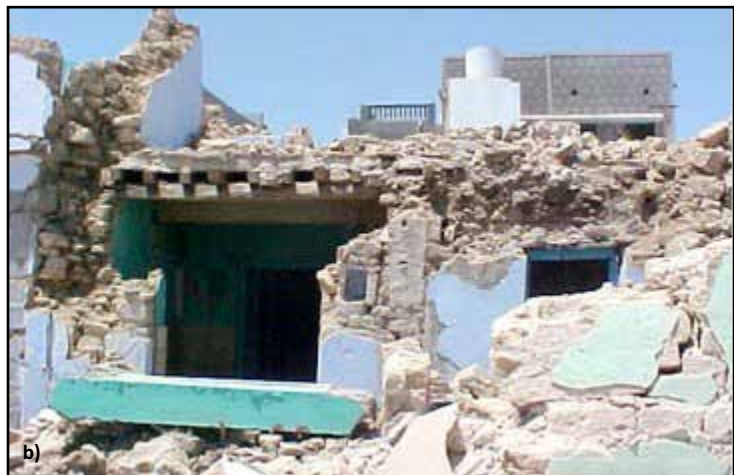
**Figure 2.14** Roof deficiencies in the area affected by the 2001 Bhuj, India, earthquake: a) discontinuous rafters over interior walls, and b) inadequate wall-to-floor connections caused the severe building damage (photos: C.V.R. Murty)

In the Anjar area of Gujarat, India, which was affected by the 2001 Bhuj earthquake, buildings are characterized by thick stone masonry walls (thickness around 750 mm) built in sandstone and lime mortar (Jain et al. 2002). In this area, the traditional buildings have timber roofs with rafters spanning two walls in a room, instead of spanning the full length of the building. As a result, the floor in each room acted as an independent system, and had a tendency to pull apart from the other floors during the strong ground shaking. This caused a partial or total collapse of many stone masonry buildings in the area (Figure 2.14).

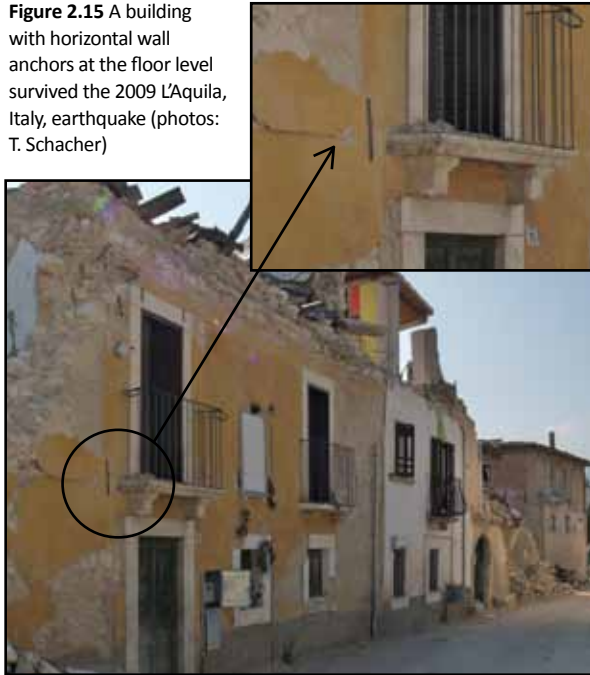
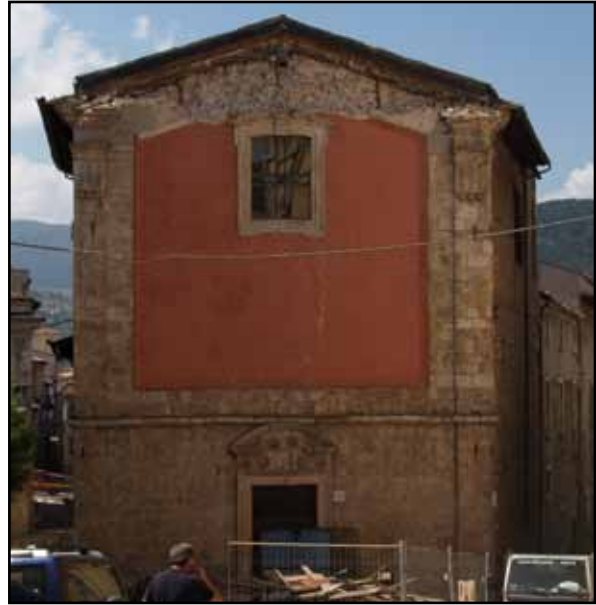
**Figure 2.16** A building with roof-to-wall anchors survived the 2009 L'Aquila, Italy, earthquake (photos: T. Schacher)

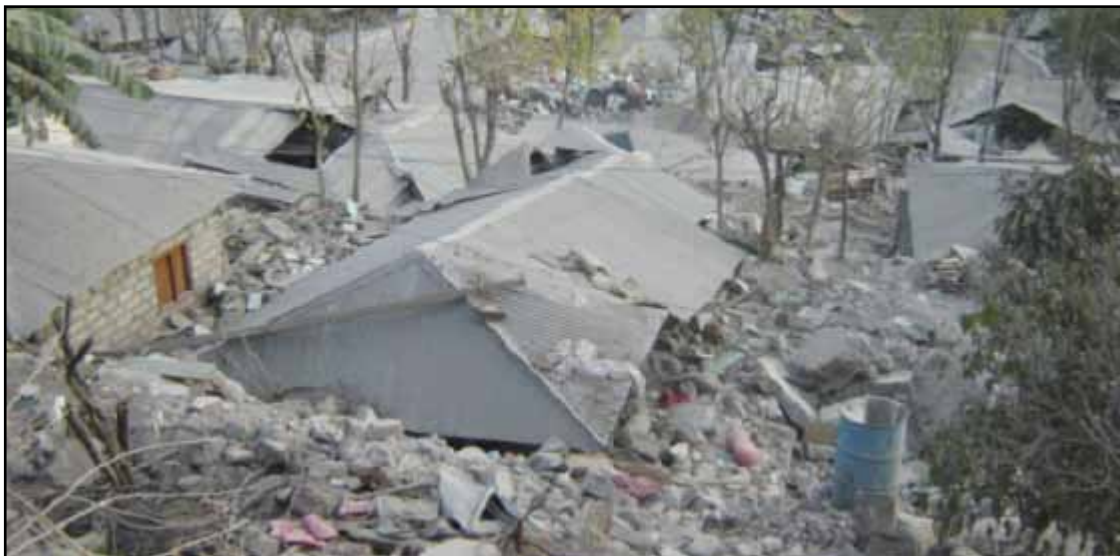
**Figure 2.17** Collapse of stone masonry buildings with hipped roofs in the 2005 Kashmir, Pakistan, earthquake (source: Bothara and Hıçyılmaz 2008)

the 2005 Kashmir, Pakistan, earthquake. These buildings have a few important seismic deficiencies, such as an absence of effective ties or ring beams (bands) at the eaves level (beneath the roof), inadequate wall-to-roof anchorage, and an absence of through-stones in the walls. Buildings of this type showed poor performance in the earthquake due

to the collapse of stone masonry walls, as shown in Figure 2.17. It should be noted that the seismic performance of hipped roofs in the earthquake was excellent in terms of maintaining their integrity and shape. After the earthquake, people were able to lift the roof of their collapsed house and rebuild the walls (Bothara and Hıçyılmaz 2008).

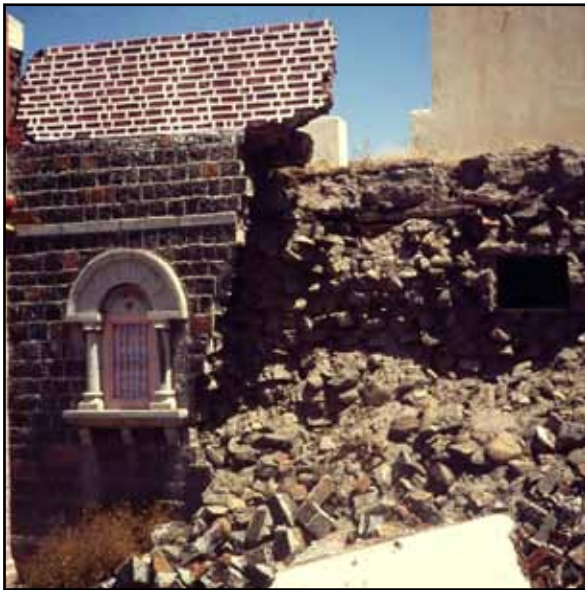
**Figure 2.23** Delamination was a common damage pattern observed in the 1993 Maharashtra, India, earthquake (photos: S. Brzev)

Delamination of the wythes in stone masonry walls has been observed in several earthquakes around the world, as shown in Figures 2.22 and 2.23. Delamination is usually initiated in the upper portion of the wall, and the appearance of the damaged wall is as if the exterior wythe has been peeled off. It was reported after the 2002 Molise earthquake in Italy that “spreading (delamination) damage in stone masonry walls begins at the top of the building, where the lack of overburden weight allows the masonry to vibrate apart. The stability of the wall can be most at risk when the masonry units vary in size and are laid with a minimum of horizontal bedding” (Decanini et al. 2004).

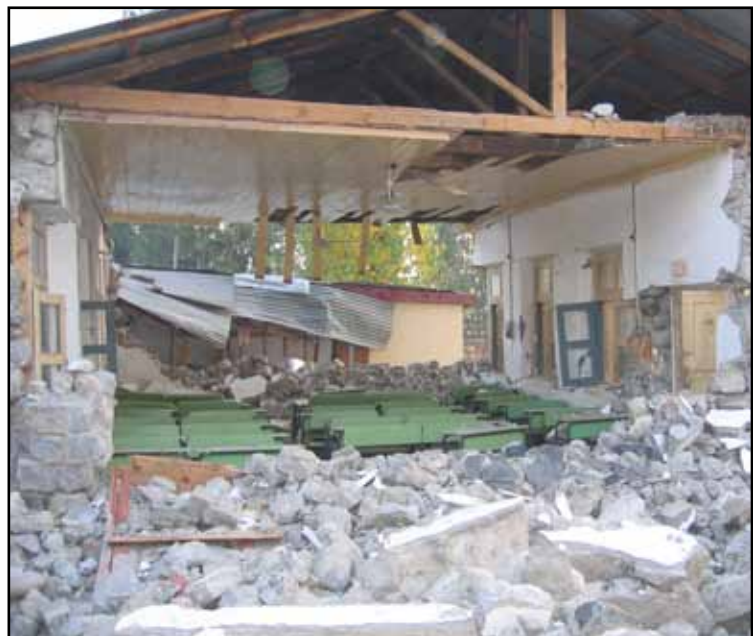
**Figure 2.28** Out-of-plane collapse of two parallel walls, NWFP Pakistan (photo: SDC)

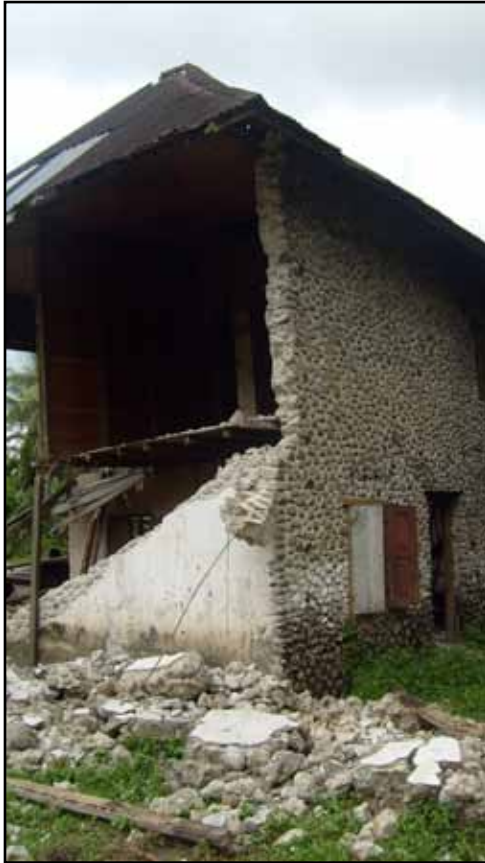
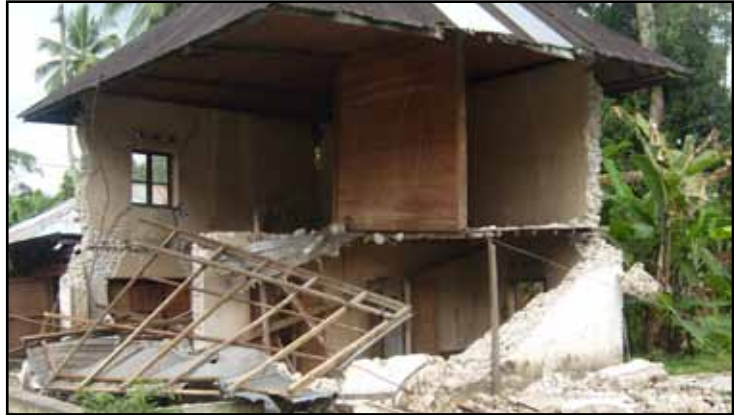
**Figure 2.29 (left and above)** Out-of-plane collapse of stone masonry walls in the 2009 Padang, Indonesia, earthquake (source: Bothara et al. 2010)

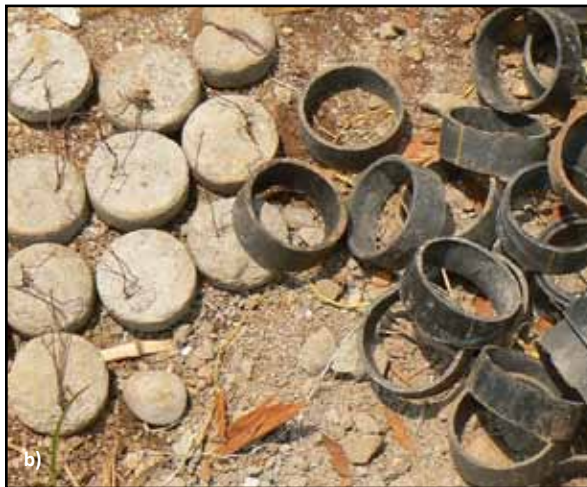
**Figure 3.19** Concrete cover in RC bands: a) exposed bars due to inadequate cover, b) concrete spacers made from PVC pipes, and c) RC band under construction showing use of concrete spacers (photos: Smart Shelter Foundation)

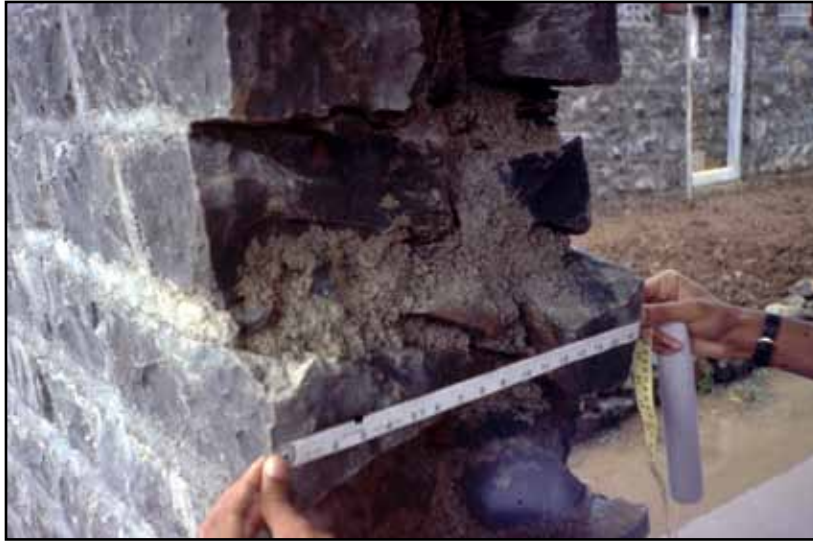
**Figure 3.27** Examples of stone masonry in cement mortar with a wall thickness limited to 450 mm (note through-stones) (photos: S. Brzev)

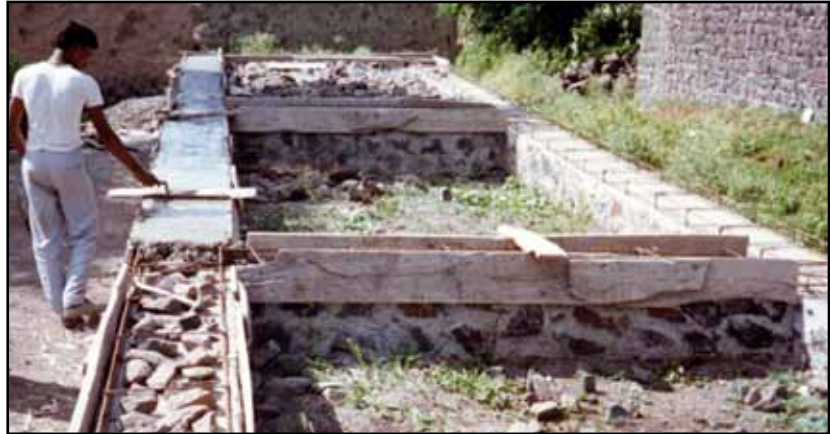
**Figure 3.39** Construction of an RC plinth band using large stone rubble (also known as "stone-crete") (photo: S. Brzev)

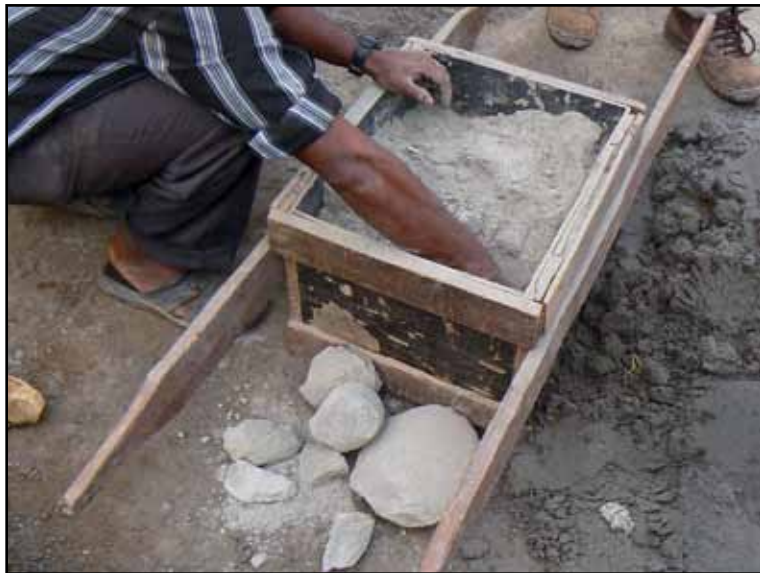
**Figure 3.43** Cement with large lumps should not be used for construction (photo: Smart Shelter Foundation)

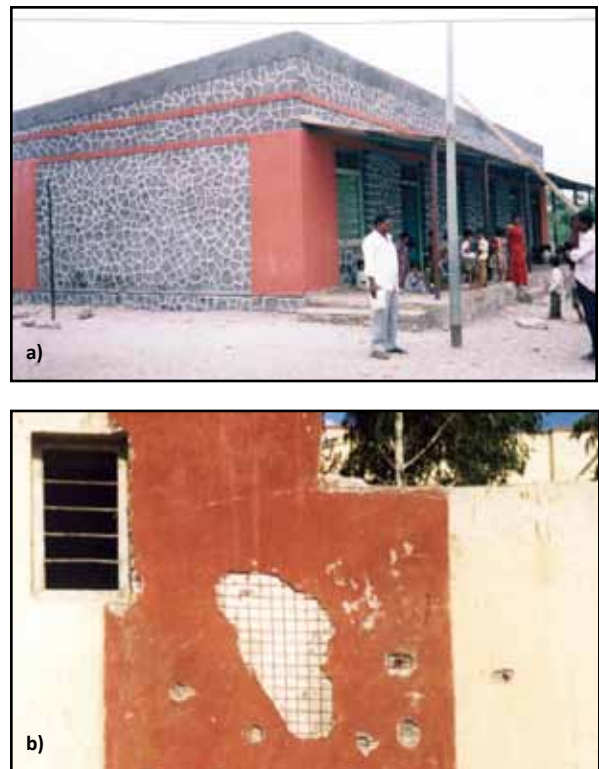
**Figure 4.11** Strengthening of intersecting walls: a) retrofitted school building in India, and b) an unsuccessful retrofit application (photos: S. Brzev)

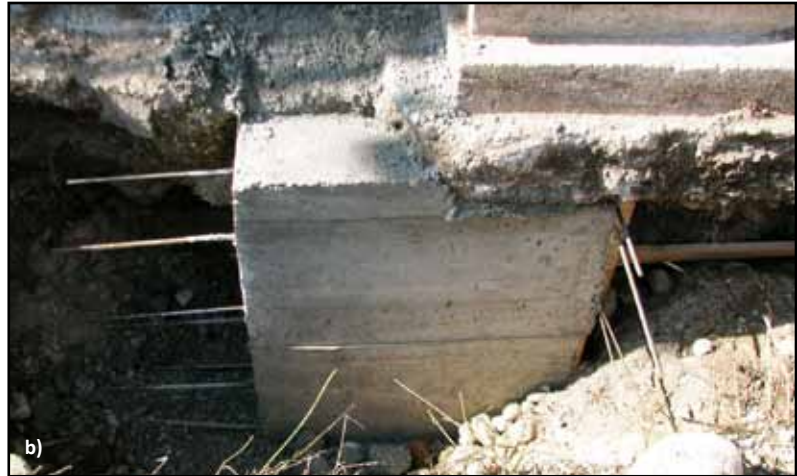
**Figure 4.30** Strengthening a stone masonry foundation: a) reinforcement cage and formwork, and b) new reinforced concrete foundation under construction (photos: M. Lutman)
