World Housing Encyclopedia

HOUSING REPORT

Non-engineered unreinforced brick masonry building

Report#	10
Last Updated	
Country	Colombia
Author(s)	Luis Gonzalo Mejia,
Reviewers	Sergio Alcocer,

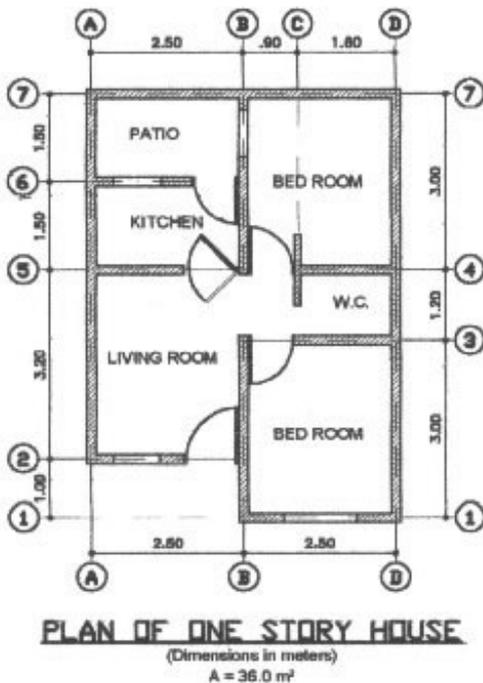
Plan of a Typical Building

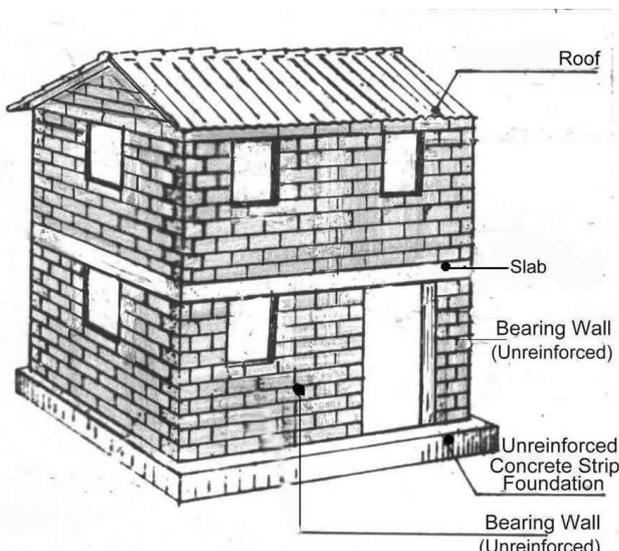
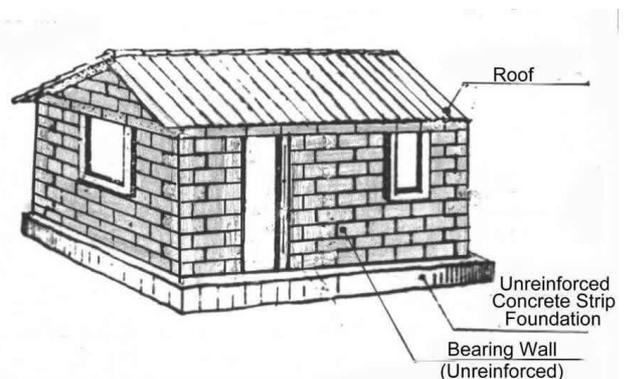
Key Load-bearing Elements

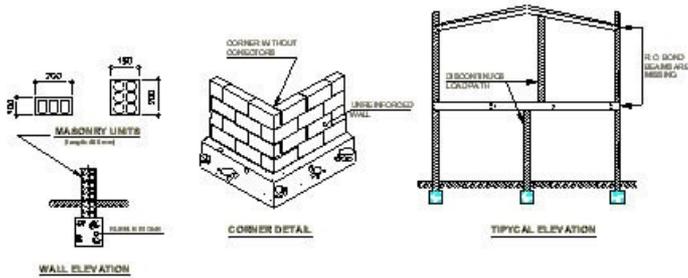
Wall Elevation

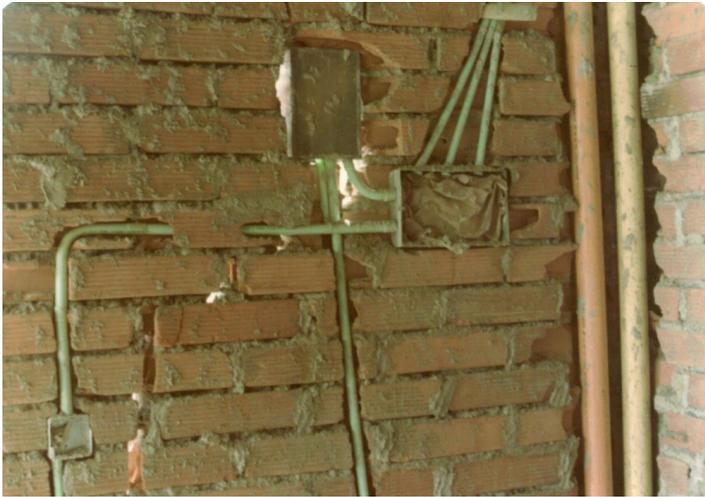
Key Seismic Deficiencies: Wall Weakness due to Electrical and Water Conduits

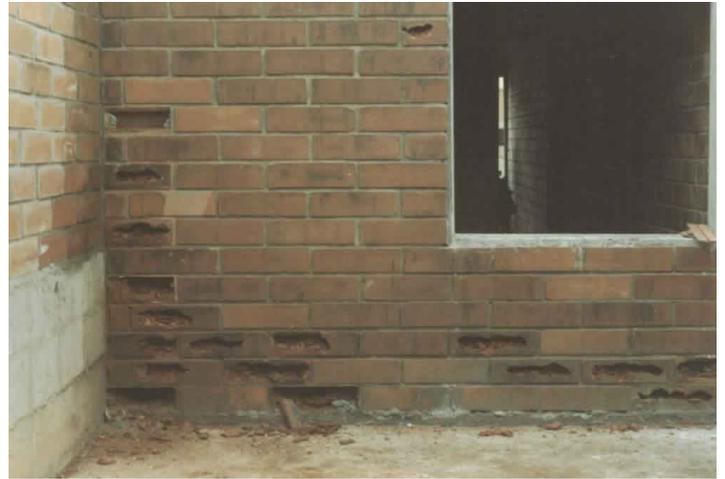
Key Seismic Deficiencies: Poor Quality of Materials

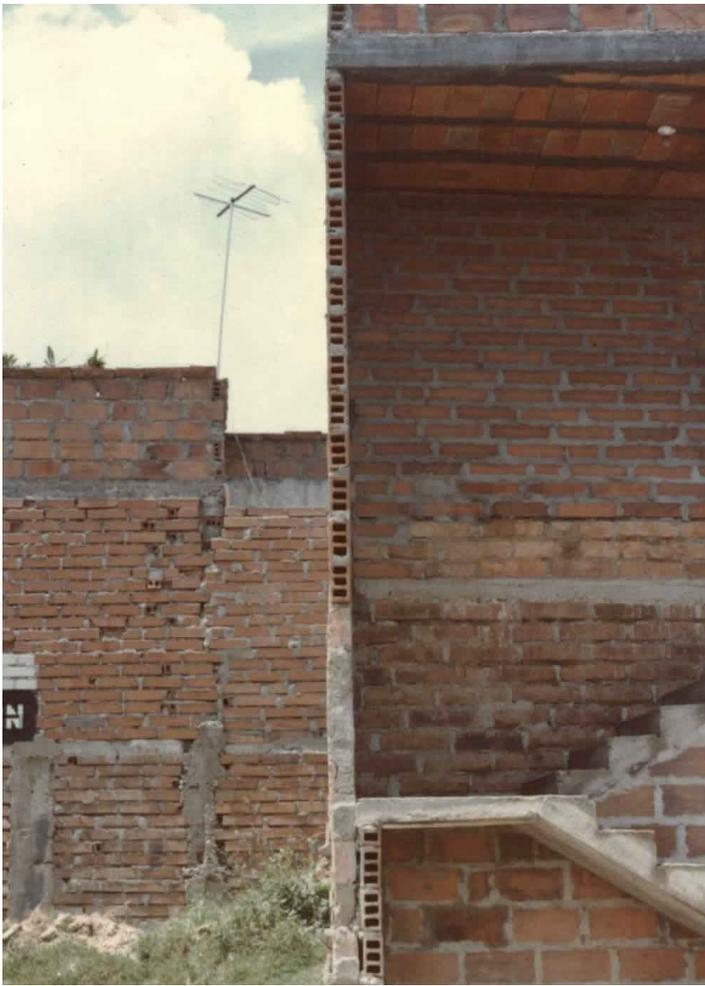
Key Seismic Deficiencies: Very Slender Walls

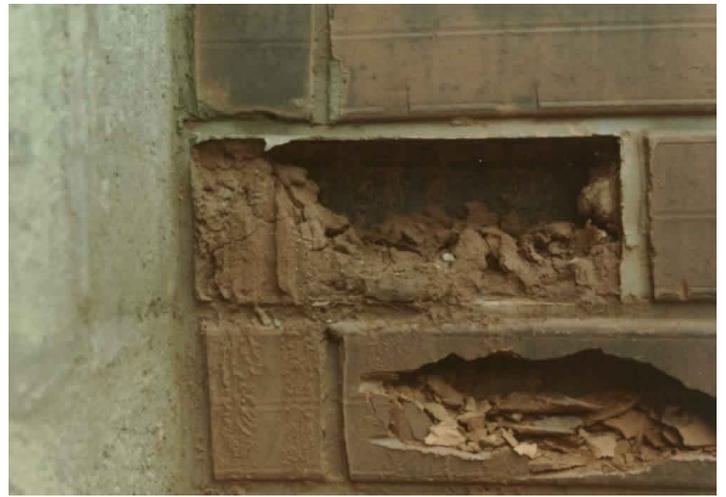
Key Seismic Deficiencies: Poor Quality of Materials

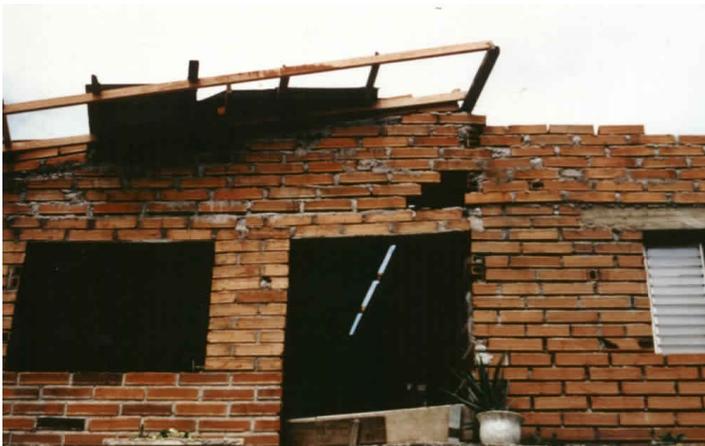
Key Seismic Deficiencies: Discontinuous Boundary Members

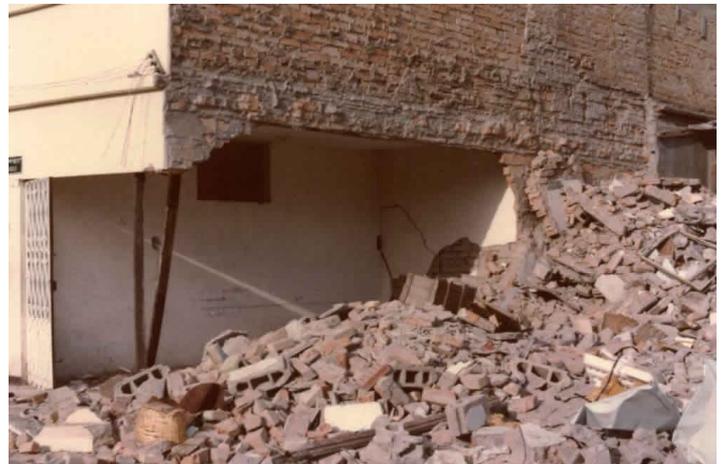
Typical Earthquake Damage: Partial Collapse

Majority of buildings of this type suddenly collapsed, killing inhabitants, particularly in the areas with pronounced soil amplification effects.

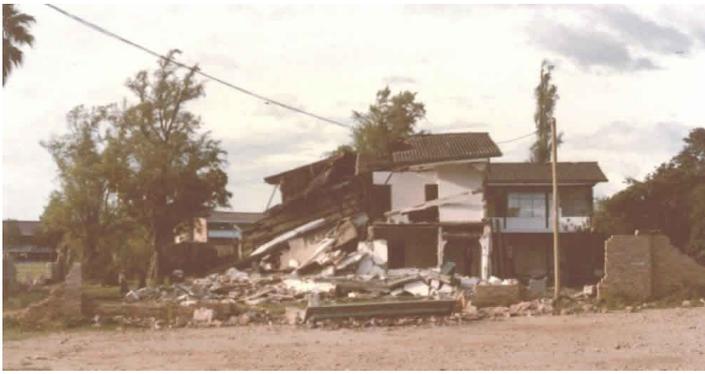
**Typical Earthquake Damage:
Structural Collapse**

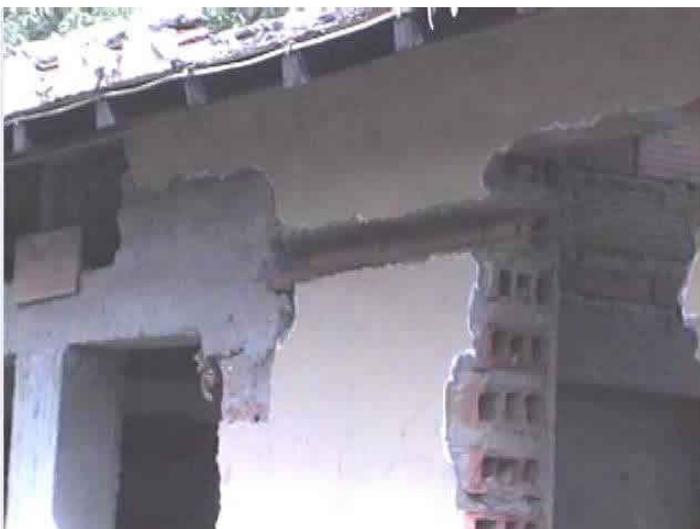
***Seismic-strengthening Techniques:
Construction of New Columns and
Bond Beams***

Although improbable for economic reasons, this construction could be strengthened as follows: 1. New boundary members (chords and collectors) are added to floor and roof to ensure the integrity and diaphragm action. Roof and slabs are anchored to the walls to ensure the inertia force transfer to the walls, as illustrated in Figure 14. 2. Whenever possible, end elements (columns-posts) are added in the selected earthquake resistant walls, as illustrated in Figures 13 and 17. Wall cracks are stitched with reinforcement and grouted with mortar to restore the wall integrity. 3. A continuous RC beam is built atop the strengthened walls in order to improve the diaphragm action at the floor level, as illustrated in Figures 12, 13, and 16. It is considered that the implementation of the above described techniques would result a significant enhancement of seismic stability in buildings of this

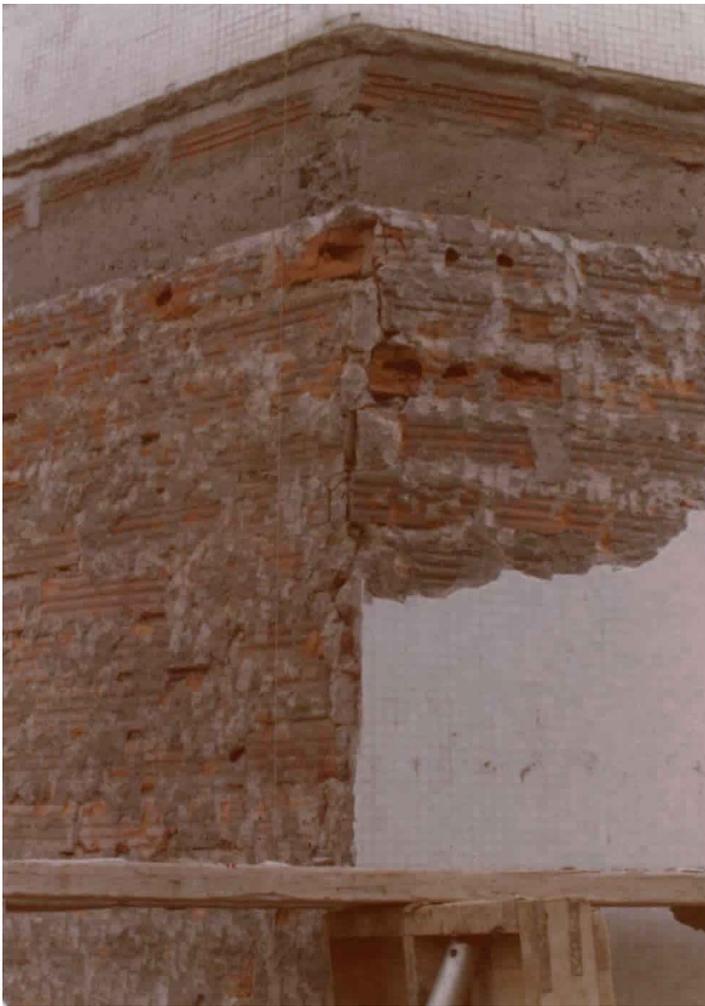
***Seismic-strengthening Techniques:
Construction of the Wall-Roof
Connection***

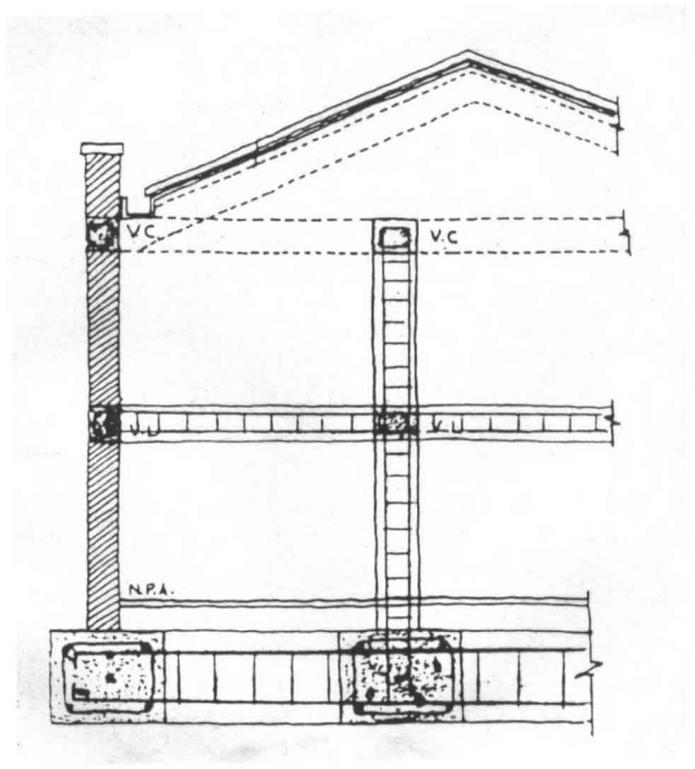
Seismic-strengthening Elements

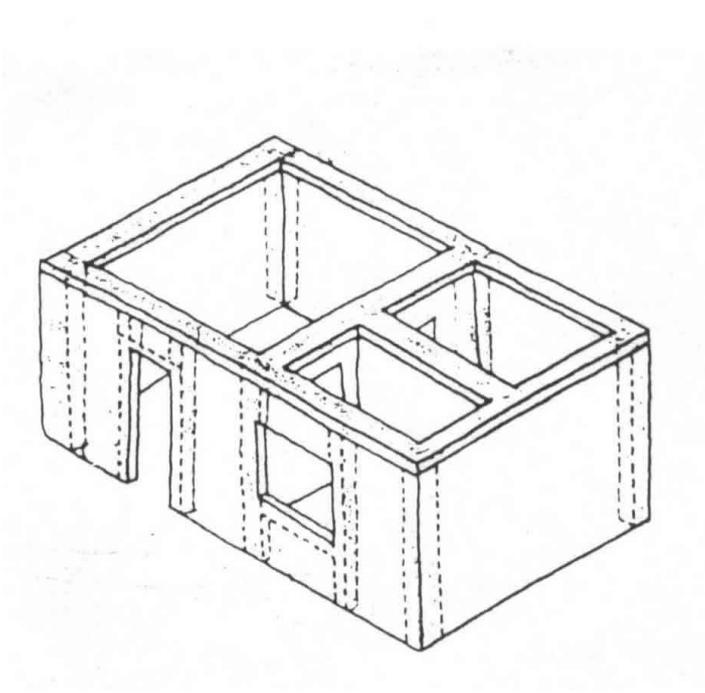
***Seismic-strengthening Techniques:
Construction of New RC Ring Beam***

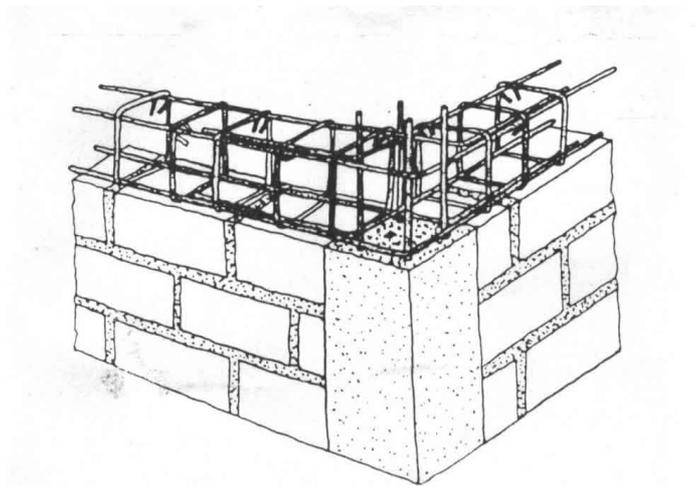
***Seismic-strengthening Techniques:
Construction of New RC Tie-
Columns***
