# World Housing Encyclopedia

## HOUSING REPORT **Adobe / Earthen House**

<b>Report#</b>	104
<b>Last Updated</b>	
<b>Country</b>	IRAN
<b>Author(s)</b>	Mehrdad Mehrain, Farzad Naeim,
<b>Reviewers</b>	Marcial Blondet,

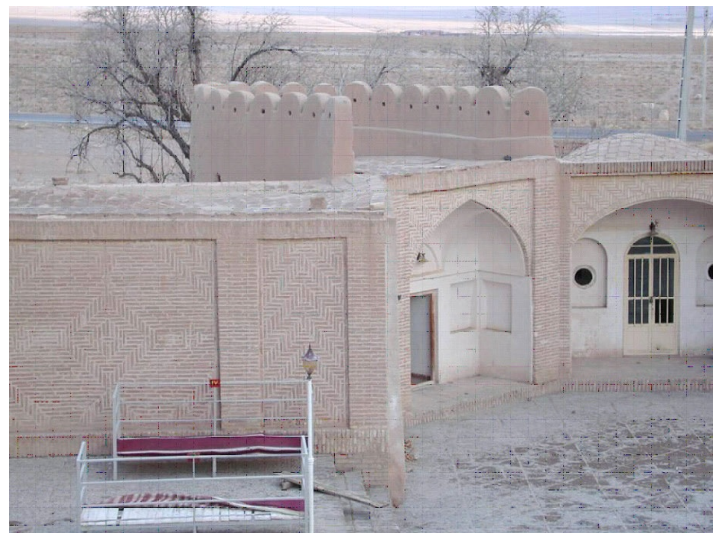
***Section of luxury adobe house.***

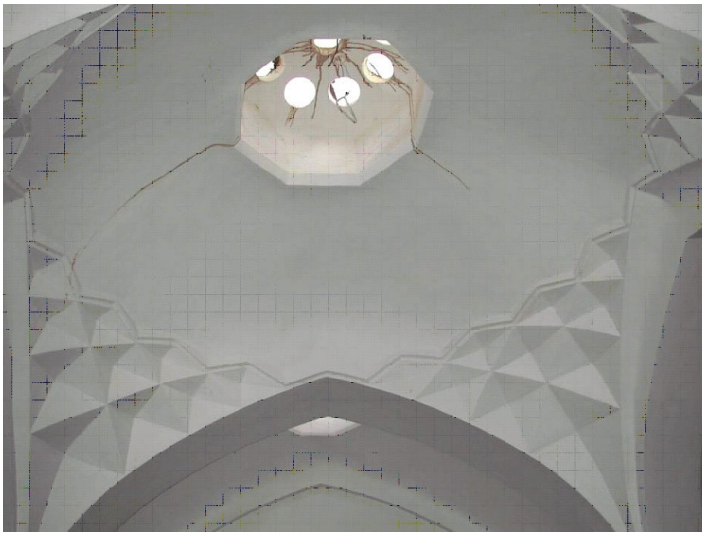
***Ceiling skylight in wealthy adobe dwelling***

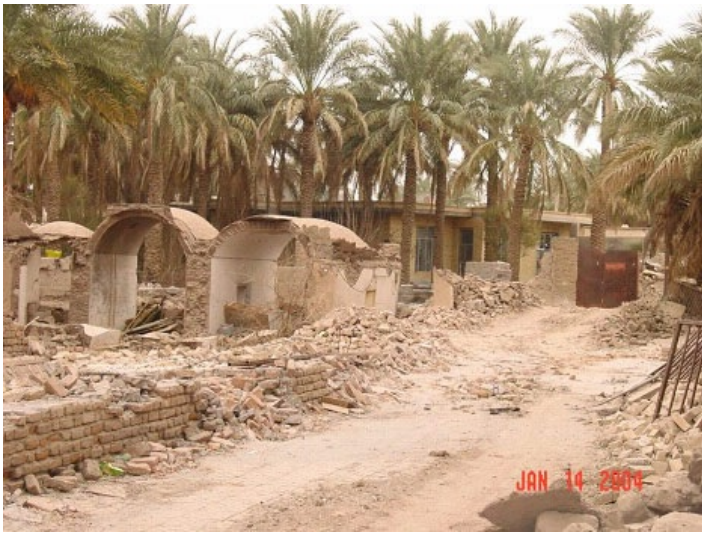
***Key Seismic Deficiency--buildings not well-tied together. Example of building collapse in Bam earthquake***

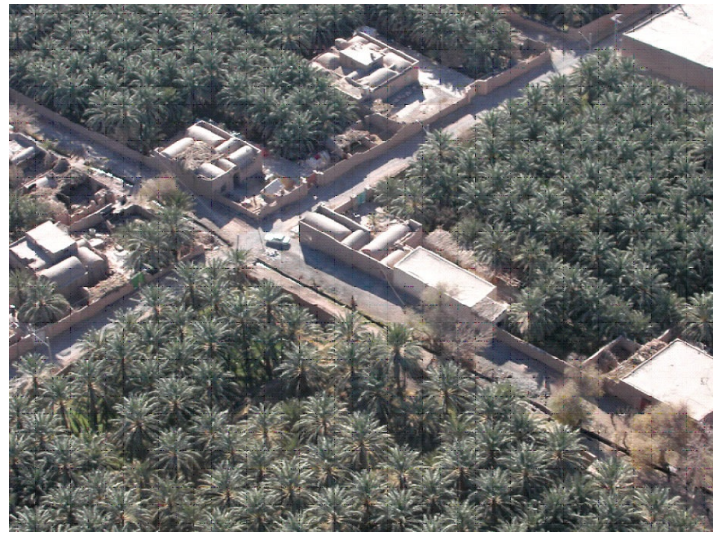
***Aerial view of roofs after Bam earthquake--multiple domes of each house are visible***

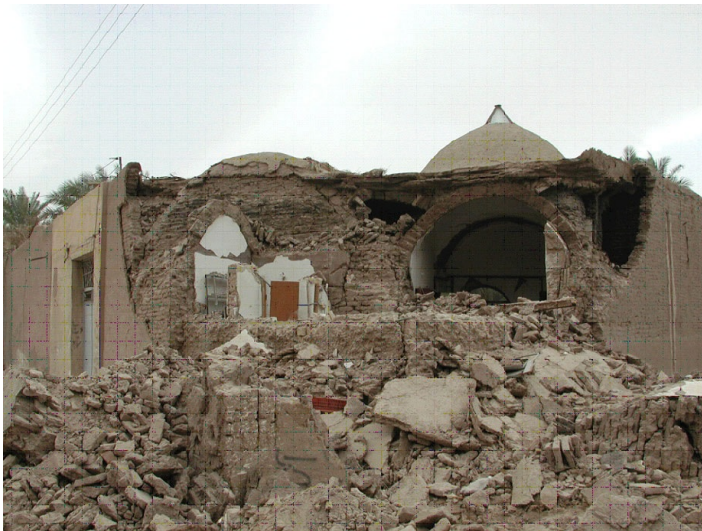
***Key Seismic Deficiency: walls are not tied to roof, and can move out-of-plane in an earthquake***

They are weak in the out of plane direction. The walls tips over or bend outwards.

It is made of weak materials. If the walls move out of plane, the roof collapses.

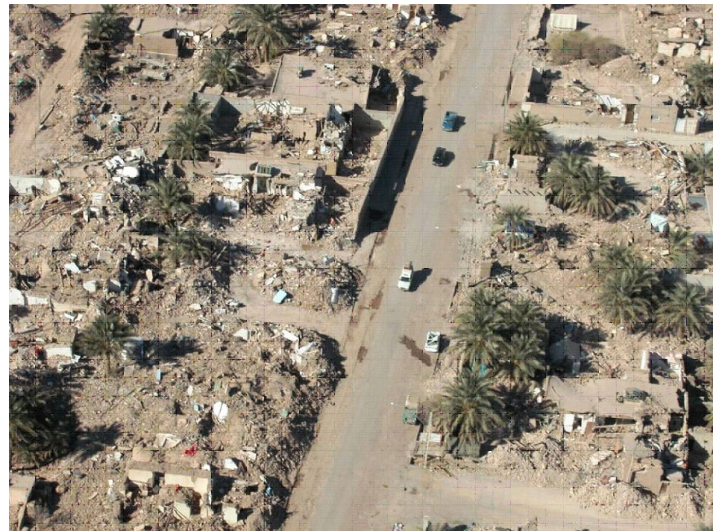
***Aerial view of complete destruction of adobe dwellings in Bam earthquake***

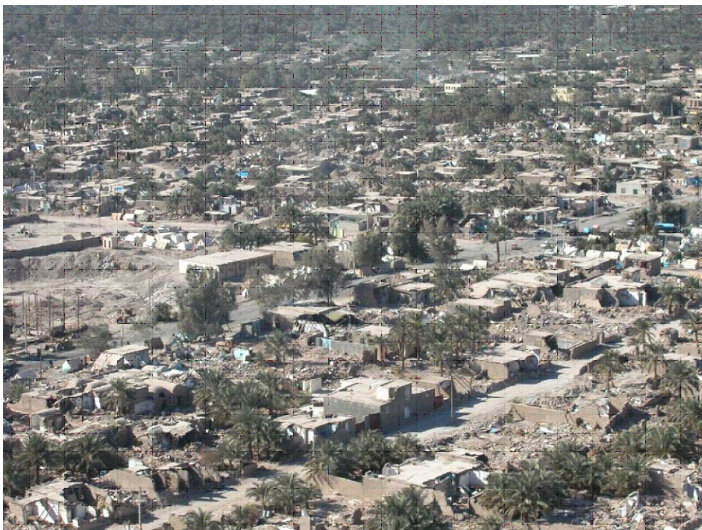
***Aerial view of neighborhood with widespread damage to adobe***

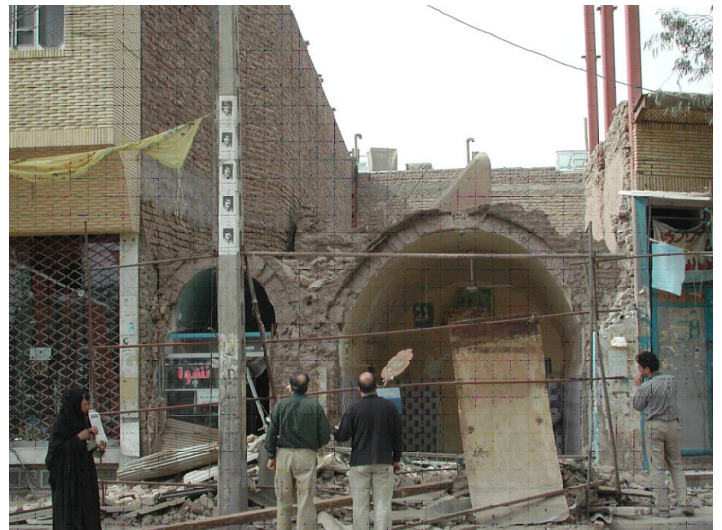
***If walls can be kept in-plane, building typically survives. Adobe***

**structures in Bam earthquake**

There are no earthquake resistant features. If the adobe walls can be kept in place, the seismic performance of the building will improve significantly .

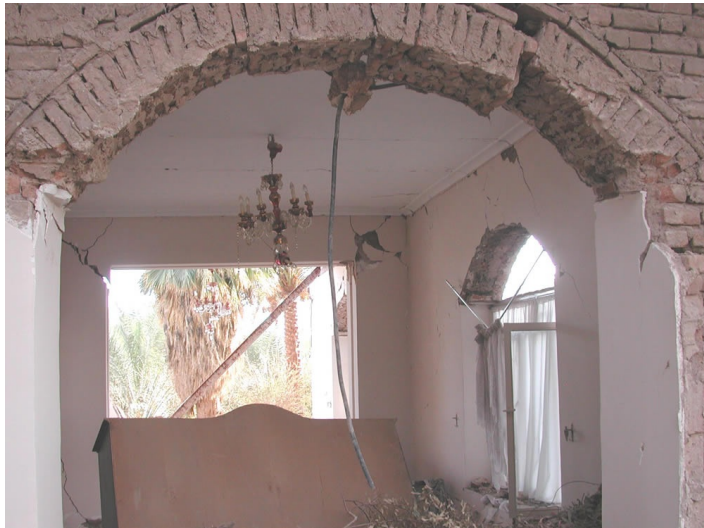
***Bam earthquake: Damage to a traditional adobe house. Non-bearing walls collapsed, bearing walls are still standing***

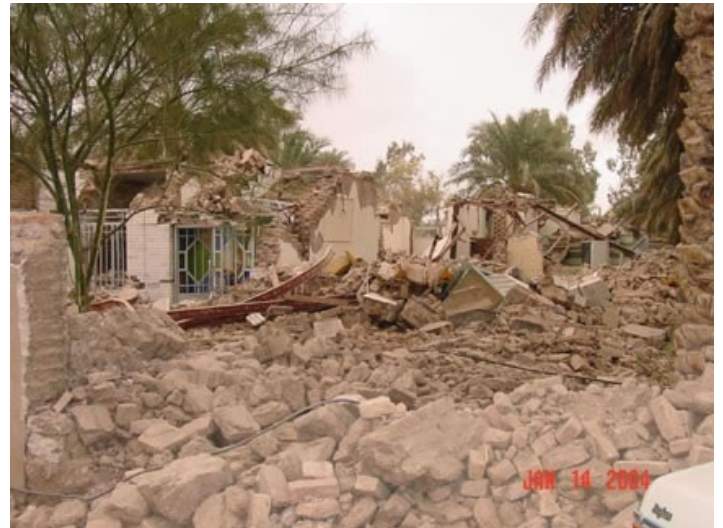
***Bam earthquake: collapsed adobe structures***

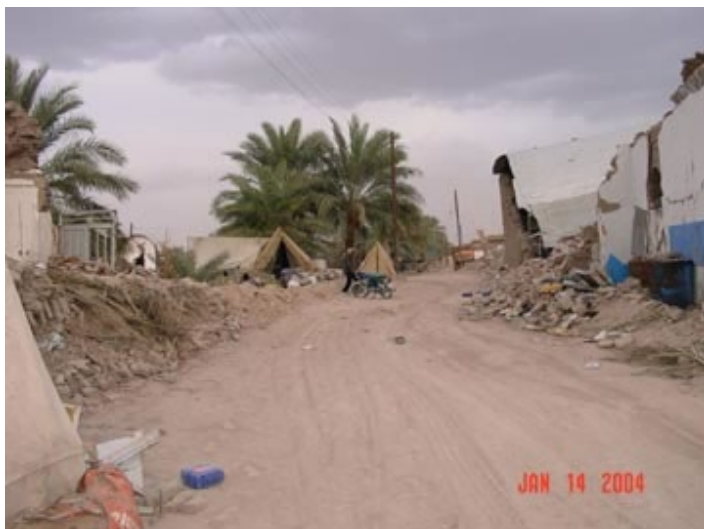
***Bam earthquake: debris cleared from roadway, partially collapsed adobe structures, tents***

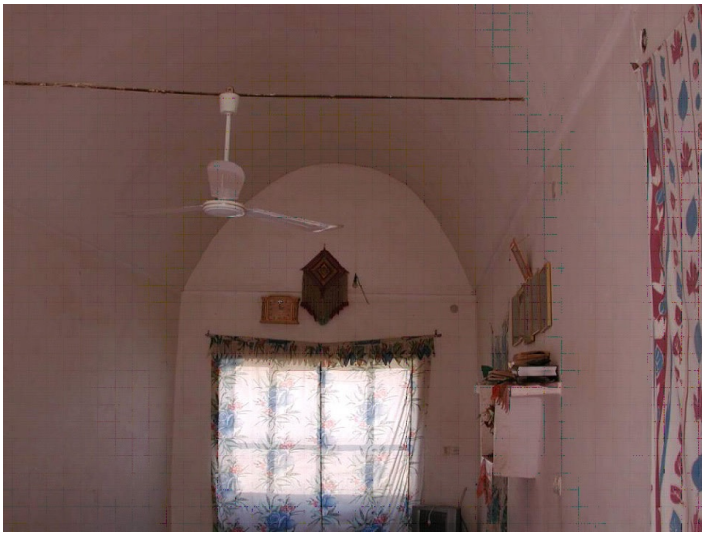
***Basic gravity strengthening technique used for several hundred years--iron rod across vaulted space, tying walls together (increases gravity resistance, not seismic resistance)***
