World Housing Encyclopedia

HOUSING REPORT

Gravity concrete frame buildings (predating seismic codes)

Report#	11
Last Updated	
Country	Colombia
Author(s)	Luis Gonzalo Mejia,
Reviewers	Sergio Alcocer,

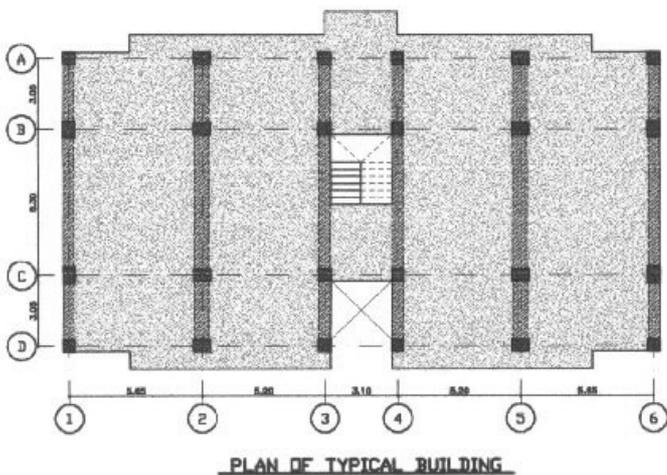
Plan of a Typical Building

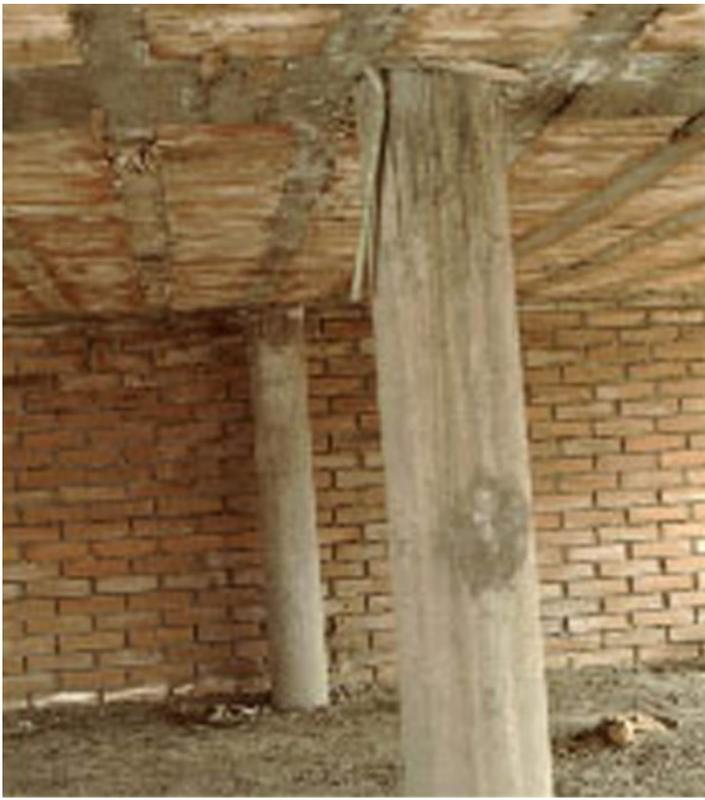
Poor Construction Practices: Beams constructed in one direction only

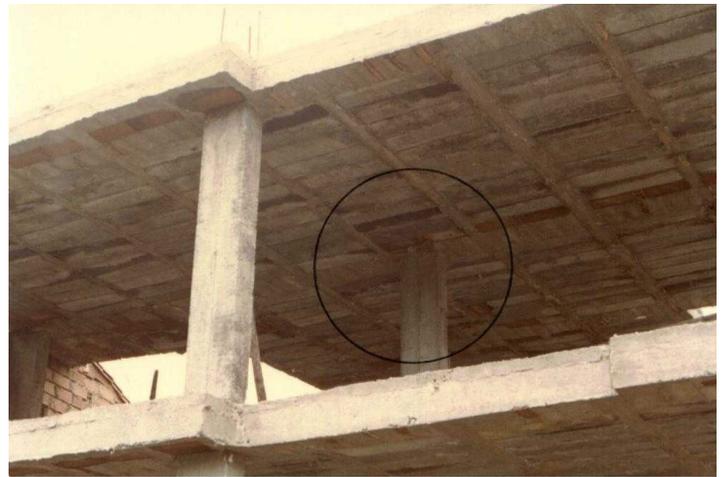
Poor Construction Practice: Beams constructed in one direction only

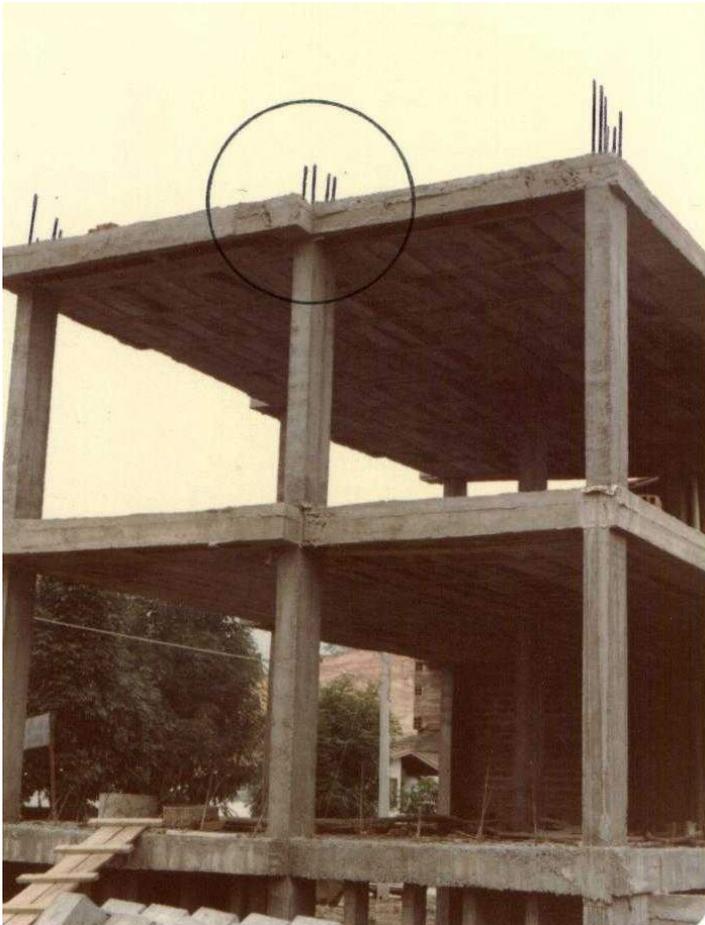
Poor Construction Practice: Inadequate splice length and location (100% splices at the column base)

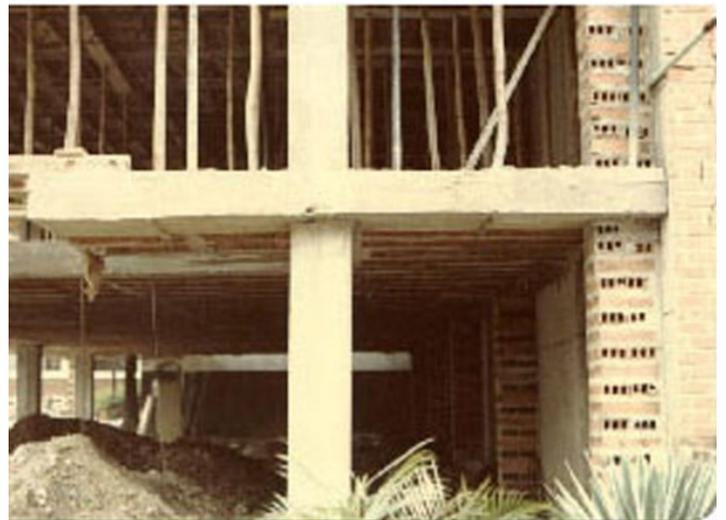
Poor Design: Combination of Concrete Frames and Unreinforced Masonry Walls or Pilasters

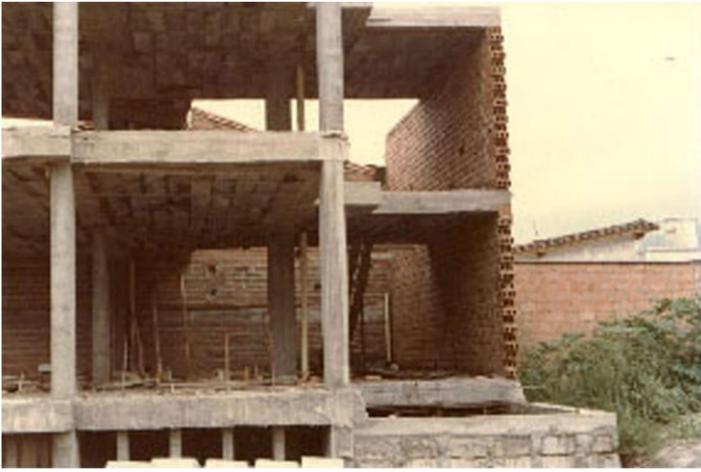
Poor Design: Combination of Concrete Frames and Unreinforced Masonry Walls or Pilasters

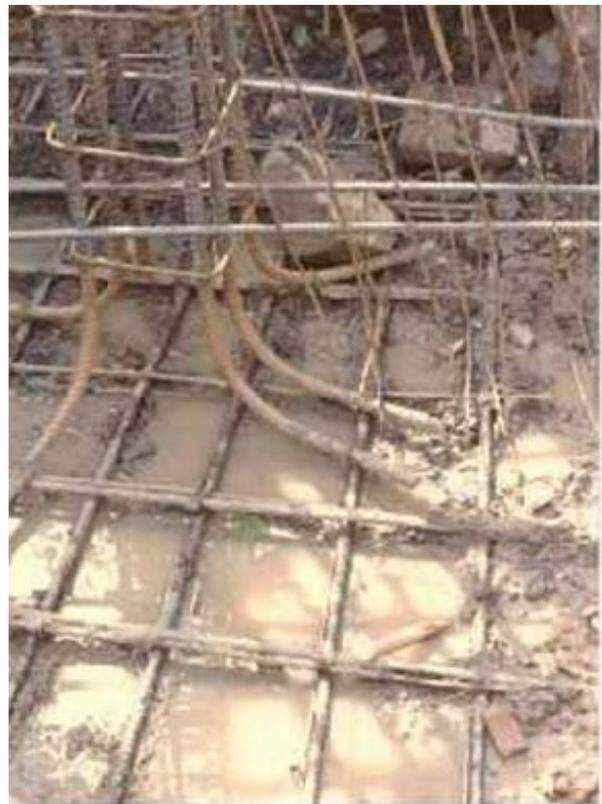
Poor Workmanship: Dirty groundwork and inappropriate column and beams

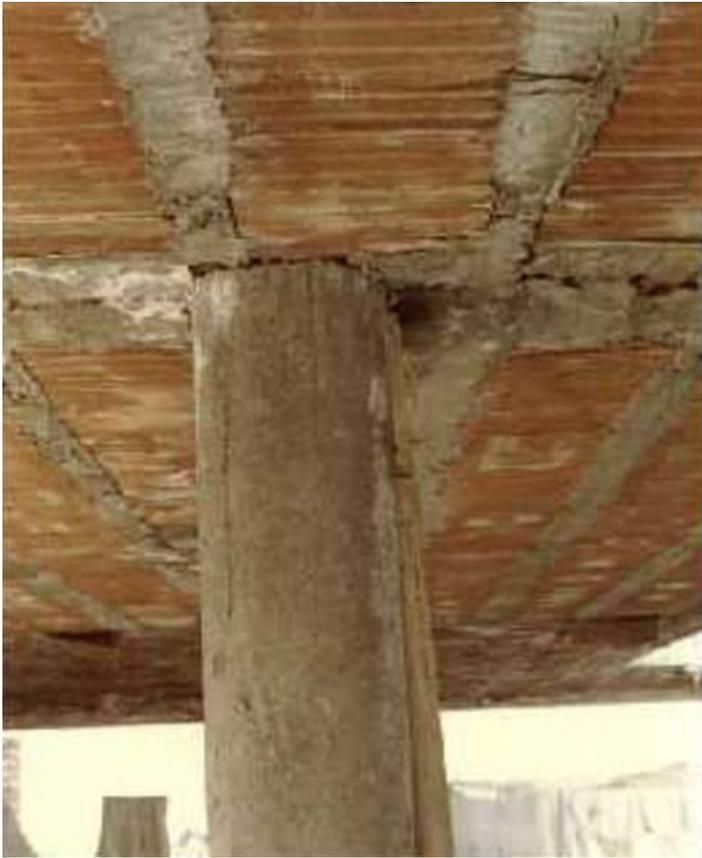
Poor Construction Practice: Drains running across the girders. Stirrups are removed to allow for the pipeline passage

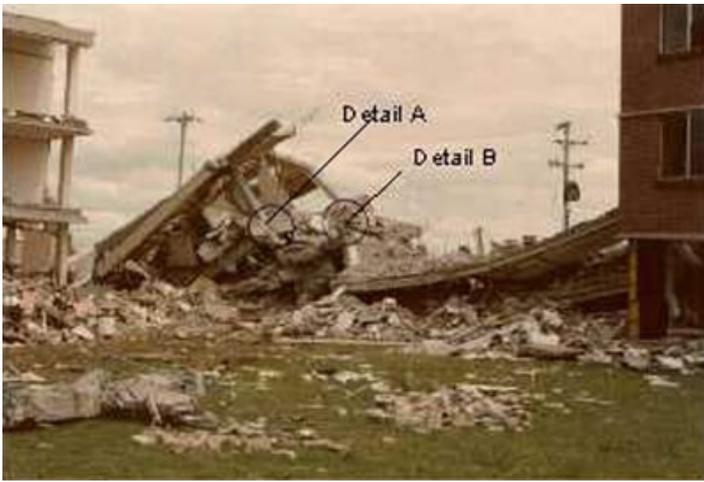
Earthquake Damage: Collapsed Building

Most buildings of this type collapsed, killing the inhabitants, especially in the areas with pronounced soil amplification. Typical patterns of earthquake damage are illustrated in Figures 14, 15, 16 and 17. The figures confirm the importance of good construction practice and its impact on seismic performance.

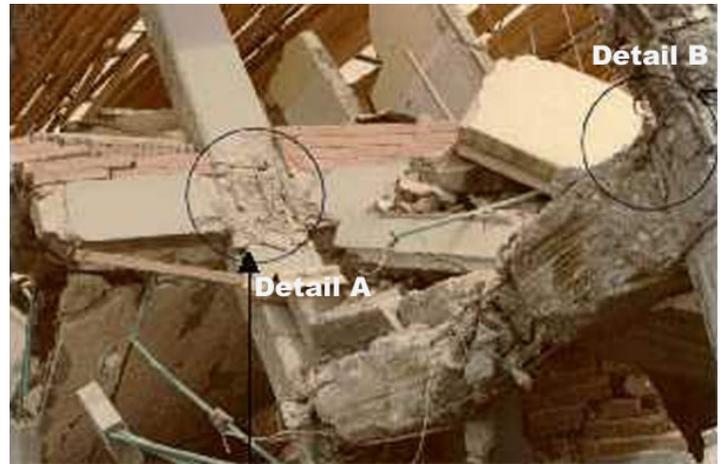
Earthquake Damage: Reinforcement splices in the joint zone (Detail A)

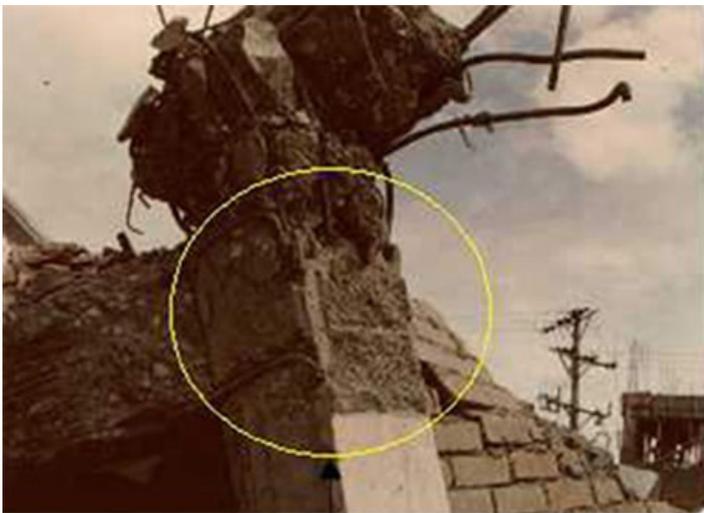
Earthquake Damage: Anchorage of beam reinforcement in the column cover area (It would be correct to anchor the reinforcement inside the joint.) Detail B

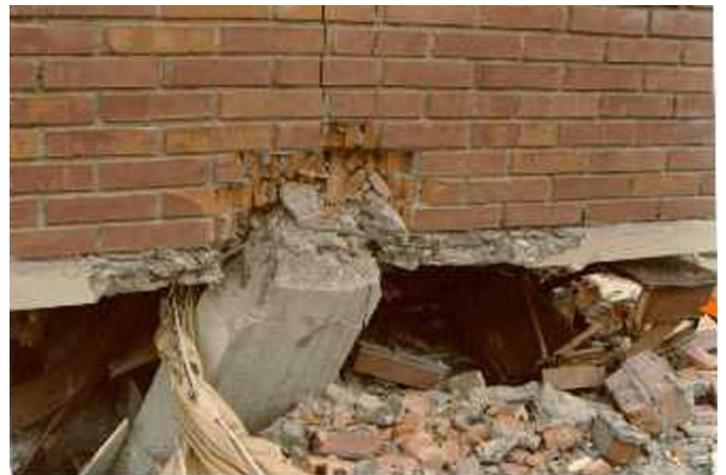
Earthquake Damage: Inadequate longitudinal and transverse reinforcement (Note the collapsed first story.)

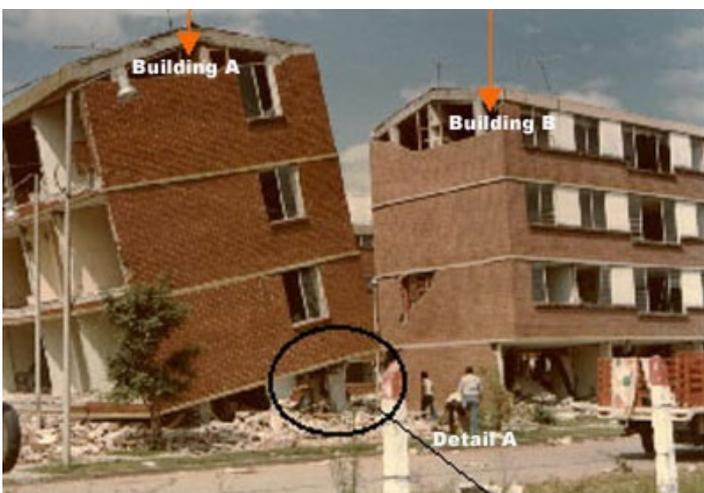
Collapsed building: Detail A shows too widely spaced stirrups

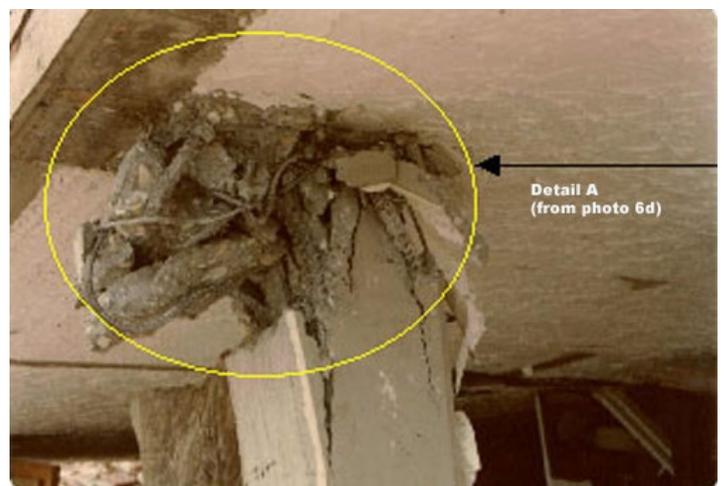
Collapsed building: Detail A shows too widely spaced stirrups

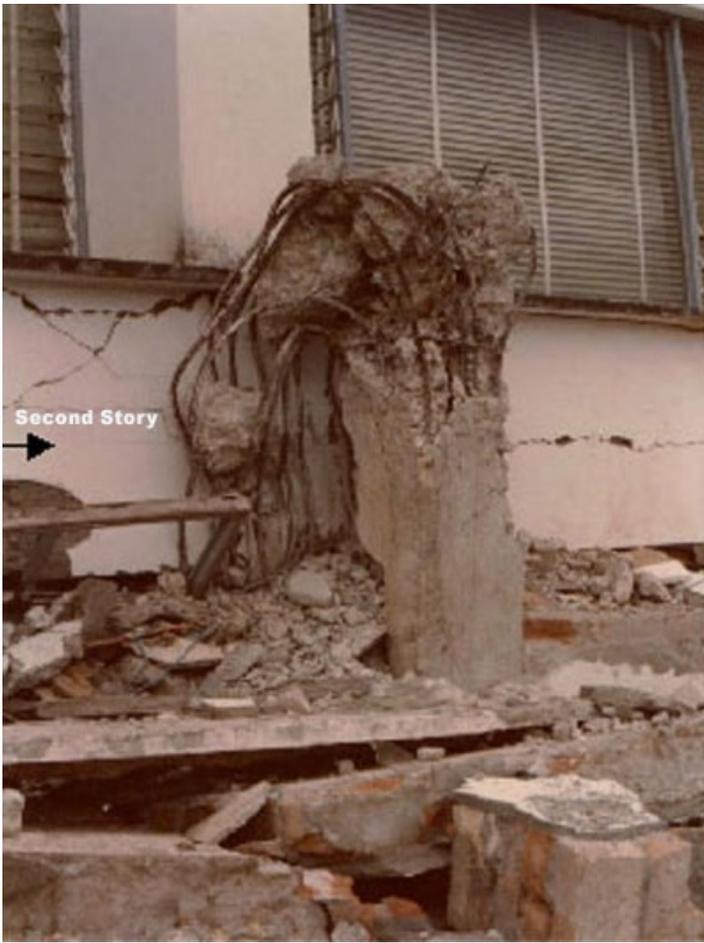
Collapsed 3-story building. (Note the total lateral drift between the 2nd and 3rd floor.)

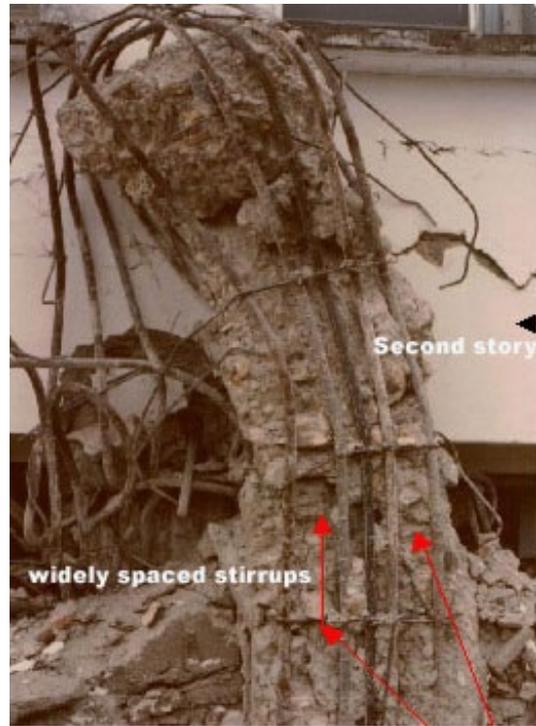
First-story column collapse due to the widely spaced stirrups and poor quality of aggregate

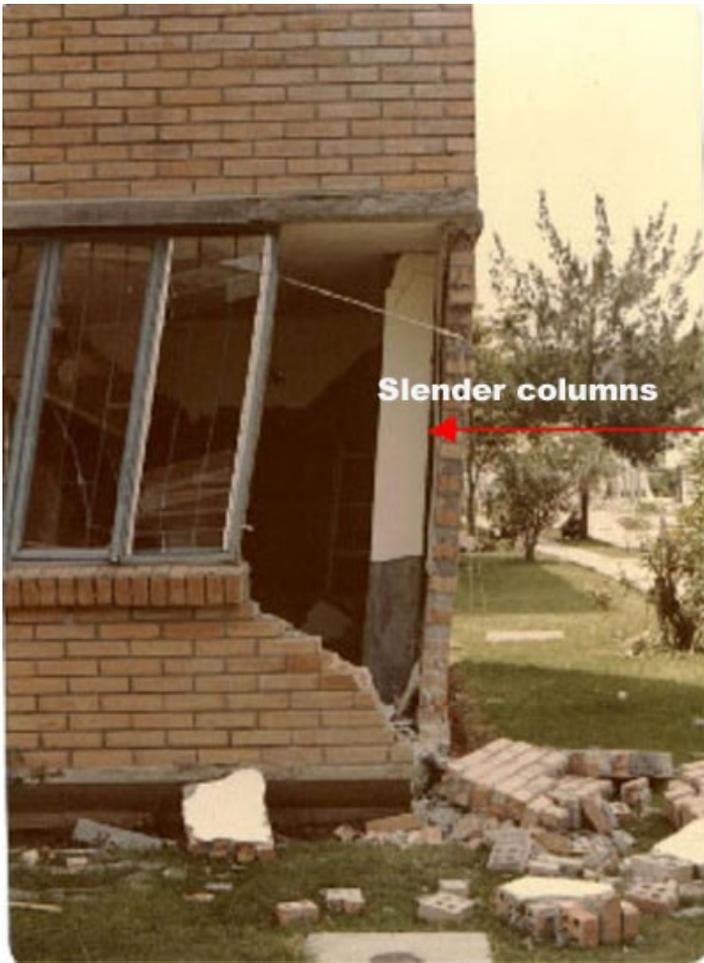
Earthquake Damage: Very Slender Columns

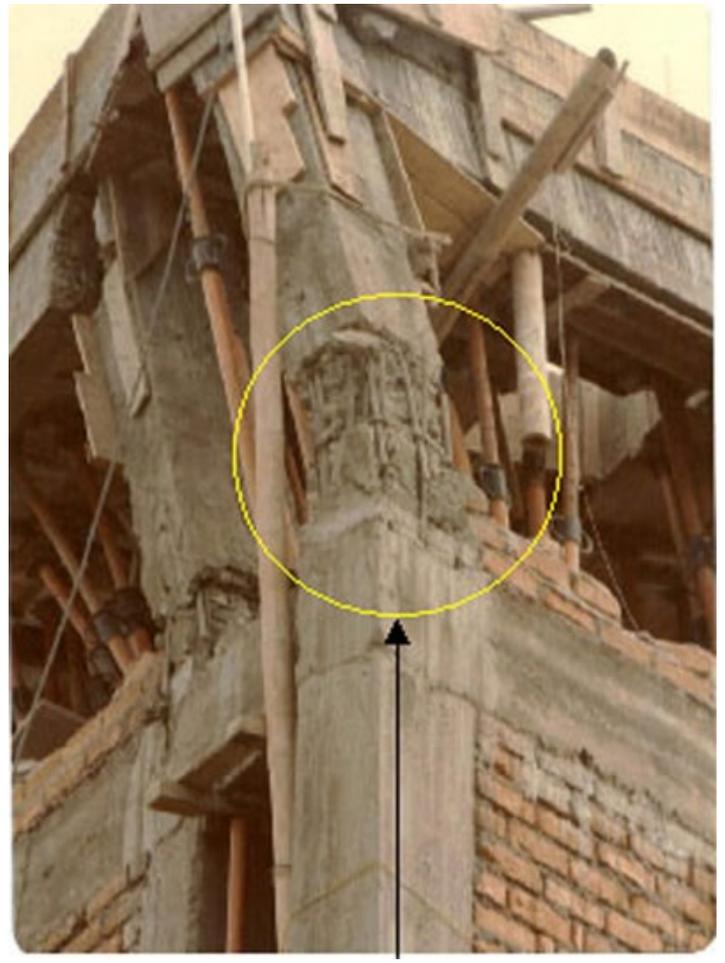
Earthquake Damage: Inadequate Columns Splices

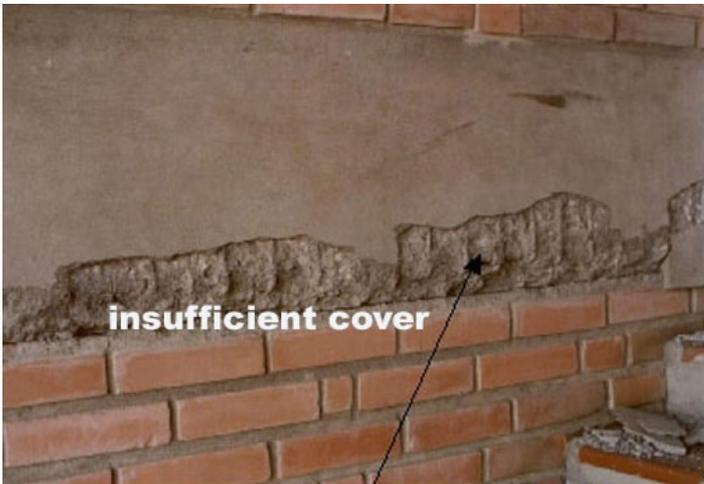
Earthquake Damage: Inadequate Concrete Cover

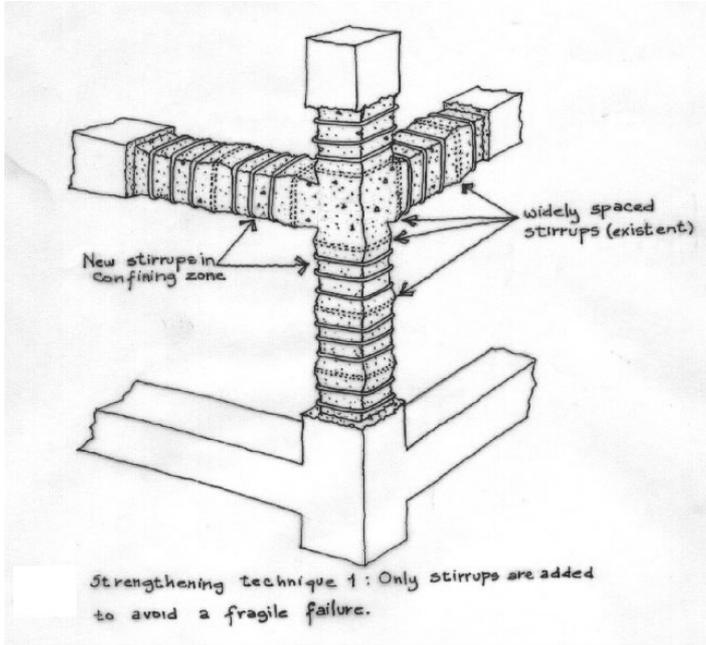
Illustration of Seismic Strengthening Techniques

Beams and columns	Technique #1: Addition of stirrups to avoid brittle failure of concrete columns and beams (FIGURE 25)
Beams and columns	Technique #2: Installation of new longitudinal and transverse reinforcement in columns (FIGURE 26)
Beams and columns	Technique #3: Installation of new longitudinal and transverse reinforcement in beams and columns (FIGURE 27)

Yes. Seismic strengthening has been used in practice by the author of this contribution, as illustrated in Figures 25-27.

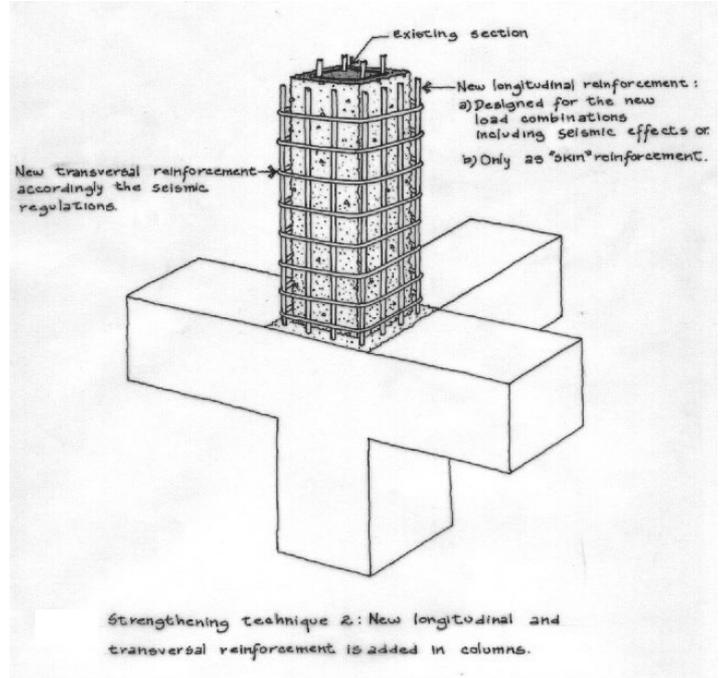
Illustration of Seismic Strengthening Techniques

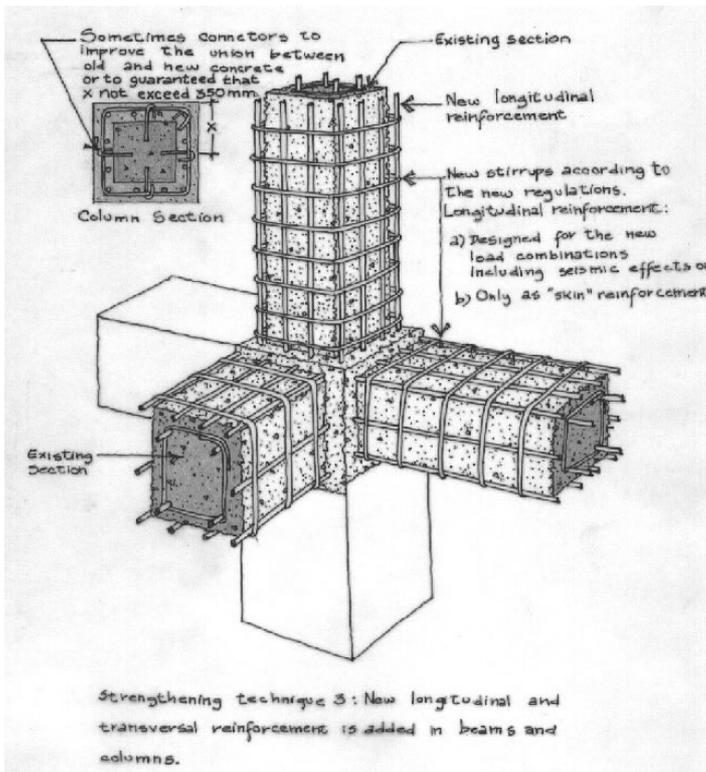
Illustration of Seismic Strengthening Techniques

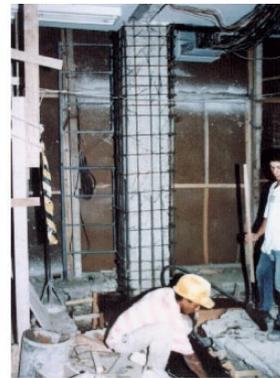
New added longitudinal and transversal reinforcement

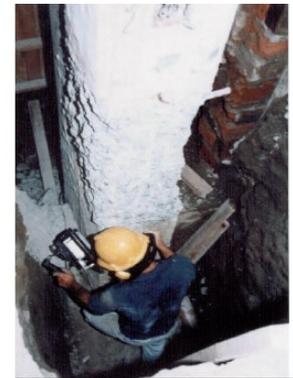
Anchorage of the new longitudinal reinforcement into the foundation

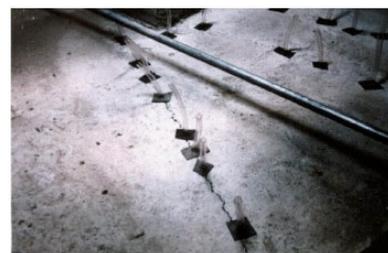
Epoxy injection of the cracks

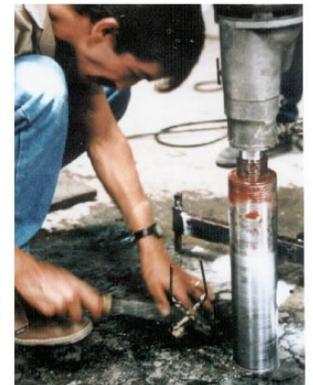
Extraction of concrete cores

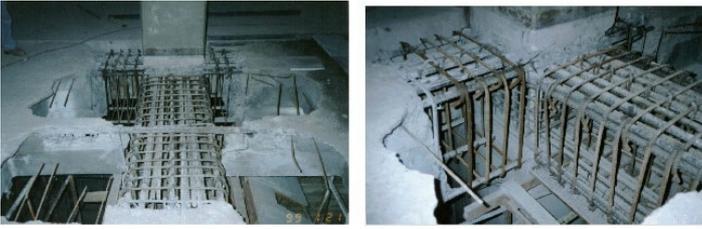
In some cases, new stirrups are installed to reinforce a beam-column joint. In this case, the existing concrete in the joint area must be carefully demolished.
