World Housing Encyclopedia

HOUSING REPORT

Unreinforced brick masonry residential building

Report#	112
Last Updated	
Country	Pakistan
Author(s)	Qaisar Ali,
Reviewers	Robin Spence,

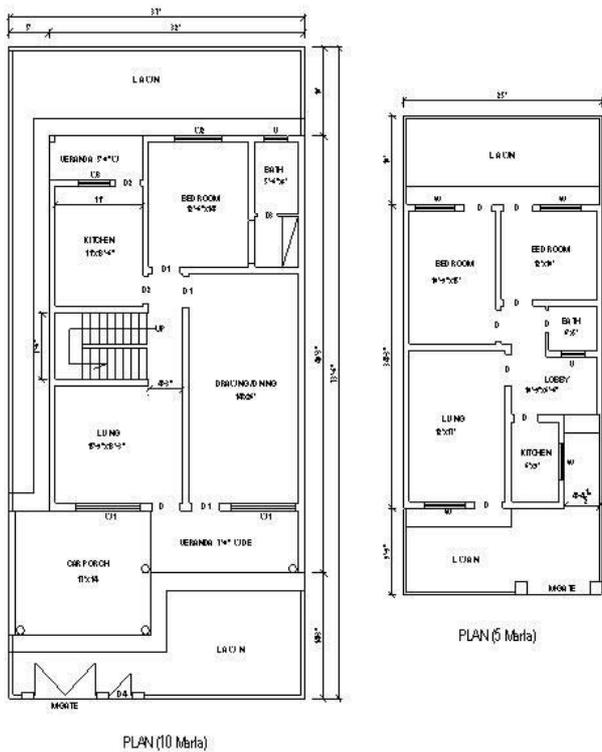
Fig 4.1: Typical plans of residential buildings in Peshawar region

Plans of typical buildings

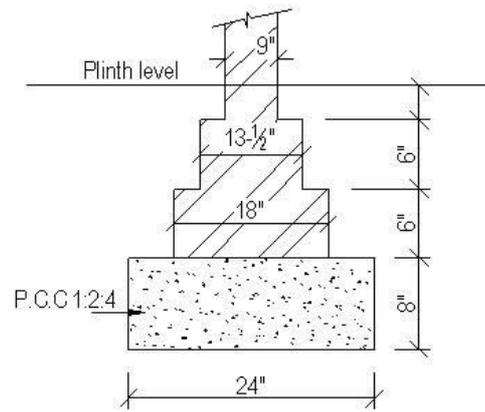
Fig 4.2: Typical Foundation

Type of Foundation	Shallow Foundation: Reinforced concrete strip footing
Additional comments on foundation	The foundation consists of plain cement concrete strip footing and several brick steps. The size of the foundation is normally 0.76 m. The thickness of the concrete strip is 150 mm.
Type of Floor System	Cast-in-place beamless reinforced concrete floor
Additional comments on floor system	
Type of Roof System	Cast-in-place beamless reinforced concrete roof
Additional comments on roof system	
Additional comments section 2	For small residential units (100 square meters), there is usually no separation distance; for larger units (280 to 900 square meters), there is separation in the range of 3 to 10 meters.

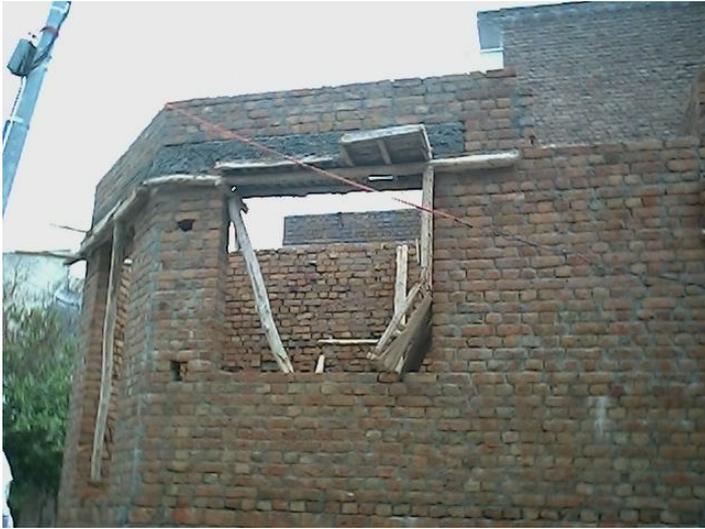
Discontinuity of lintel beams

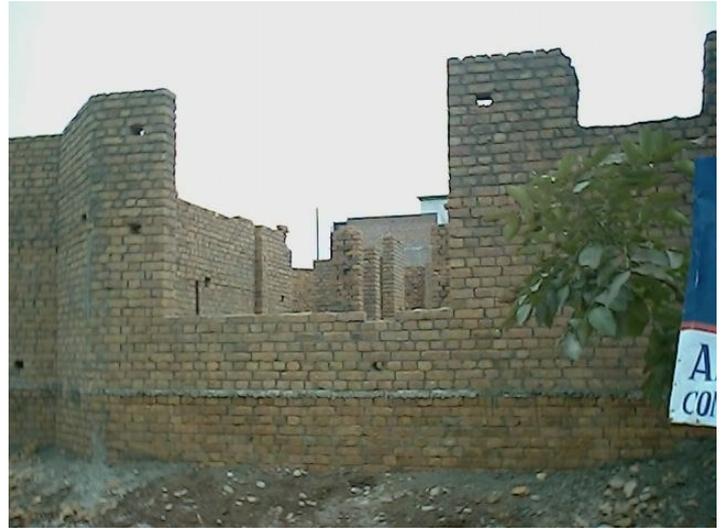
Large openings in walls

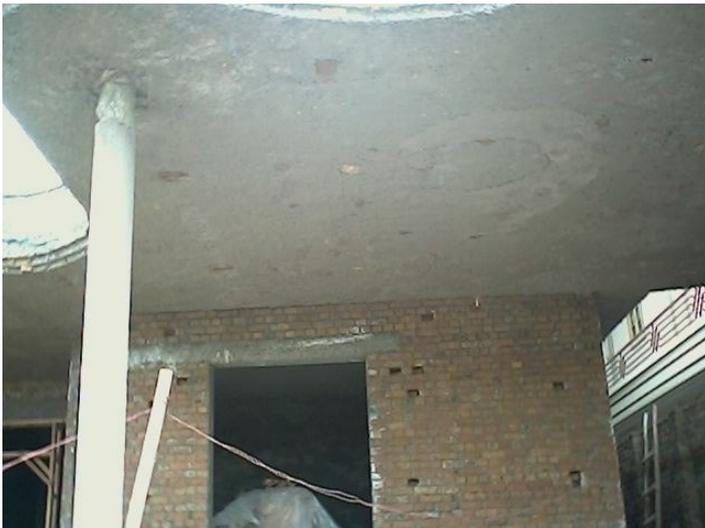
Poor quality of RC work in roof slab (A large number of bricks are placed in RC work to save cement concrete)

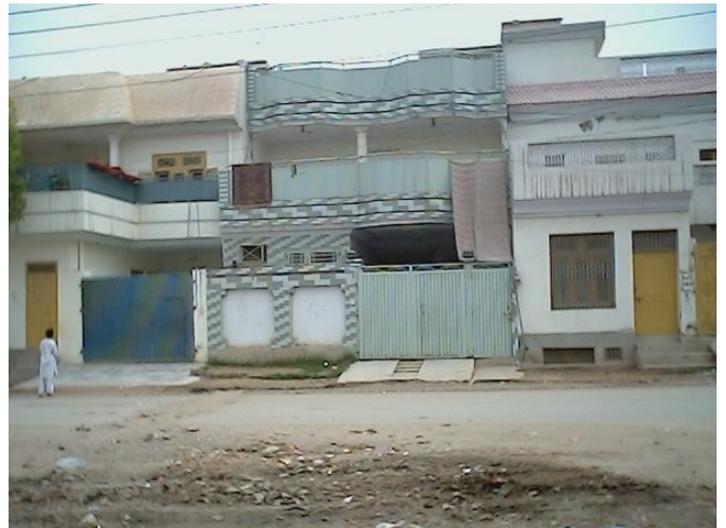
No seismic gap between buildings

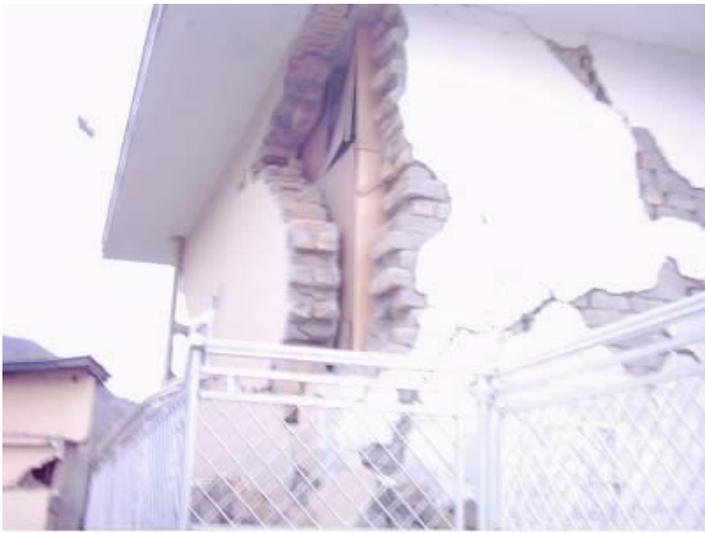
Corner failure in in a two story brick masonry house at Muzaffarabad, Kashmir, (from Kashmir earthquake Oct 08, 2005)

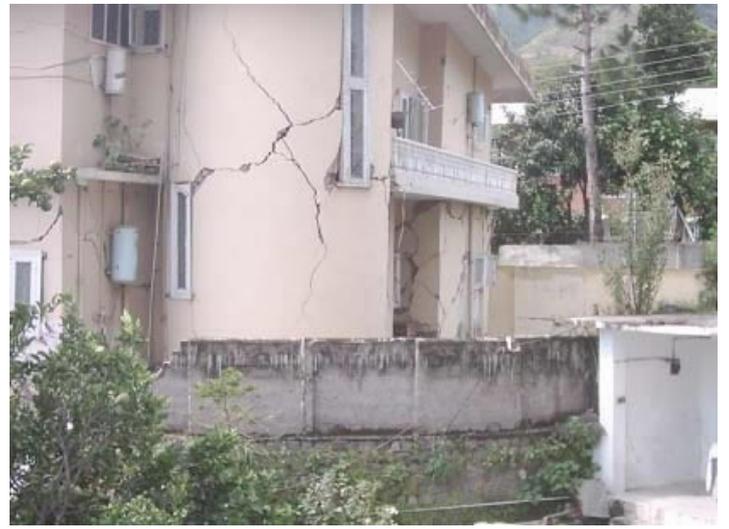
Typical Scissor type cracks in a two story brick masonry house at Muzaffarabad, Kashmir (from Kashmir earthquake Oct 08, 2005)

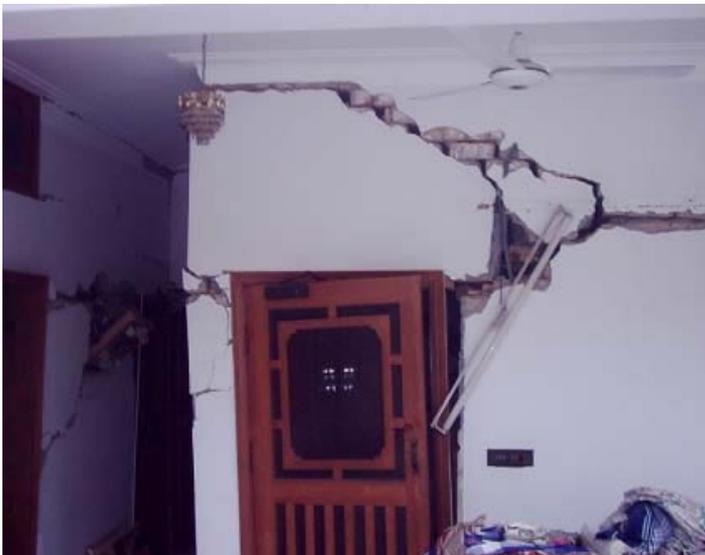
Cracks above door opening and along lintel in a 4.5 inch (125 mm) thick wall in a partition wall in a house at Muzaffarabad, Kashmir, (from Kashmir earthquake Oct 08, 2005)

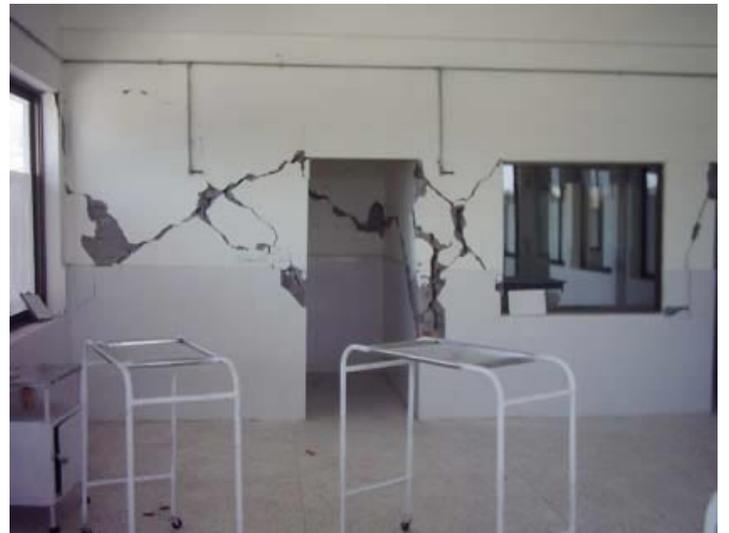
Typical cracks in pier: Manserhra Hospital NWFP Pakistan (from Kashmir earthquake Oct 08, 2005)

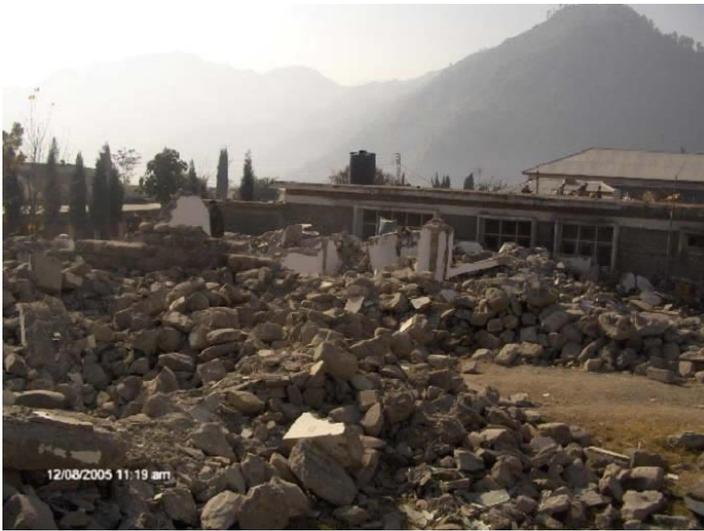
DHQ Garhi Habibullah (NWFP, Pakistan): collapsed buildings constructed with stone Masonry. Note a stone masonry building in the back ground having a bond beam at roof level is still standing

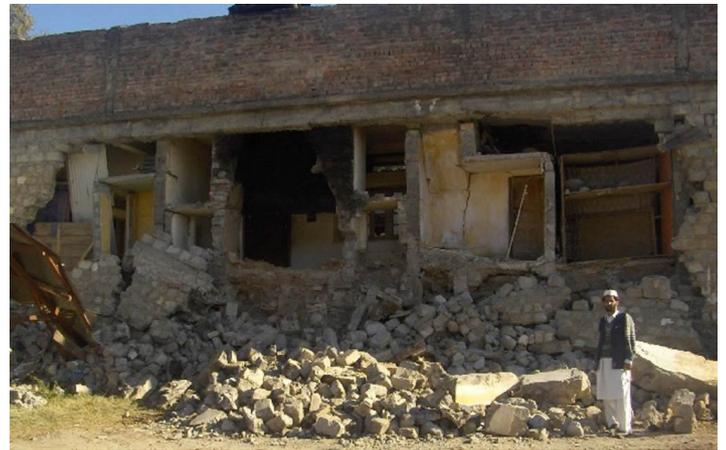
Shinkiari (NWFP Pakistan): out of plane flexural failure of load bearing wall constructed with block masonry. Note 6ft high parapet wall constructed with brick masonry is still standing in spite of higher inertial forces experienced as an appen

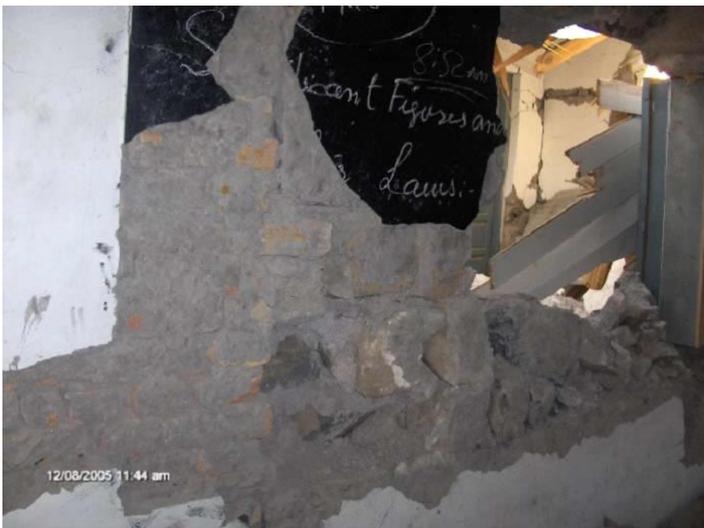
GHS School Garhi Habibullah (NWFP Pakistan): Half of the wall was constructed with stone and rest with brick masonry. Part of wall constructed with stone masonry was collapsed due to lack of cohesion with cement sand mortar
