World Housing Encyclopedia

HOUSING REPORT

Stonework building with wooden timber roof

Report#	114
Last Updated	
Country	Iran
Author(s)	Masoud N. Ahari, Alireza Azarbakht,
Reviewers	Svetlana N. Brzev ,

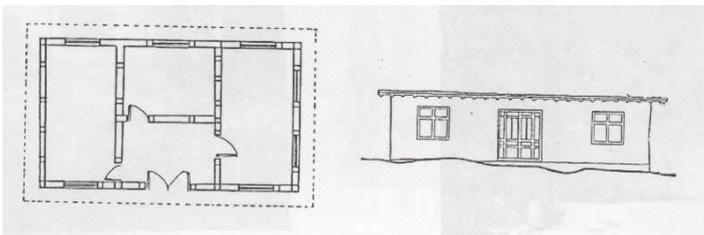
Elevation and a Plan of a Typical Building [7]

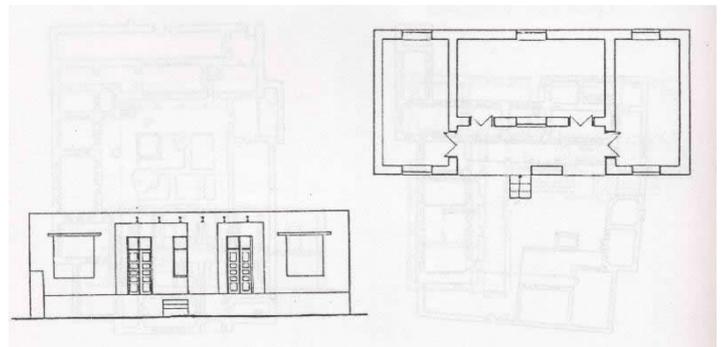
Elevation and a Plan of a Typical Building [7]

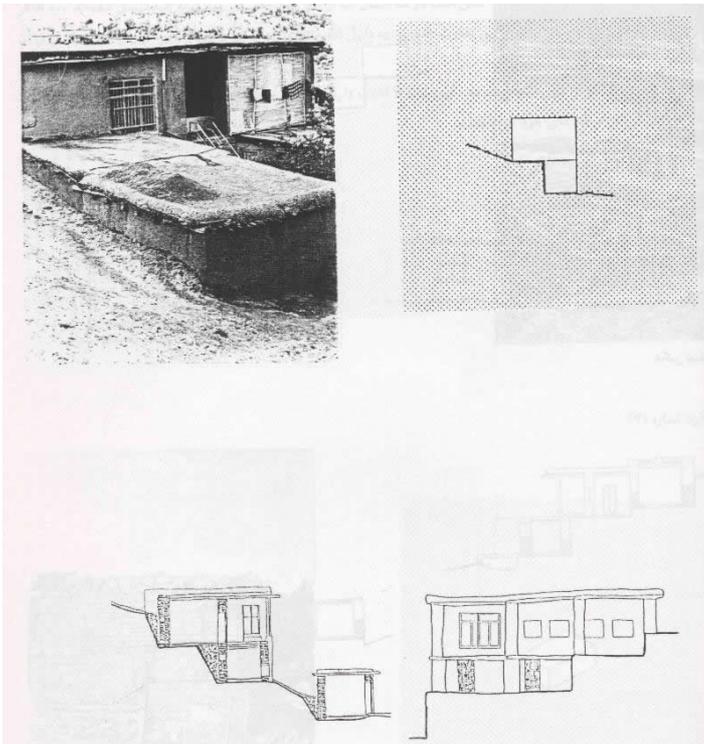
Elevation of a Typical Building [7]

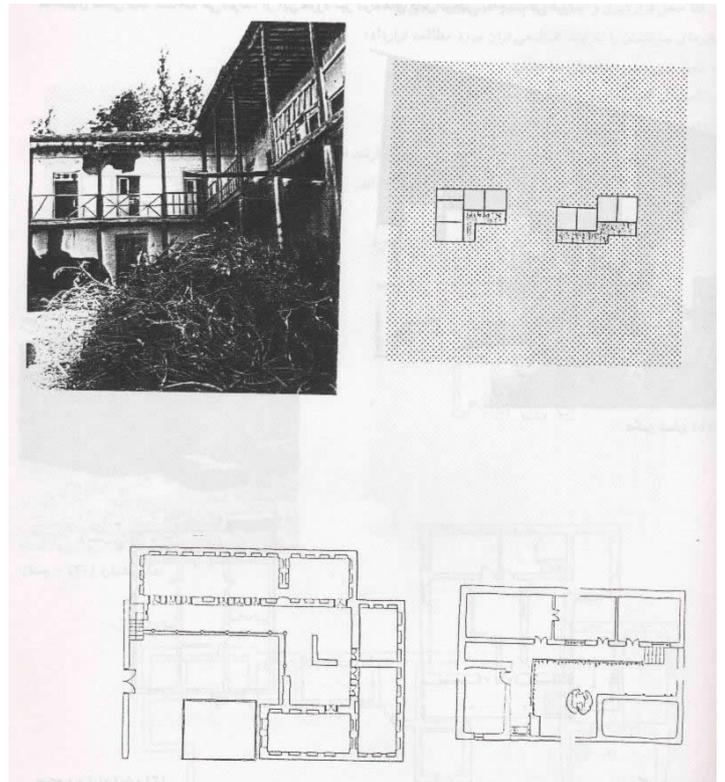
View and Plan of a Typical Building [7]

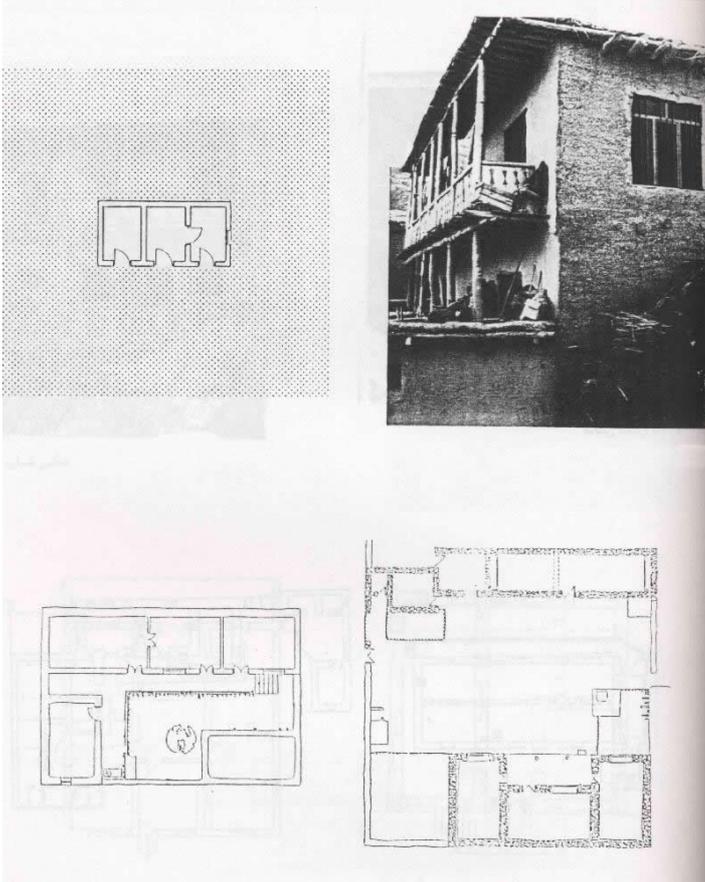
View and Plan of a Typical Building [7]

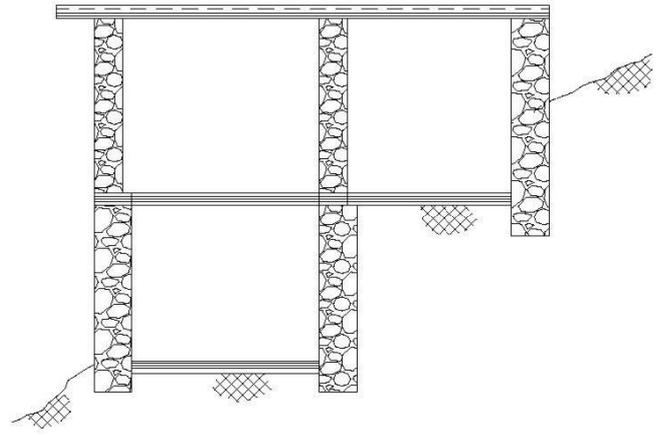
Two story stone masonry house on a slope

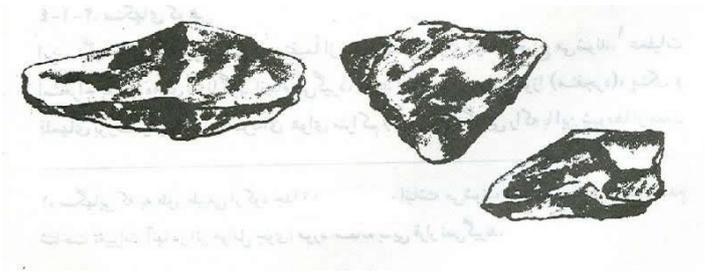
Carcass Stone [1]

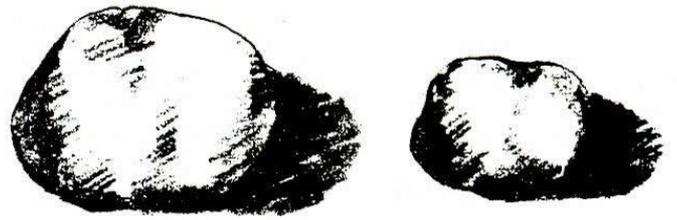
Rubble Stone [1]

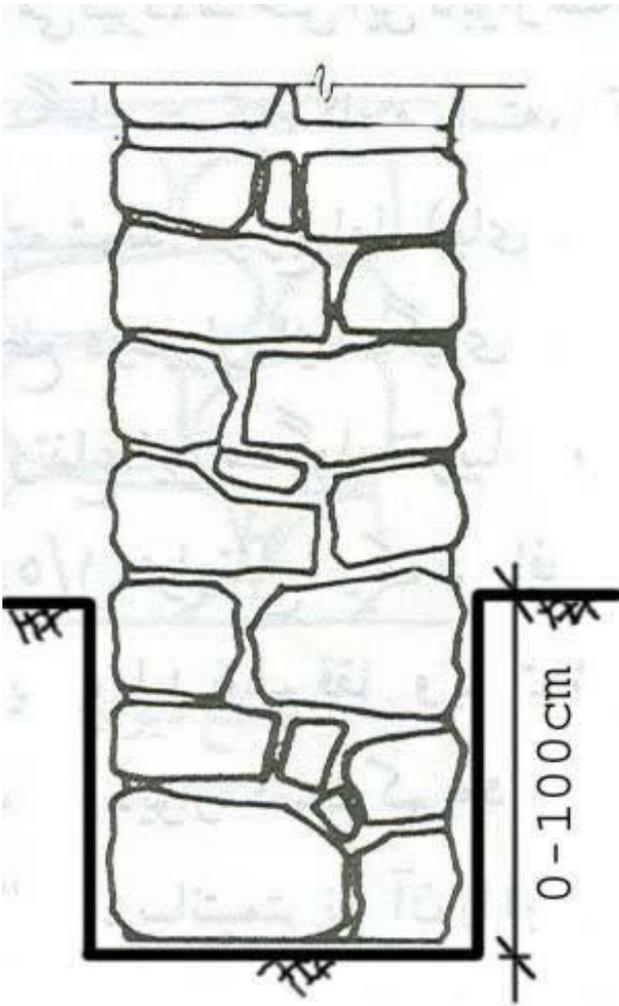
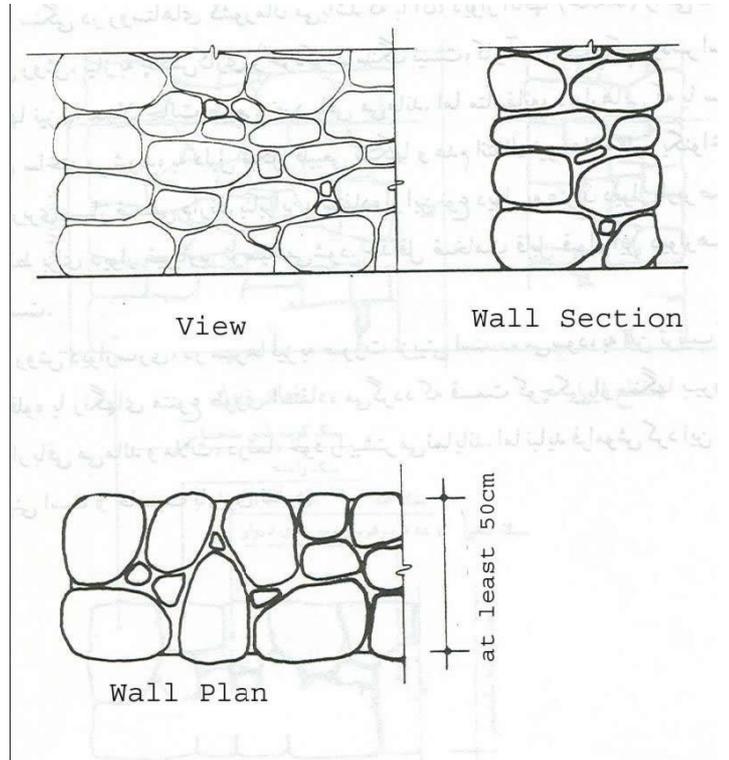
Walls with Rubble Stone [1]

Stone Walls Foundation

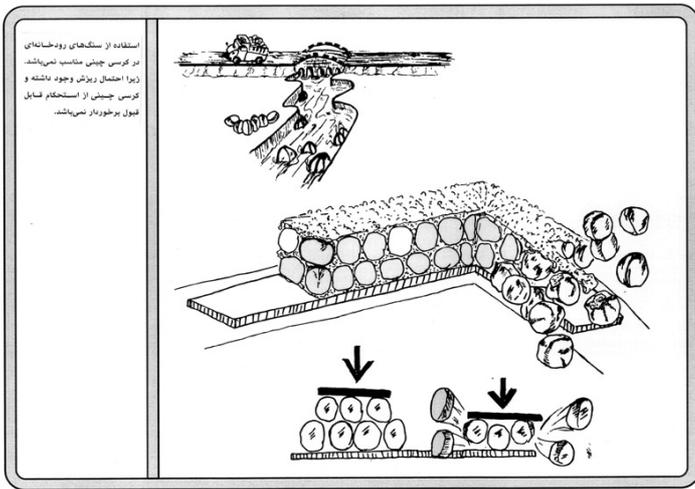
Seismic Behavior of Rubble Stone [9]

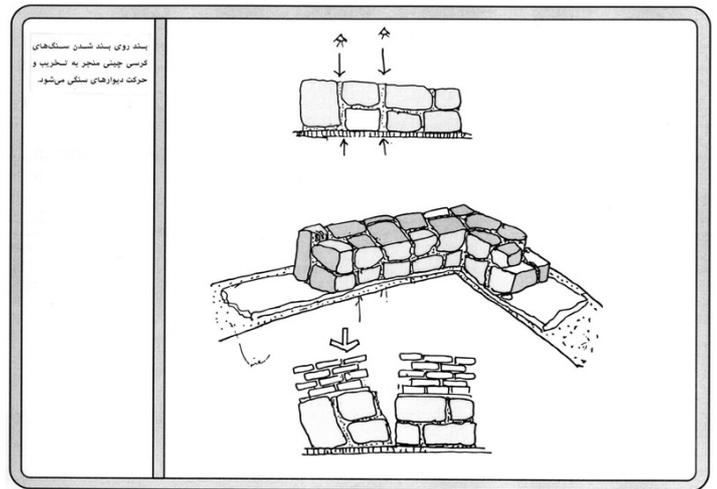
Seismic Behavior of Carcass Stone [9]

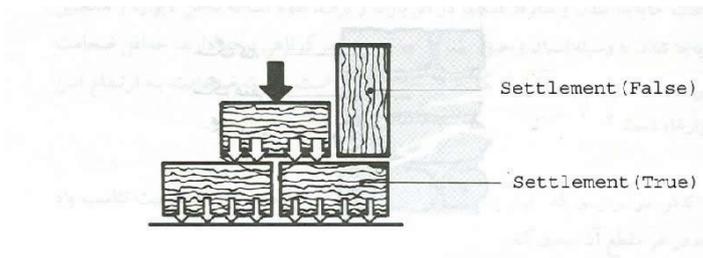
Laods sould be perpendicular to stone fibres

Stone Settlement [1]

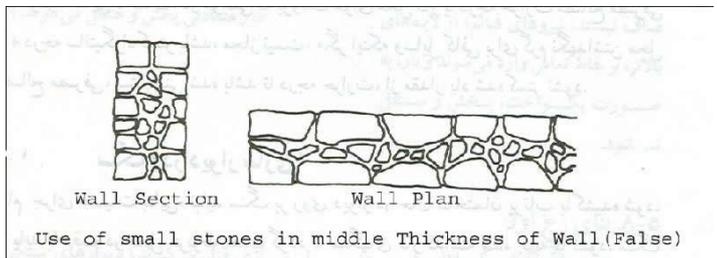
Vulnerable Walls (Buckling of outer stones) [1]

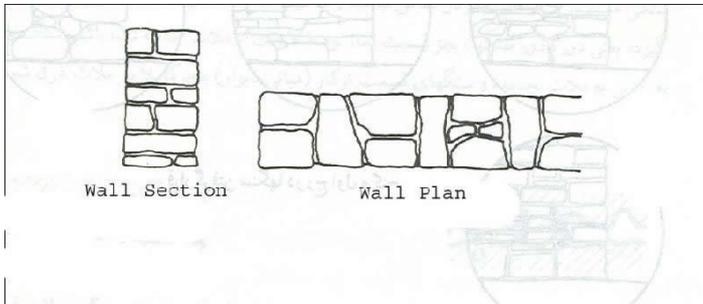
Adequate walls [1]

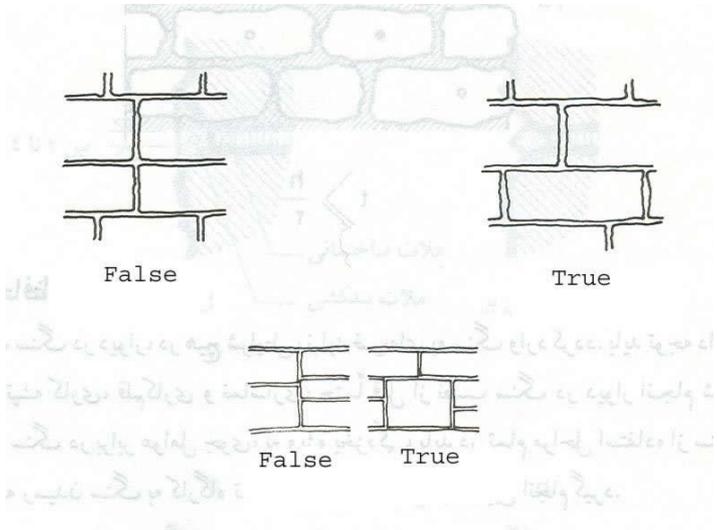
Stone Units Arrangements [1]

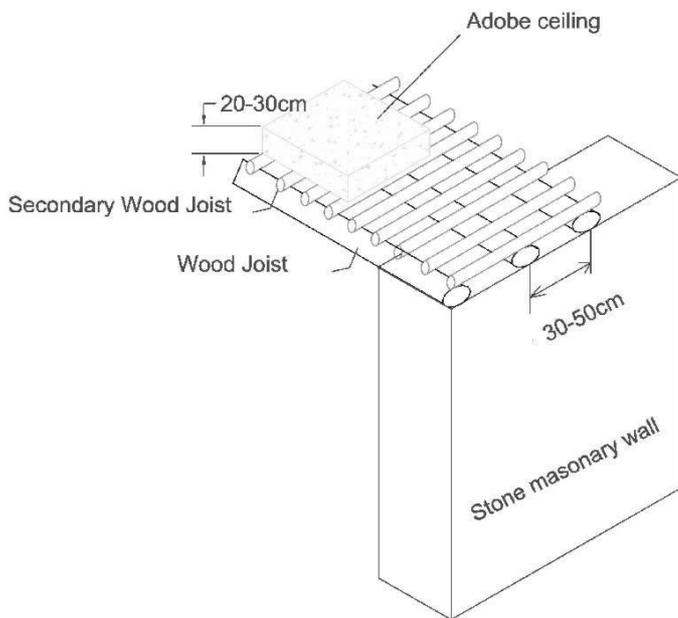
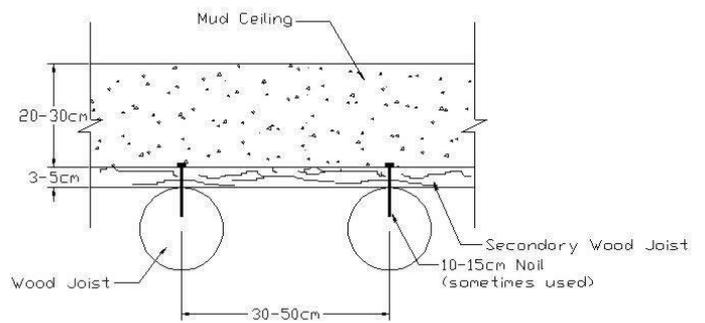
Roof Details (using secondary wood joists)

Typical Detail of Connection between Wall and Roof

The roof includes wooden joists and a set of secondary joists which are plastered with a thick layer of mud (Figures 24, 25 and 5).

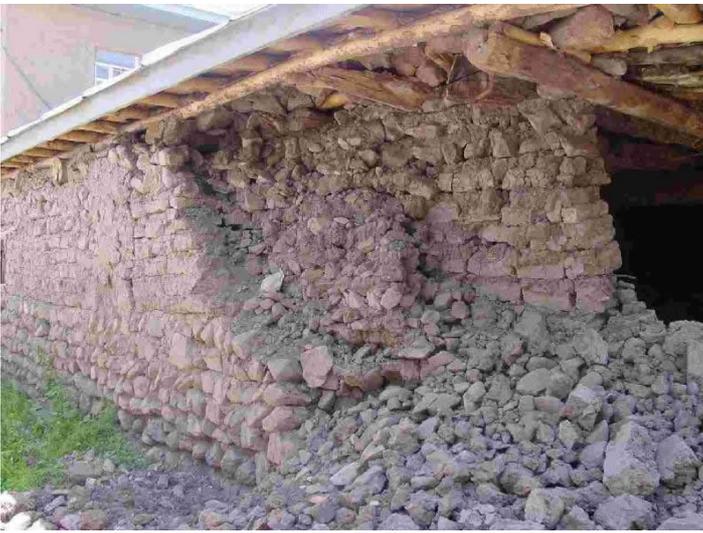
Typical external walls damage in Firoozabad-Kagoor earthquakes [3]

During earthquakes in the mountainous regions of Iran, there is extensive damage and many casualties in these buildings due to wall collapses. Figures 26 through 24 show typical damage of stone walls from earthquakes. After wall failure, the heavy roof generally collapses. Figures 30, 31 and 32 show evidence of this phenomenon.

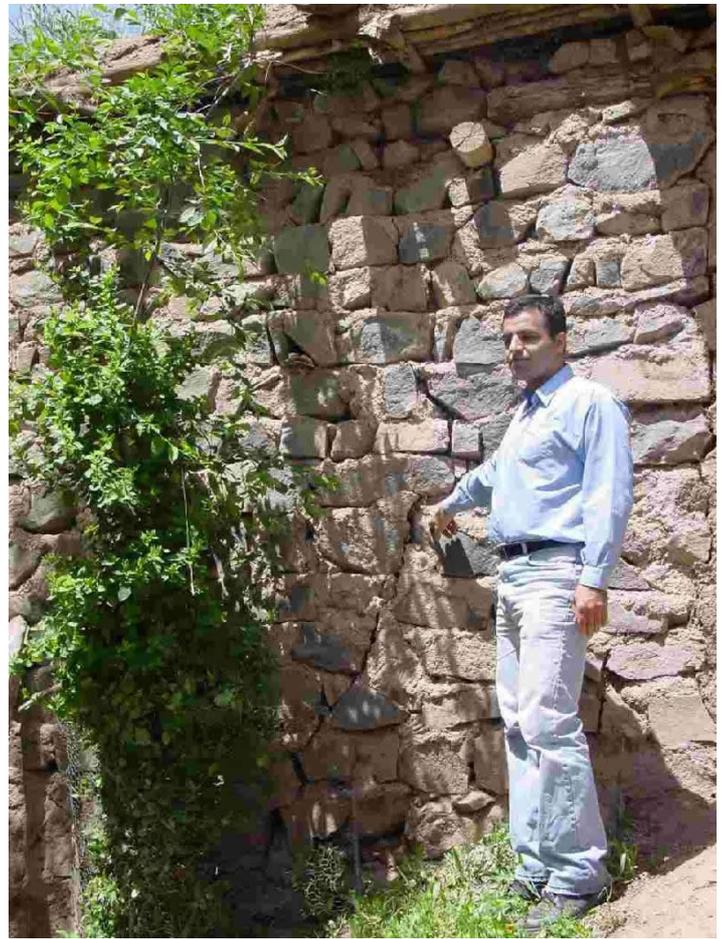
Typical external walls damage in Firoozabad-Kagoor earthquakes [3]

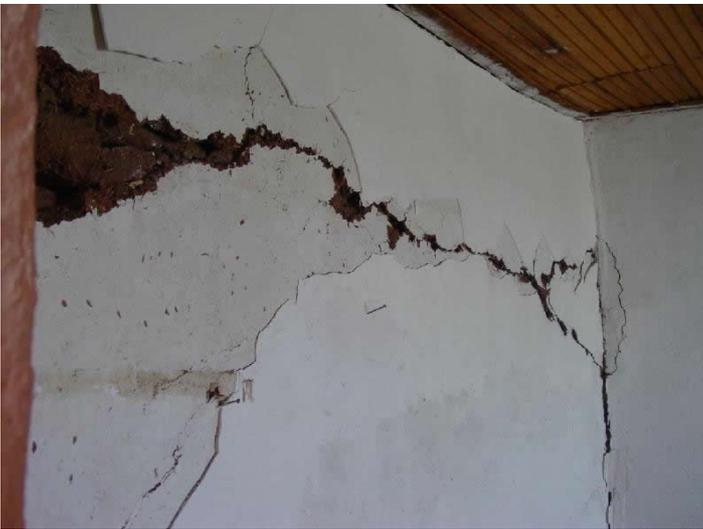
Typical internal walls damage in Firoozabad-Kagoor earthquakes [3]

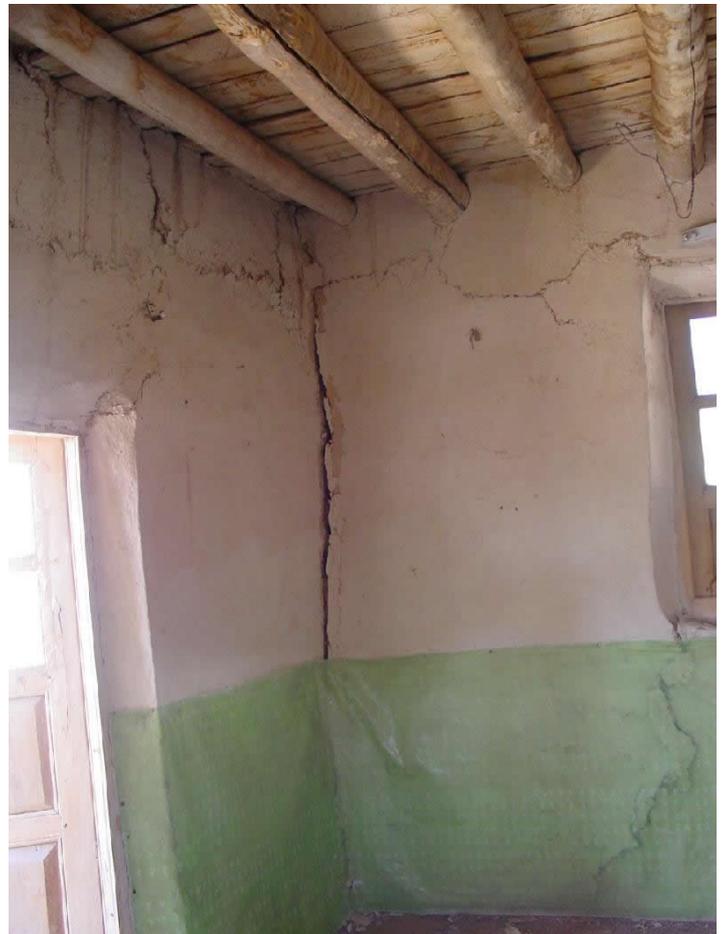
Typical internal walls damage in

Firoozabad-Kagoor earthquakes [3]

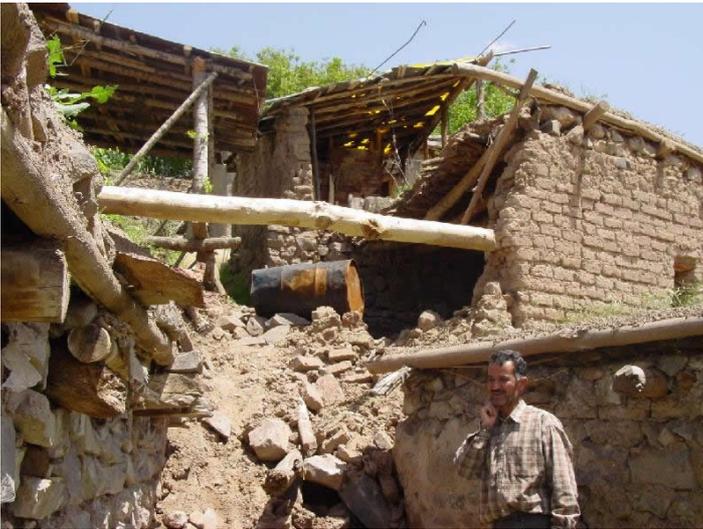
Typical roof damage in Firoozabad-Kagoor earthquakes [3]

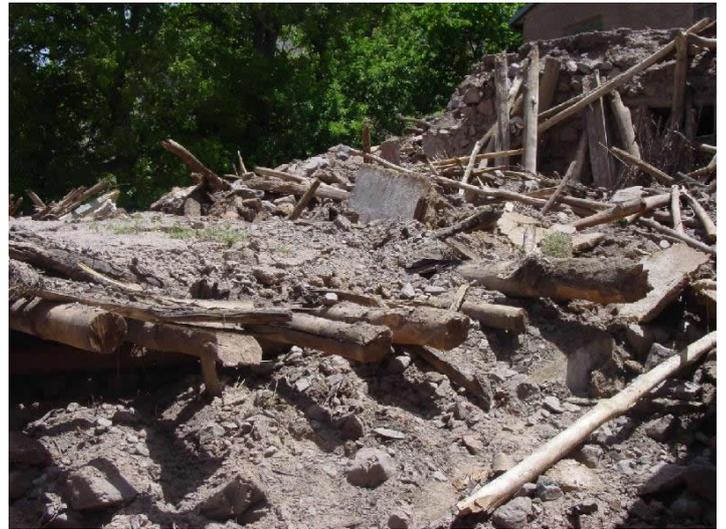
Typical roof damage in Firoozabad-Kagoor earthquakes [3]

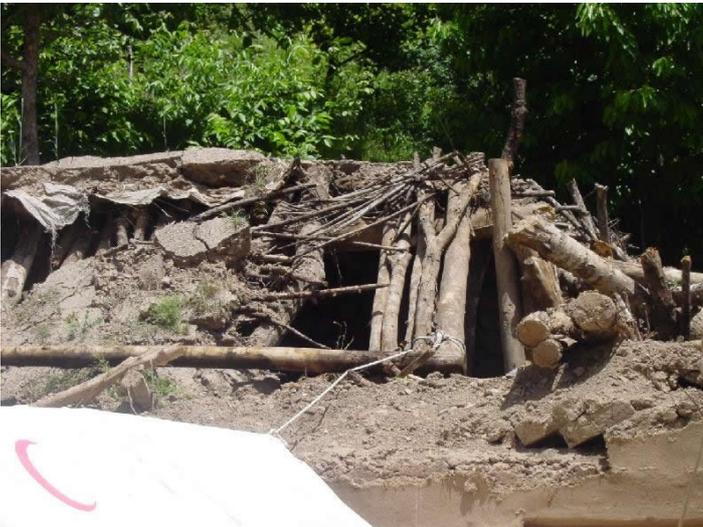
Typical roof damage in Firoozabad-Kagoor earthquakes [3]

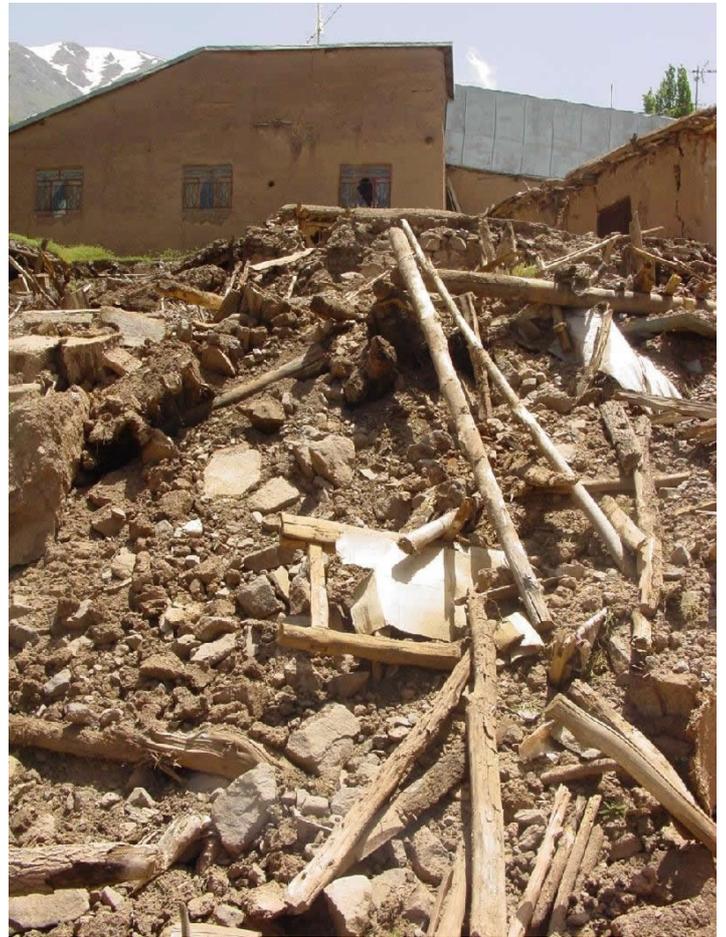
Total collapse of stonework building in Firoozabad-Kagoor earthquakes [3]

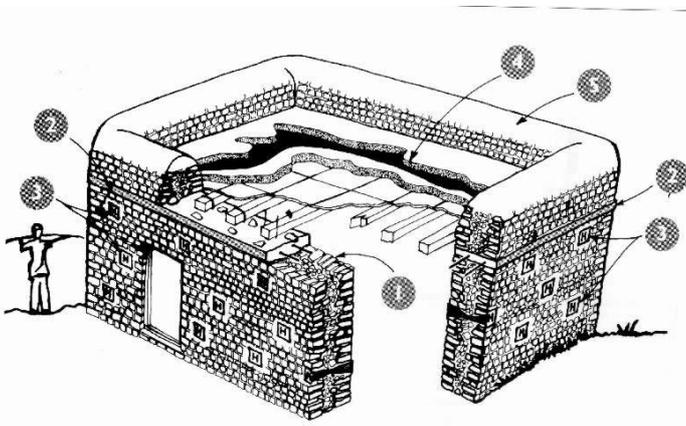
Retrofitting components

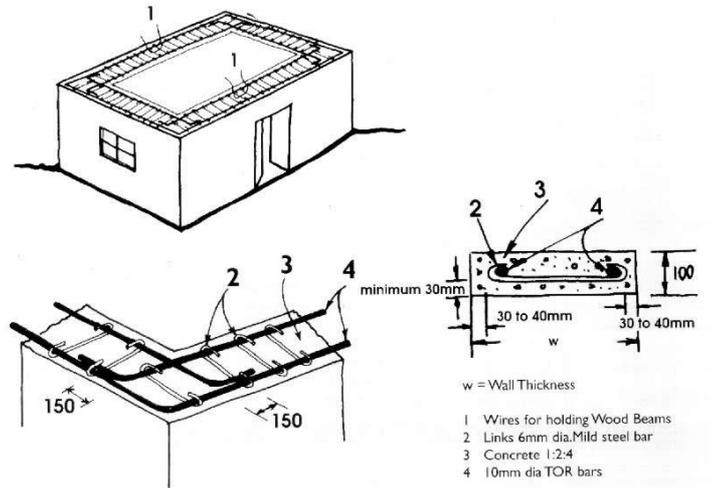
R.C. Band below Roof Beams

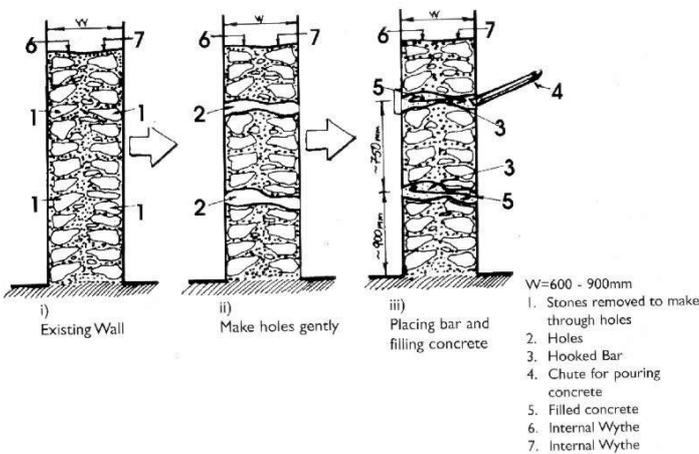
Providing R.C.

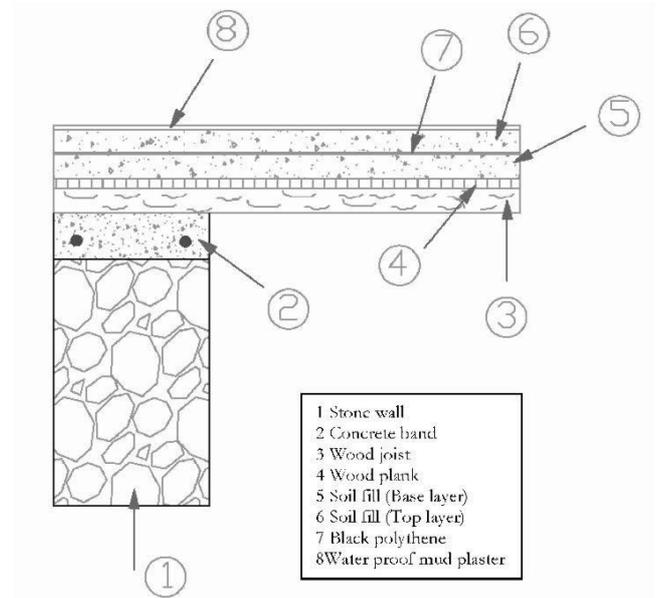
Polythene sheet placements
