World Housing Encyclopedia

HOUSING REPORT

Timber Frame Brick House with Attic

Report#	116
Last Updated	
Country	India
Author(s)	Amit Kumar , Jeewan Pundit,
Reviewers	Ravi Sinha ,

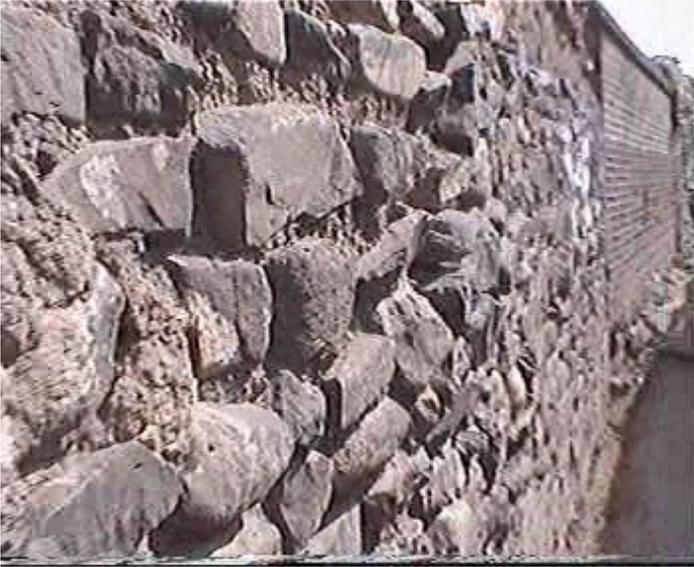
Change in Construction Material

It is found that comparatively older buildings are generally made with sufficient precision and good building skills. Extensions or modifications, however, are generally done without appropriate building construction techniques. In urban areas, the outermost rooms are converted into shops or used for commercial purposes. It has been found that some modification and extension has been done with heterogeneous materials and structural systems. One example of such modification is the continuation of an existing brick wall with random rubble masonry (Figure-3,4,5). The older houses are made up with mud mortar but recently extensions are built with cement mortar. These type of modifications and alterations adversely affect the seismic performance.

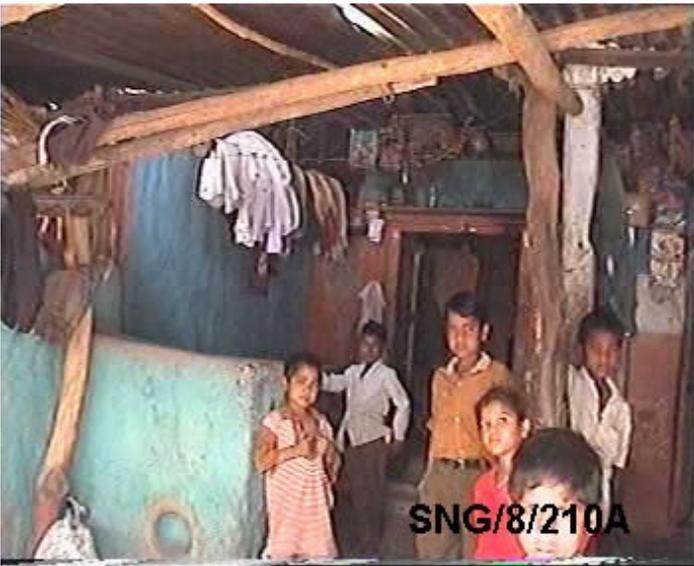
Discontinued Column and Beam Connection with Existing Part

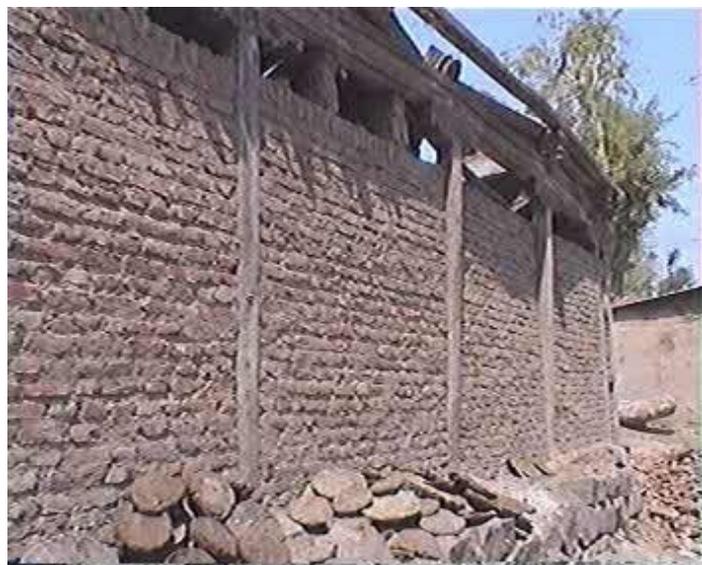
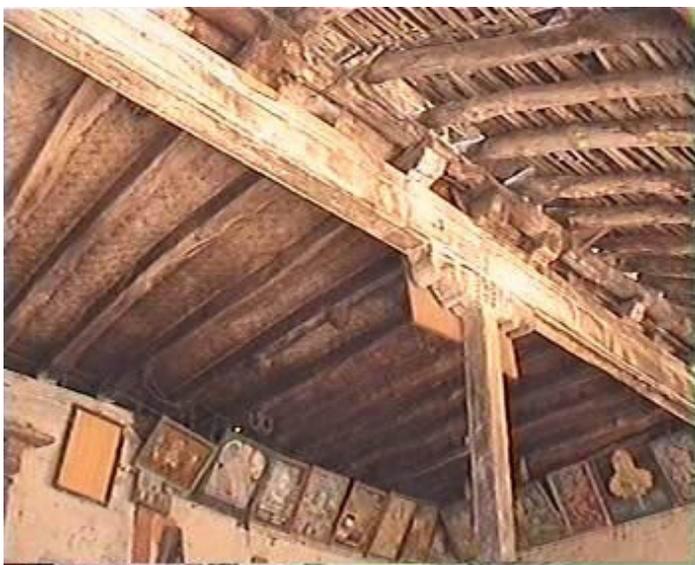
Details of Timber Frame

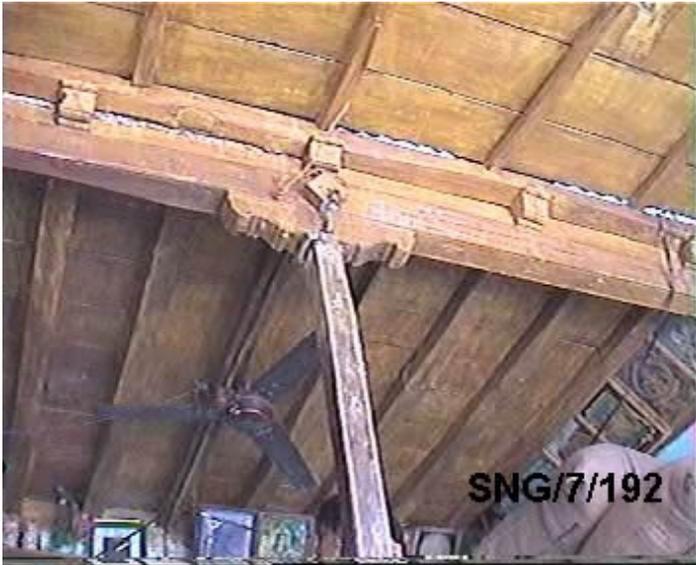
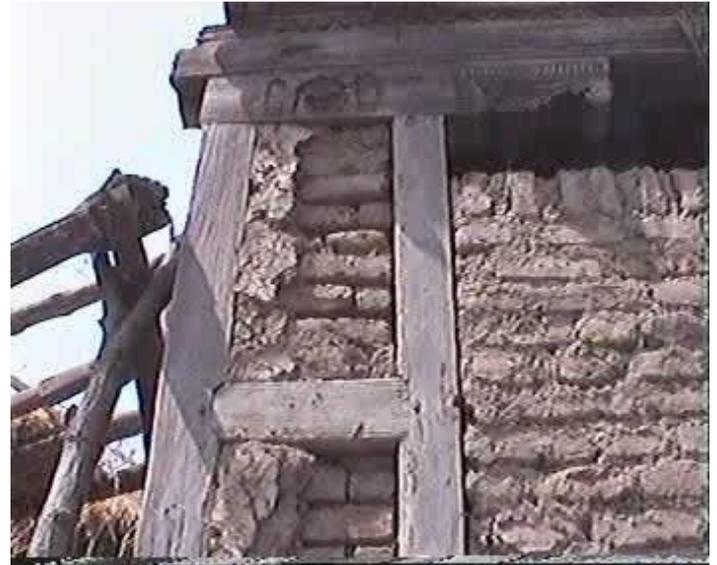
Column and Beam Joint

The connectivity between the column and beam is found to be very good with proper joint system (Figure-8,9). The first floor is made up of timber plank (Figure-10). The thickness of wooden plank varies from 0.1m to 0.125 m. The wooden platform is covered with bamboo mat and finally plastered with mud. The thickness of mud plaster is limited to 0.05m. The timber posts for the attic, which support the sloping roof, extend from the timber rafters. The attic is used for storing grain and other household items. Sometimes it is used as a living room. It is generally observed that the gable portion of wall is not provided with a timber band. The sloping roof of the house is resting on the gable end, which is very vulnerable to lateral dynamic forces. Perfect timber framed buildings are very good at resisting earthquake forces. The evidence of good performance of this building was shown in the Latur earthquake in 1993. The building may sway but will definitely avoid total collapse. The damage pattern of such building may be referred to in Figure-11. The damage to the building was due to heavy and thick external walls and roof. The walls are not attached to the timber frame. The only attachment is achieved by the inside and outside plastering. The roofing elements are partly resting on outer walls and partly on intermittent timber columns. These buildings do not require many resources for retrofitting and restrengthening. Gravity load-bearing system: The vertical load-resisting system is confined masonry wall system. The infill walls are made of brick masonry. These infill walls are the gravity load-bearing structures. The walls partially take the load of roofing elements.

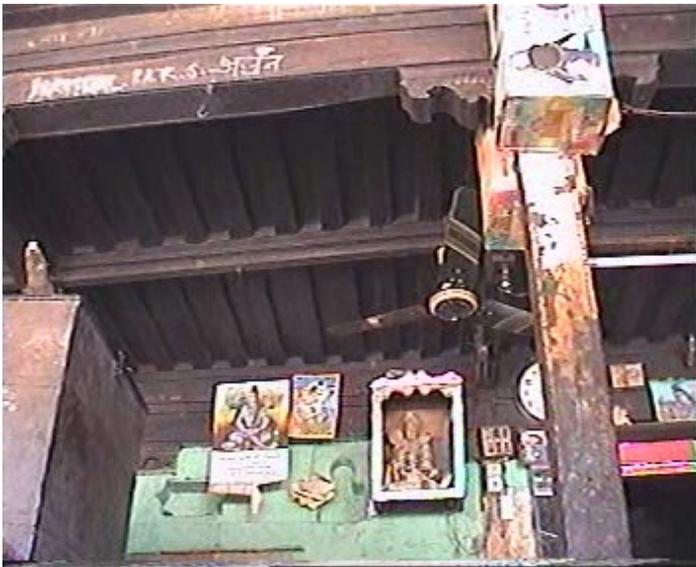
Construction Details of First Floor

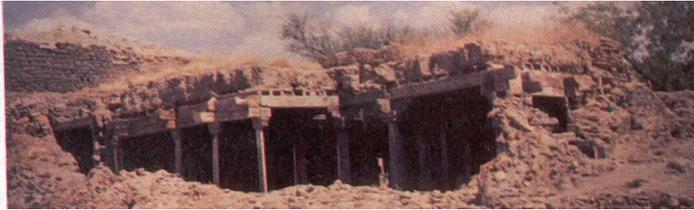
Damage Pattern of Building

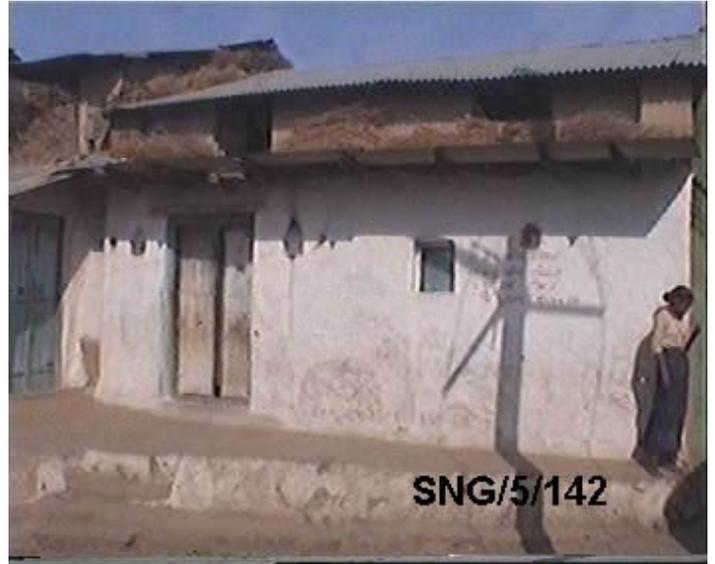
Openings at Different Level

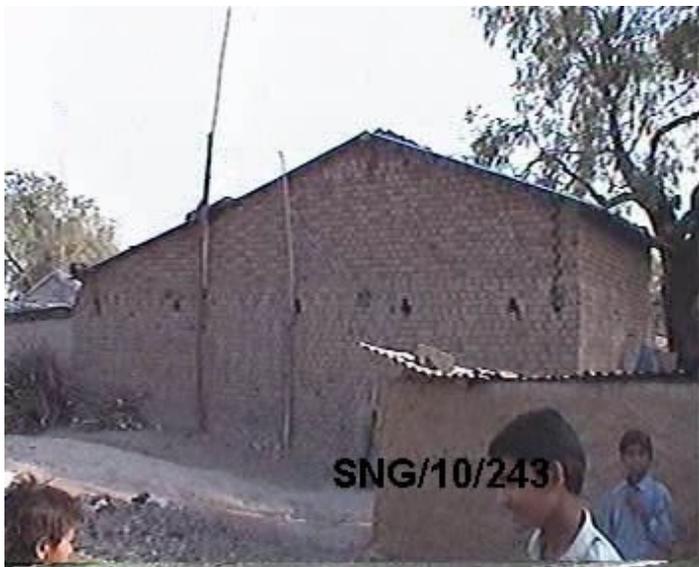
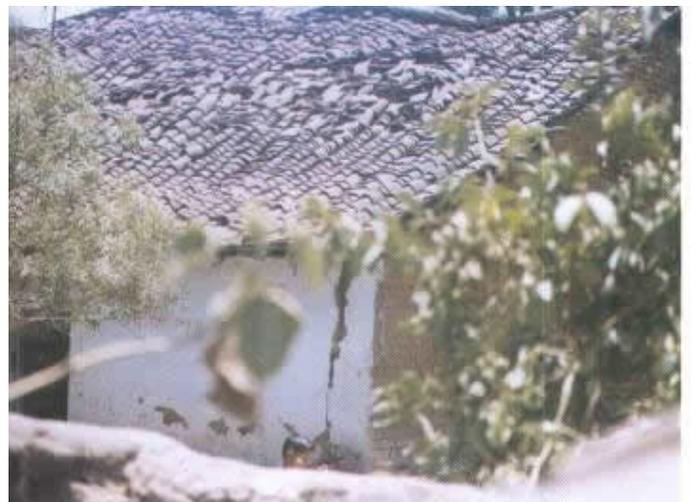
Corner Separation

Overall damage patterns observed in past earthquakes for this type of construction included: (wall) --Corner separation (Figure-13,14) --Damage to partition wall (Figure-15) --Overturning of walls -- Deep cracking in walls --Gable failure (Figure-16,17). (frame) --Swaying of columns (Figure-18) -- Excessive deflection in beams --Joint failure of beams and columns(Figure-18) --Collapse of frame structure. (roof and floors) --Collapse of roof (Figure-15) --Displacement of roof covering tiles -- Joint failure of purlins and rafter.

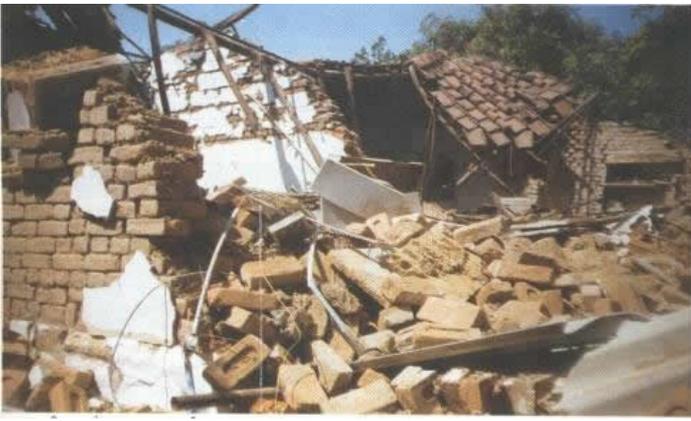
Damage to partition wall

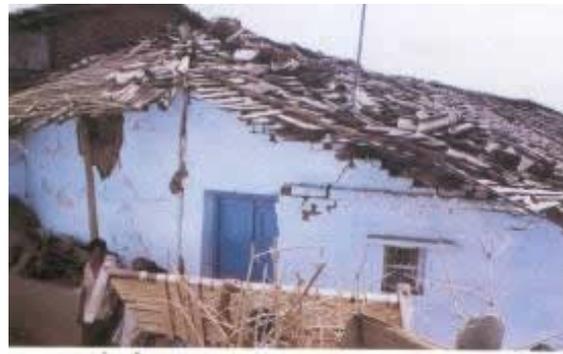
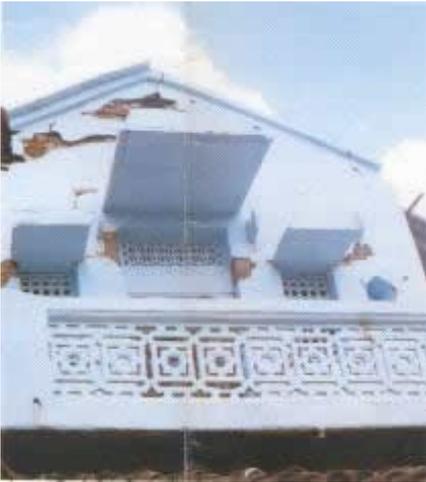
Gable Failure

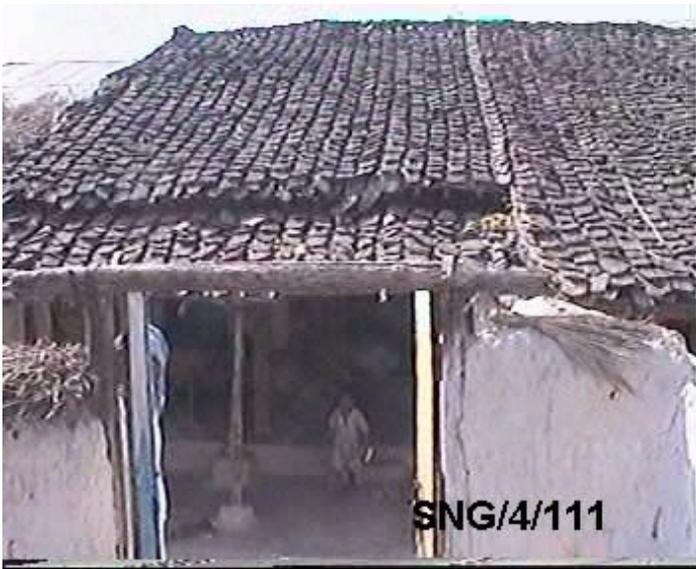
Heavy Roofing Elements

Seismic deficiency in roof and floors	--Heavy roofing elements(Figure-19) --No proper joints between rafters and purlins (Figure-20) -- Poor linkage between roofing elements and wall.
Earthquake resilient features in roof and floors	--Many houses are covered with galvanized iron sheet, which is light in weight, thus reducing seismic forces on building (Figure-21).
Seismic deficiency in foundation	
Earthquake-resilient features in foundation

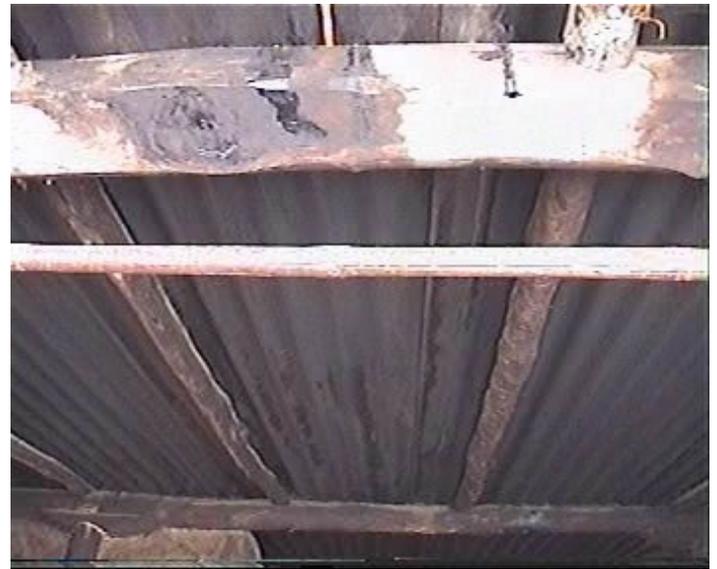
No Proper Joints between Rafters and Purlins

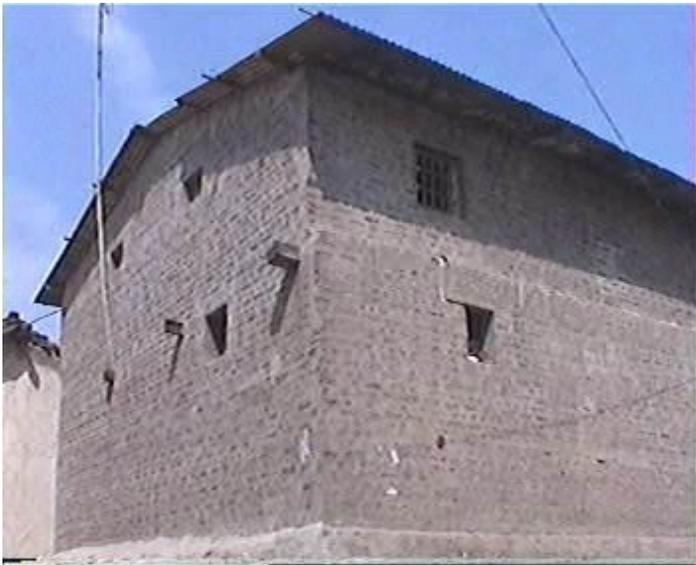
Houses Are Covered with Galvanized Iron Sheet

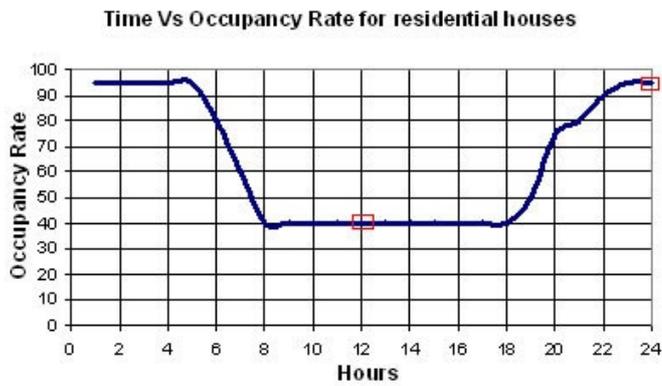
Graph of Time vs Occupancy Rate for Residential Houses

In semi-urban to rural areas, the male members are going to agricultural fields for cultivation. The graph shows the variation in occupancy of typical building. See the graph in Figure-24.
