World Housing Encyclopedia

HOUSING REPORT

Clay brick/concrete block masonry walls with concrete floors (predating seismic codes or with a few seismic features)

Report#	12
Last Updated	
Country	Colombia
Author(s)	Luis Gonzalo Mejia,
Reviewers	Sergio Alcocer ,

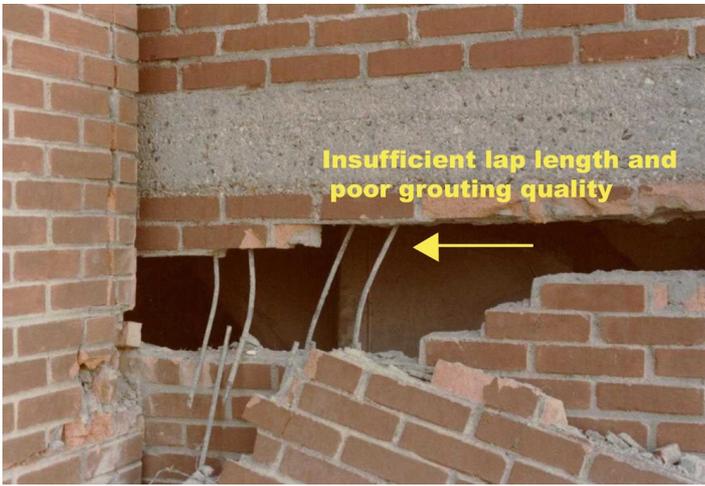
Key Seismic Deficiencies - Inadequate Reinforcement and Poor Grouting (note the reinforcement bar slippage)

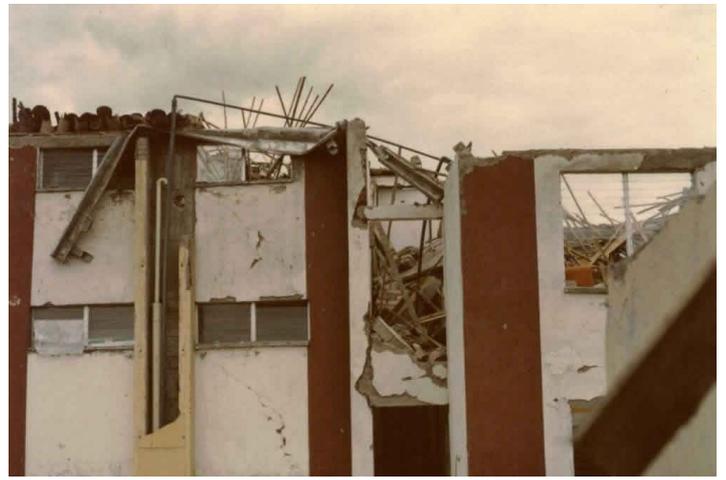
Seismic Deficiencies - Discontinuous R/C Bond Beams

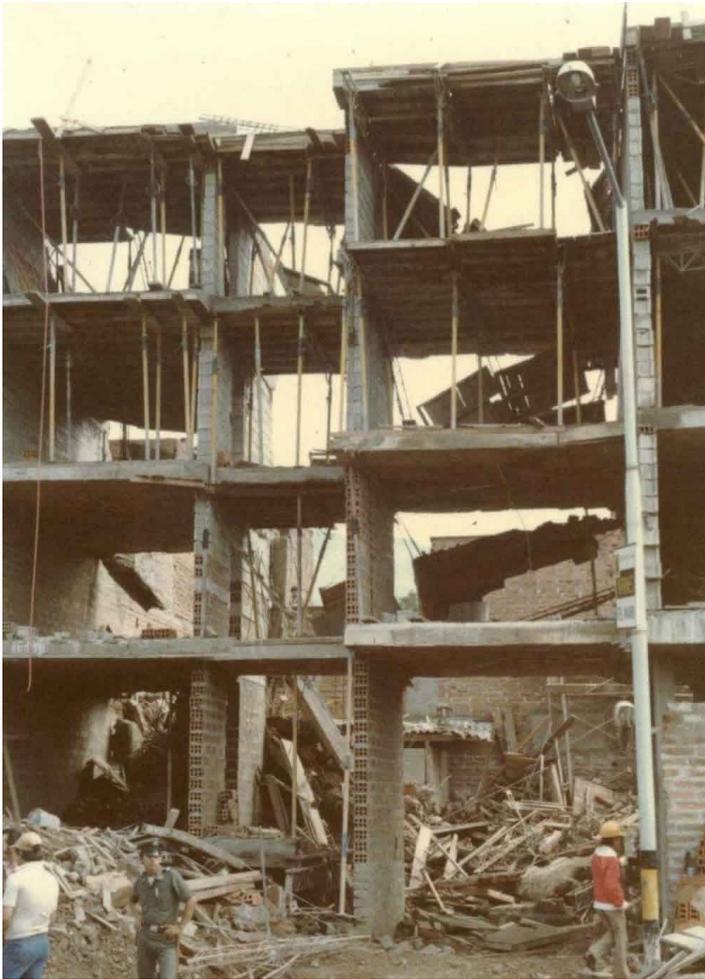
Poor construction practice - unreinforced masonry walls and the absence of cross walls (note that both clay bricks and concrete blocks were used for the wall construction)

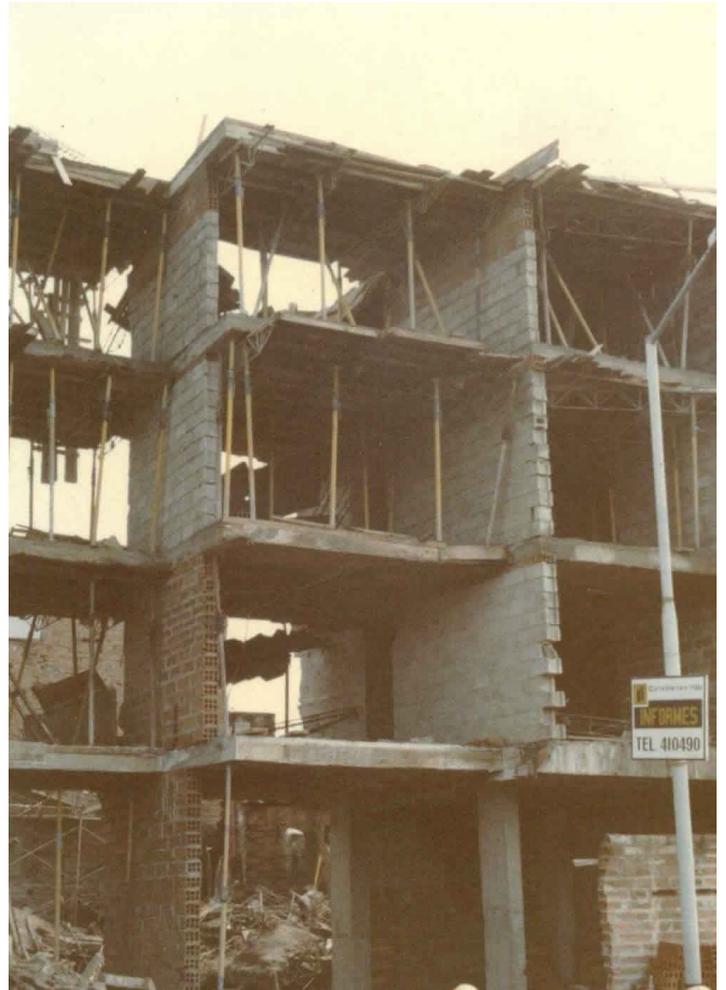
Vertical Stiffness Discontinuity - Walls Interrupted at the First Story and Replaced with Columns

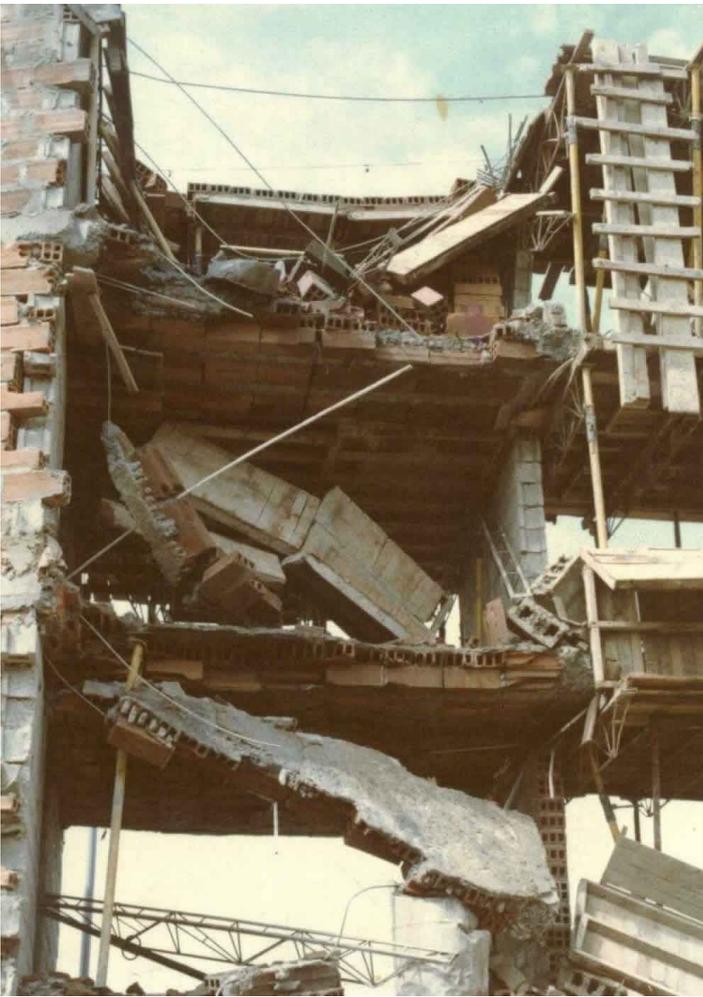
Seismic Deficiencies - An Example of a Building Collapse Caused by Gravity Loads Only (buildings with such weaknesses have very little chance to survive earthquake effects)

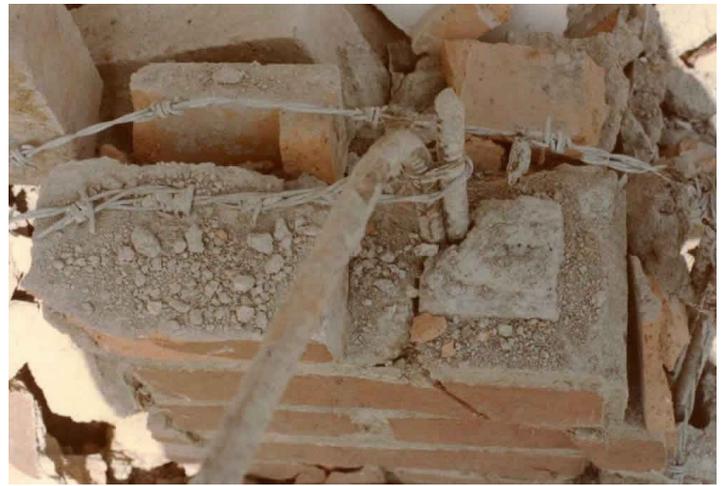
Seismic Deficiencies - Poor Quality of Materials (mortar and grout); Inadequate Vertical and Horizontal Reinforcement

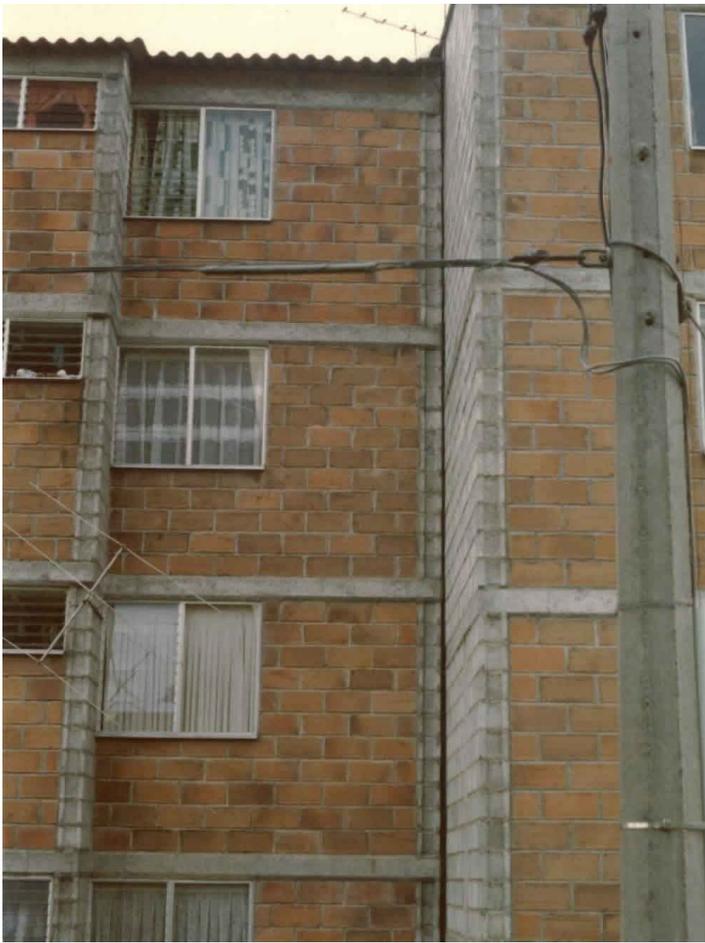
A building weakened due to tilting induced by a pre-earthquake foundation settlement (separation between the two buildings was 100 mm at ground level but 0 mm at the top). Such buildings are likely to suffer more extensive earthquake damage

Additional comments on structural and architectural features for seismic resistance	Foundation Performance: Occasionally, there are buildings with induced weaknesses caused by foundation movements (please see Figure 12). Wall-Roof connections: See Additional Comments in Sections 2.10 & 2.11 #Type of floor/roof system#.
--	--

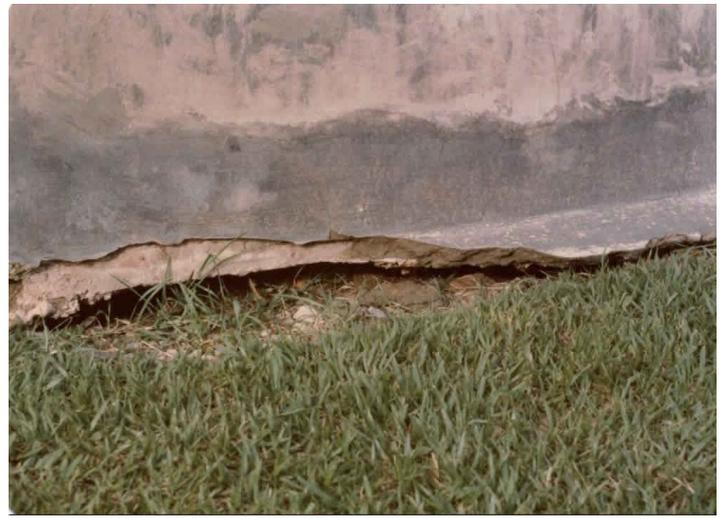
A building weakened due to tilting induced by a pre-earthquake foundation settlement (separation between the two buildings was 100 mm at ground level but 0 mm at the top). Such buildings are likely to suffer more extensively earthquake damage

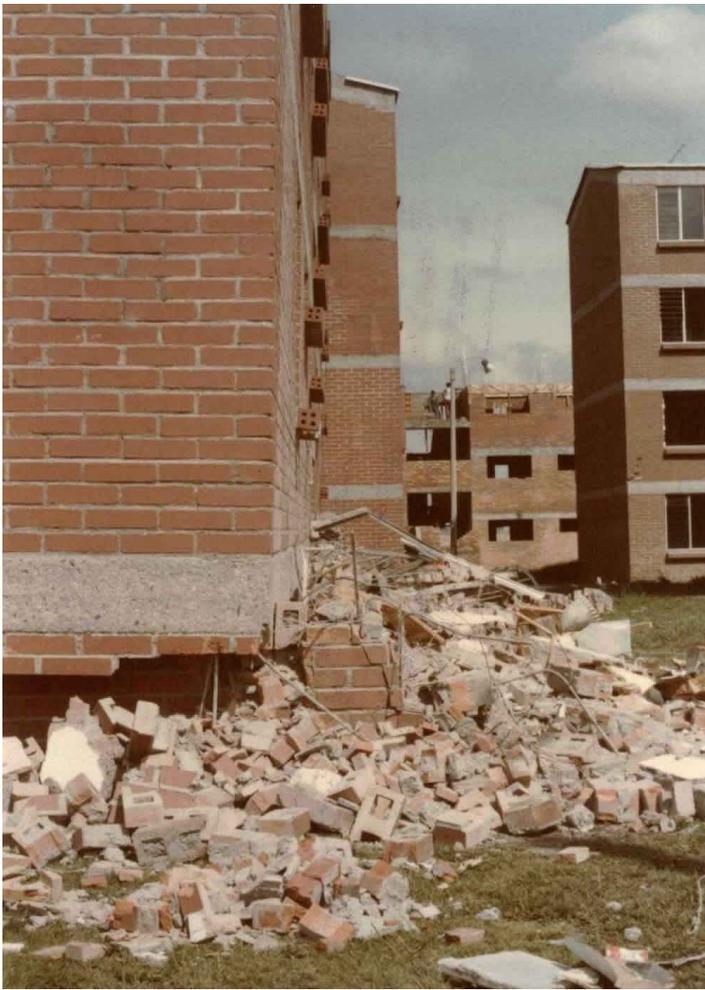
Typical Earthquake Damage - Lateral Movement of the Collapsed Building Relative to the Foundations

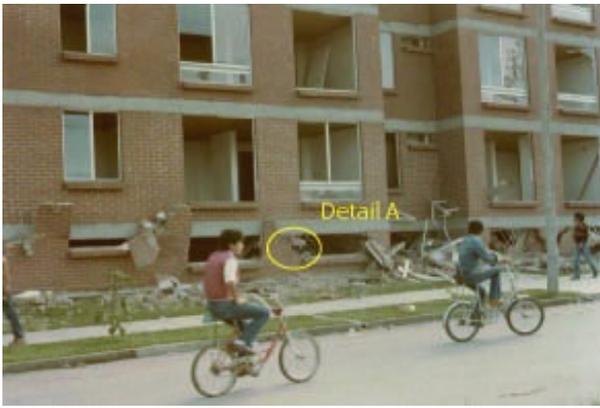
Typical Earthquake Damage - Failure of Load bearing Masonry Walls

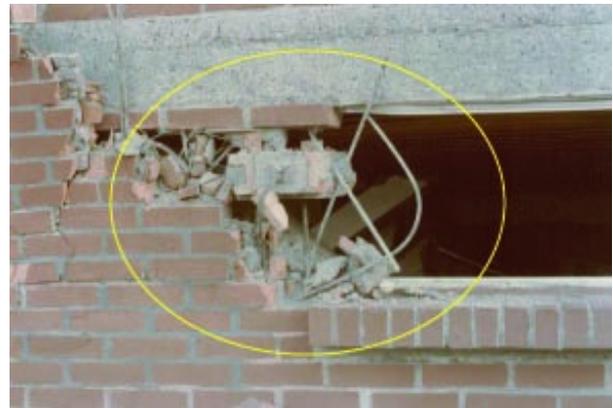
Typical Earthquake Damage - Inadequate Reinforcement (Detail A shown on Figure 16)

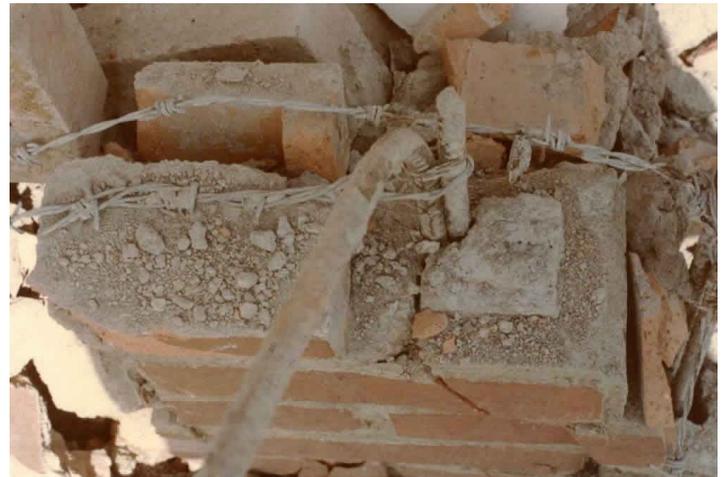
Typical Earthquake Damage - Poor Workmanship and Inadequate Reinforcement (this is an enlarged detail B shown of Figure 18)

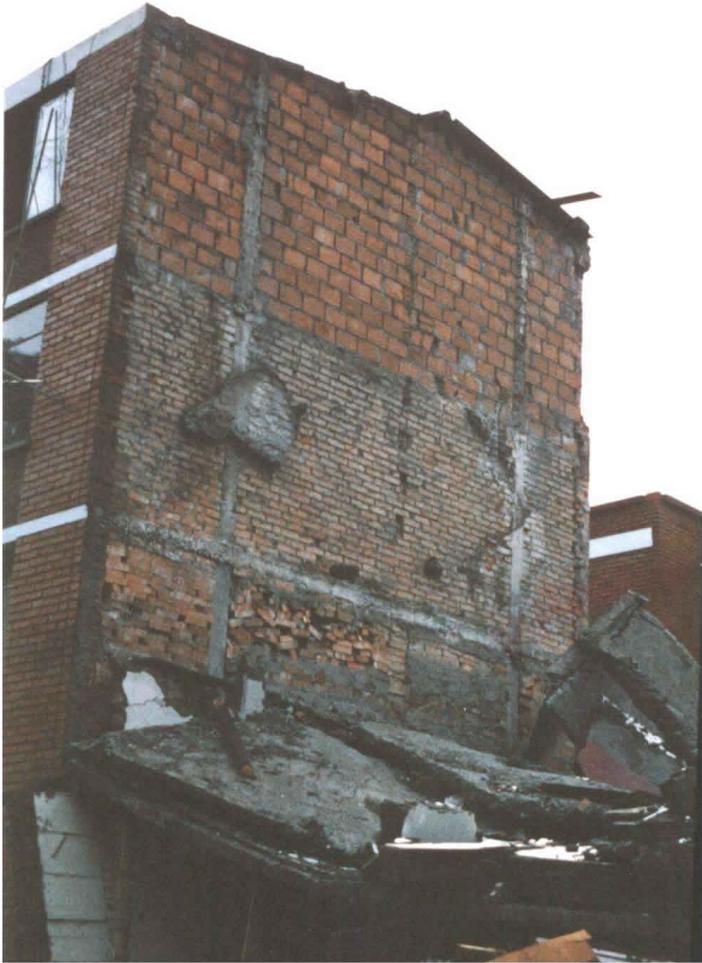
Typical Earthquake Damage Illustrating Two Similar Confined Masonry Buildings (note that the building on the right-hand side collapsed while the one on the left remained standing)

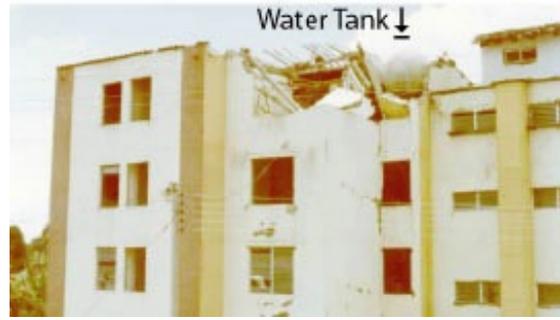
Typical Earthquake Damage - Collapsed Roof; note the absence of continuous RC bond beam and the wall-roof connection; the water tank at the roof "walked off" and had contributed to the roof collapse

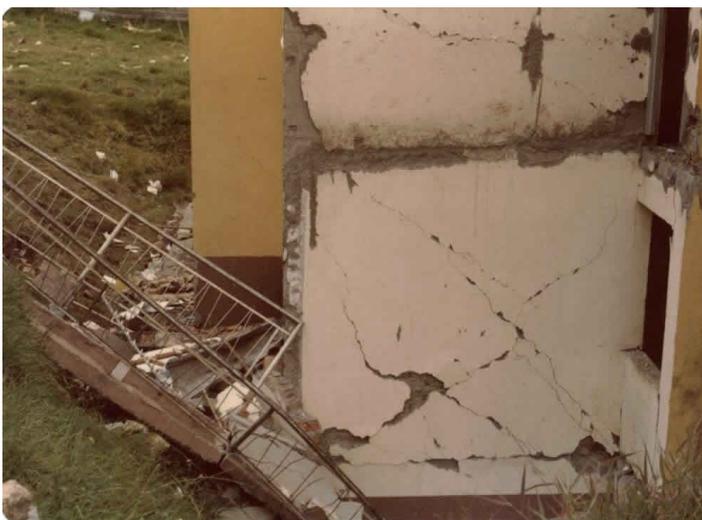
Typical Earthquake Damage - Importance of the Details in Seismic Design : The "access bridge" to this building did not have adequate bearing length and had collapsed, thus leaving inhabitants

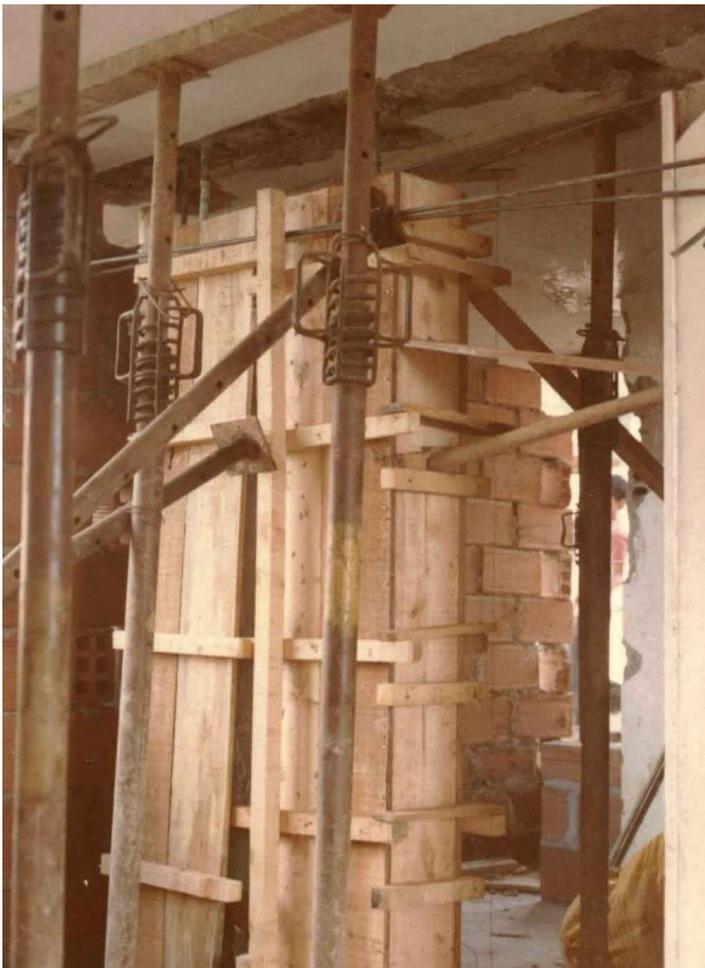
***Seismic Strengthening Techniques-
Installation of New Concrete Tie
Columns***
