World Housing Encyclopedia

HOUSING REPORT

Adobe / Earthen House : Adobe block walls

Report#	137
Last Updated	
Country	Nicaragua
Author(s)	Matthew A. French, ,
Reviewers	Andrew W. Charleson,

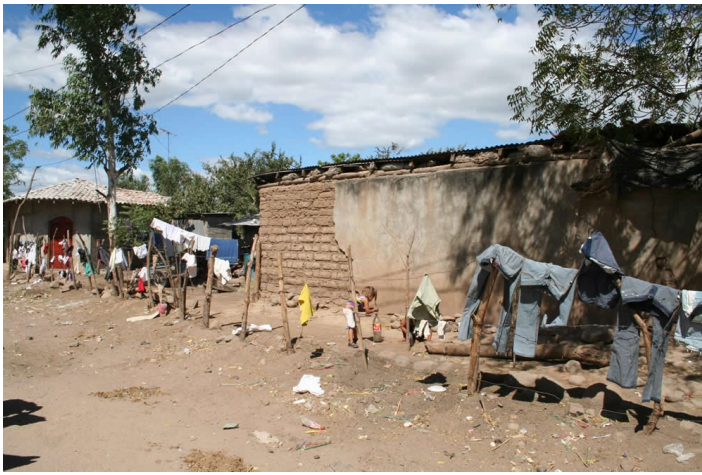
View from the road. The exterior plaster on the left side has fallen off due to the lack of eaves.

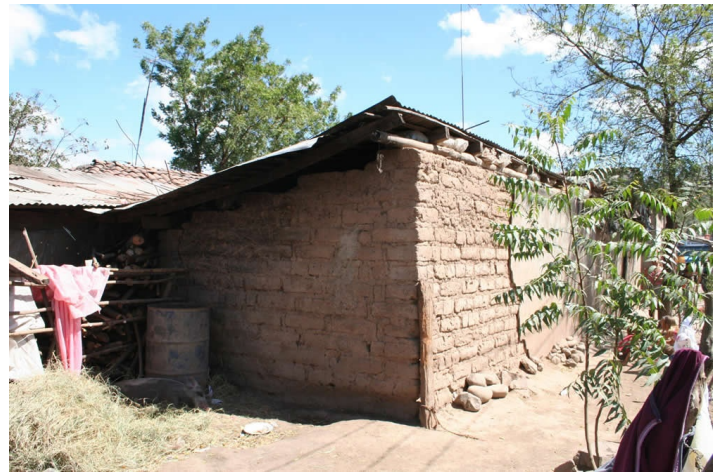
Roof and wall connection.

features in frame	
Seismic deficiency in roof and floors	The roof is poorly connected to the walls, and these poor connections ensure that it can not be counted on to act as a rigid diaphragm for the transfer of loads.
Earthquake resilient features in roof and floors	The roofing material is lightweight, so the risk of injury from roof collapse is minimized.
Seismic deficiency in foundation	
Earthquake-resilient features in foundation

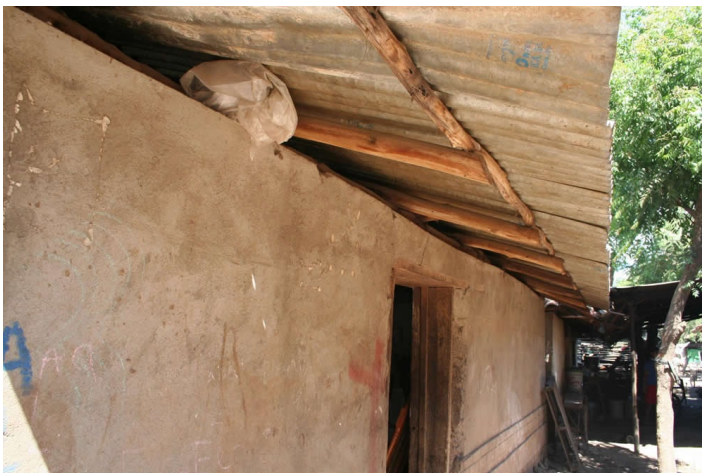
Timber roof framing and plastered wall.
