# World Housing Encyclopedia

## HOUSING REPORT

### Stone masonry residential buildings

<b>Report#</b>	138
<b>Last Updated</b>	
<b>Country</b>	Pakistan
<b>Author(s)</b>	Qaisar Ali , Taj Muhammad,
<b>Reviewers</b>	Robin Spence,

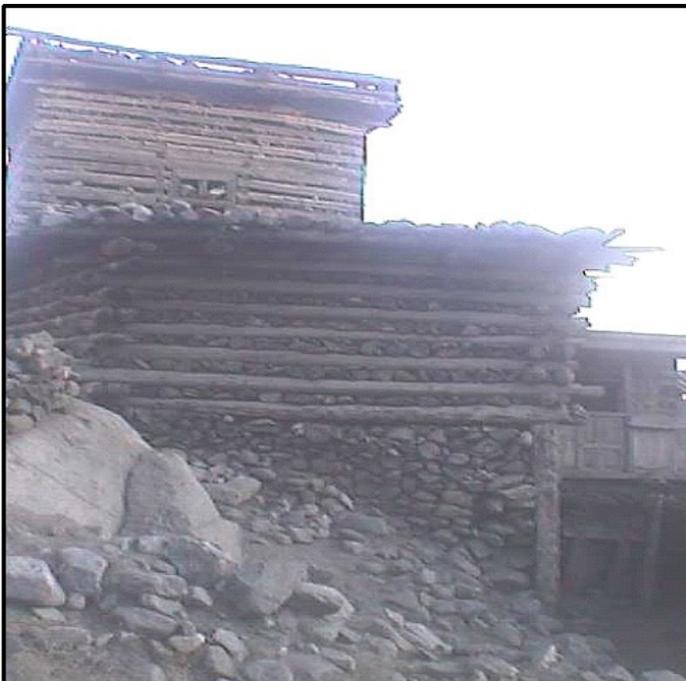
Figure 5 (a): An old house with wooden seismic bands.

***An old house with wooden seismic bands***

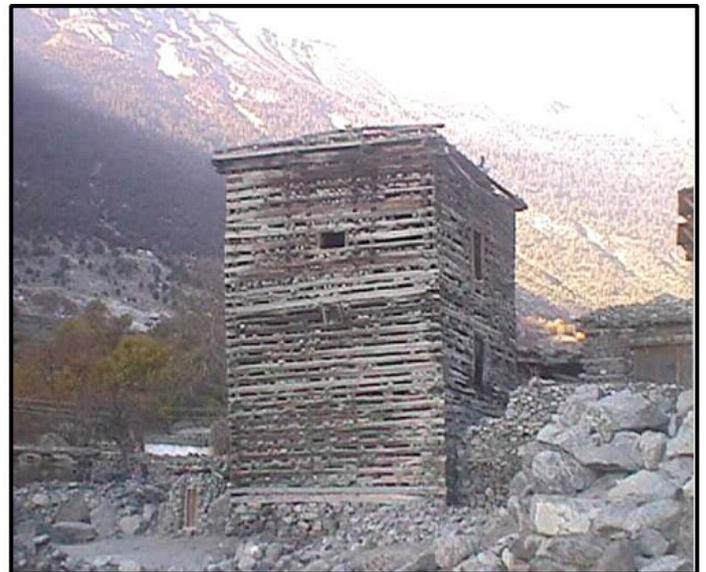
Figure 5 (b): A historical three story building, with single room at each floor; well standing the past seismic events.

***A historical three story building, with single room at each floor; well standing the past seismic events***

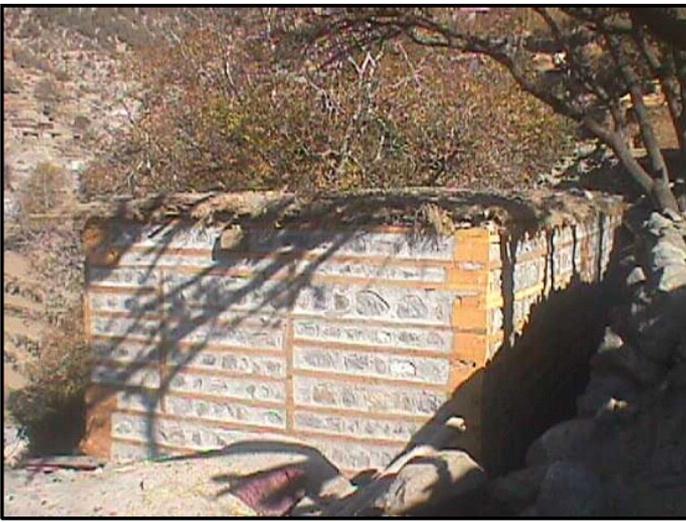
Figure 5 (c): A recently built stone masonry house in cement sand mortar and earthen roof; horizontal and vertical wooden bands are clearly visible.

***A recently built stone masonry house in cement sand mortar and earthen roof; horizontal and vertical wooden bands are clearly visible***

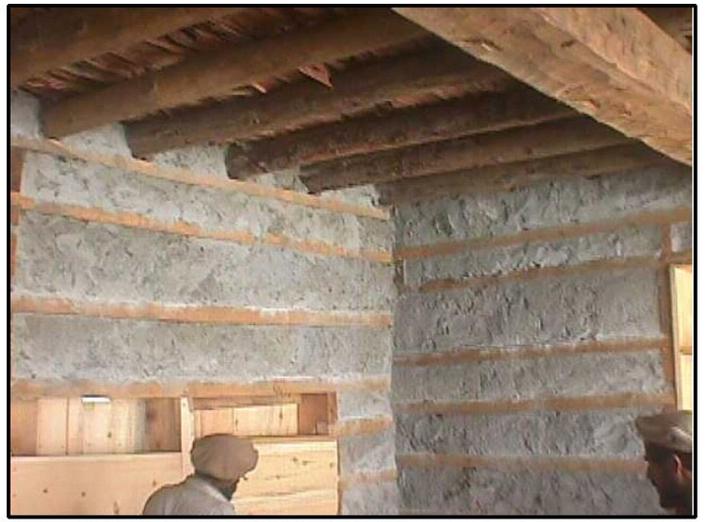
Figure 5 (d): Inner close view of building in fig 5 c.

***Inner close view of building in previous figure (fig 16)***

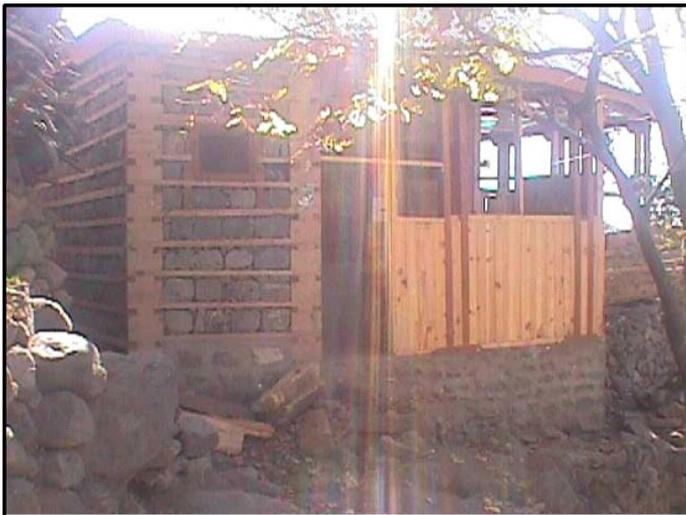
Figure 5 (e): An under construction house, being built with wooden seismic bands.

***A house under construction, being built with wooden seismic bands***

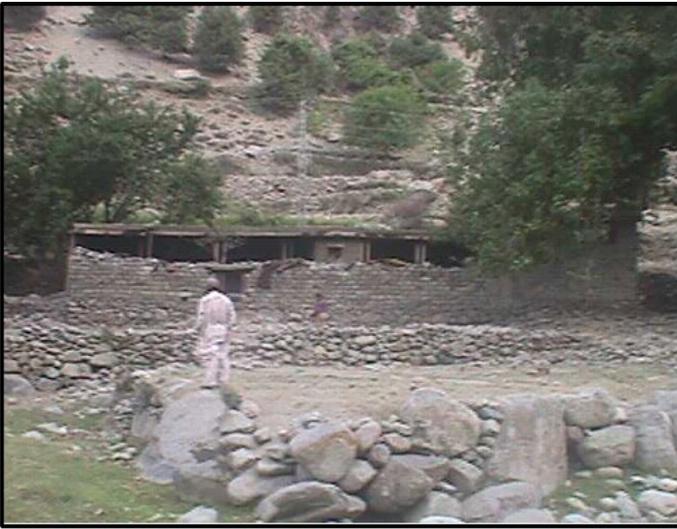
Figure 6 (b): Out-of-plane failure of stone masonry in dry; Pakistan earthquake of October 08, 2005

***Out-of-plane failure of stone masonry with no mortar; Pakistan earthquake of October 08, 2005***

In-plane shear and out-of-plane failure of walls; roof collapse.

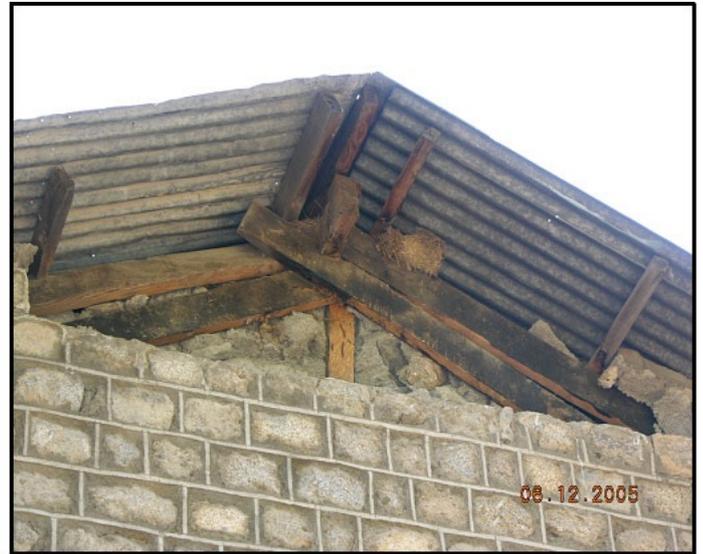
Figure 6 (c): Gable wall failure: Pakistan earthquake of October 08, 2005.

***Gable wall failure: Pakistan earthquake of October 08, 2005***

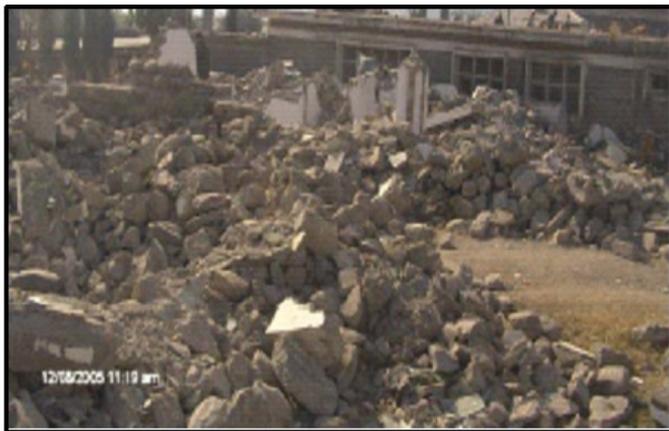
Figure 6 (d): Debris of buildings collapsed due to lateral thrust in addition to seismic forces. Note a building in the background with rigid diaphragm is still standing; Pakistan earthquake of October 08, 2005.

***Debris of buildings collapsed due to lateral thrust in addition to seismic forces. Note a building in the background with rigid diaphragm is still standing; Pakistan earthquake of October 08, 2005***

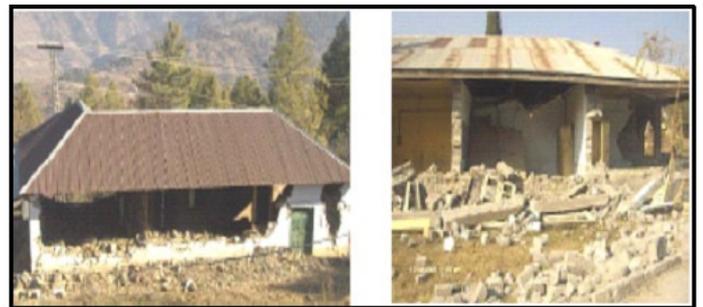
Figure 6 (e): Out of plane bending failure of masonry walls due to additional thrust from roof trusses; Pakistan earthquake of October 08, 2005.

***Out of plane bending failure of masonry walls due to additional thrust from roof trusses; Pakistan earthquake of October 08, 2005***

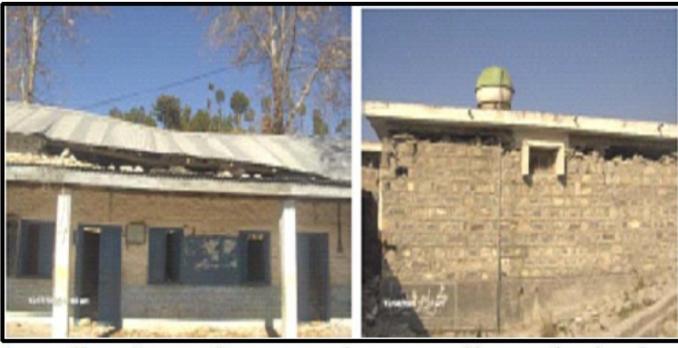
Figure 6 (f): Slippage of top course of masonry; Pakistan earthquake of October 08, 2005.

***Slippage of top course of masonry;  
Pakistan earthquake of October 08,  
2005***

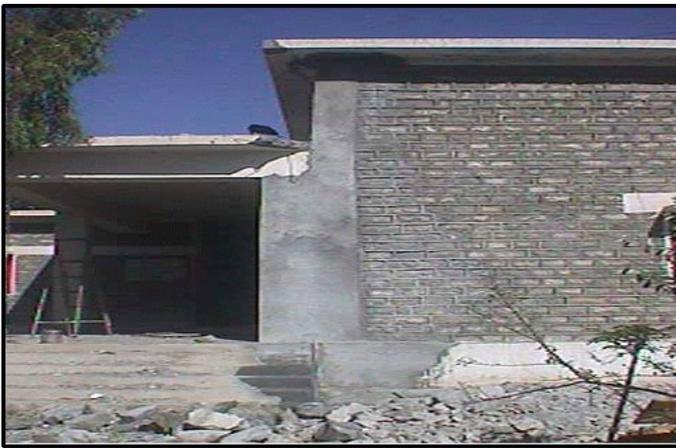
Figure 7 (a): Seismic strengthening technique; Column repaired after the earthquake.

***Seismic strengthening technique; column repaired after the earthquake***

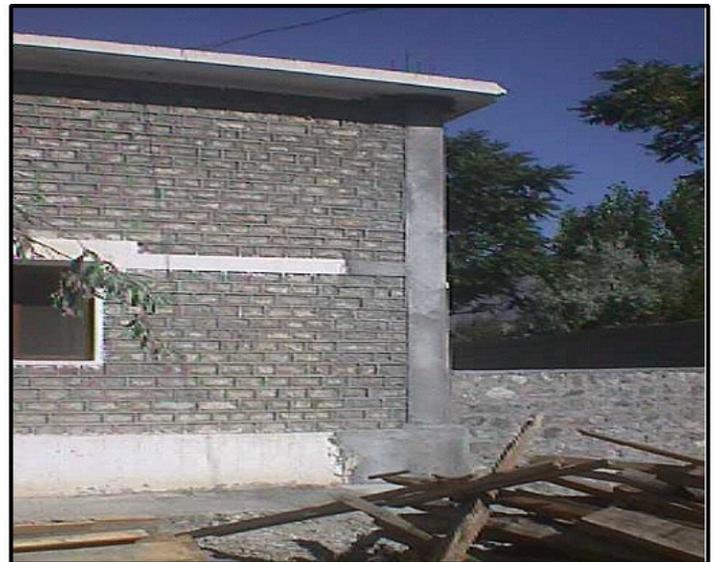
Figure 7 (b): Seismic strengthening techniques; Column repaired after the earthquake.

***Seismic strengthening techniques; column repaired after the earthquake***
