# World Housing Encyclopedia

## HOUSING REPORT Vivienda de Adobe (Adobe house)

<b>Report#</b>	14
<b>Last Updated</b>	
<b>Country</b>	El Salvador
<b>Author(s)</b>	Manuel A. Lopez, Julian Bommer, Gilda Benavidez,
<b>Reviewers</b>	Sergio Alcocer,

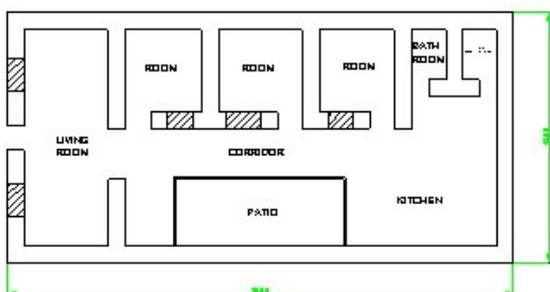
**Plan of a Typical Building**

**Plan of a typical rural dwelling**

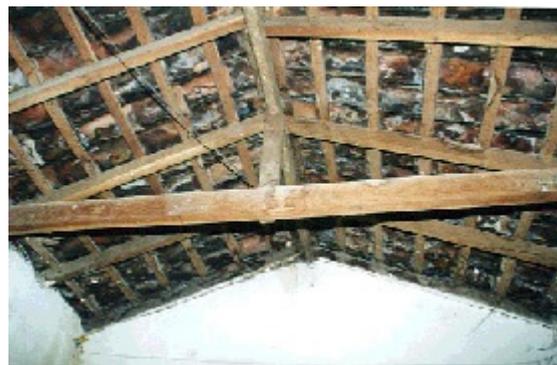
**Critical Structural Details: An illustration of wood beams supporting clay tiles and roof-wall connections**

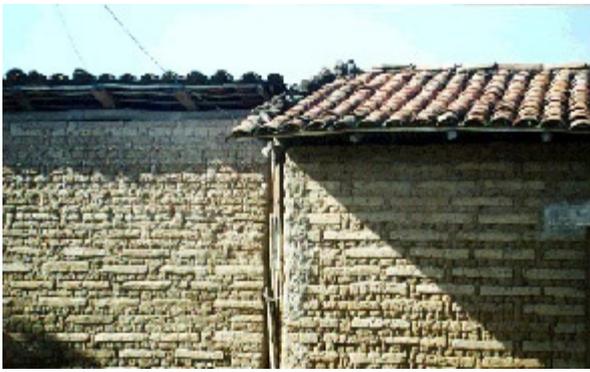
**Wall connections**

Walls: There is lack of dependable joints among walls, especially at the top of walls. This causes adjacent walls to open up during an earthquake.

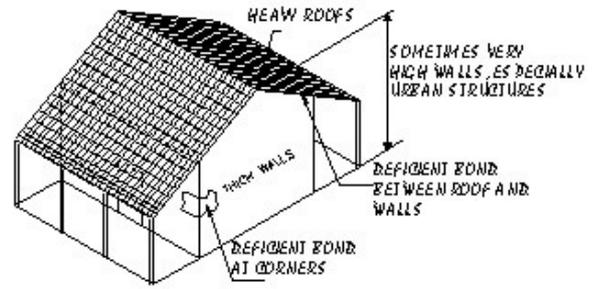
**An illustration of Key Seismic Features and/or Deficiencies**

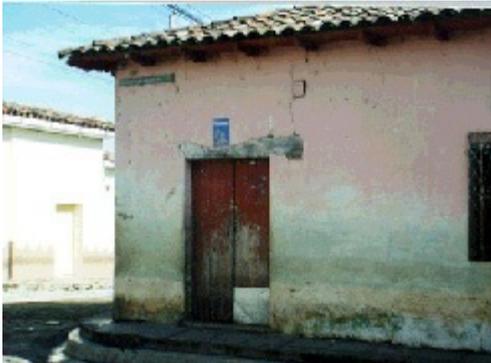
**Deficient bedding of lintels**

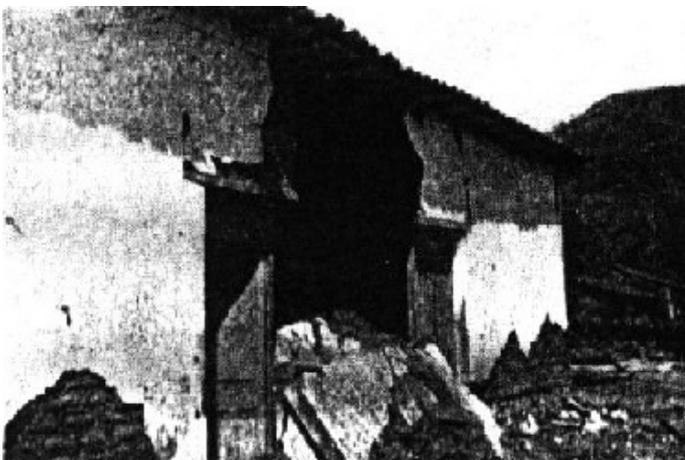
*Damage to an adobe house in the 1936 San Vicente earthquake*

Wall: Damages due flexural and shear effects. Roof and floor: Total and partial collapse of the roof due to material degradation and loss of support from walls.

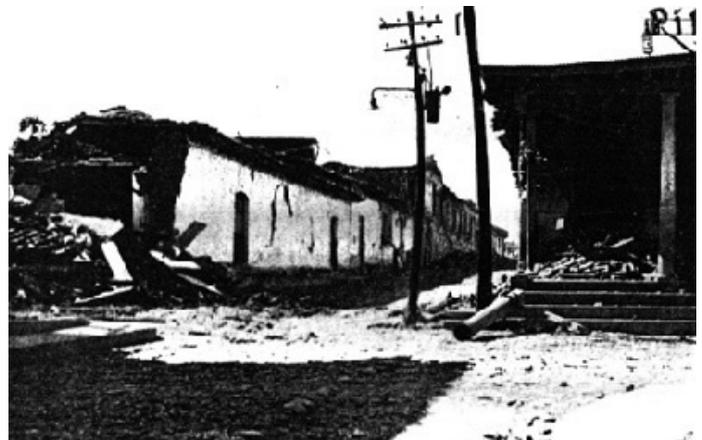
*Damage to adobe houses in the 1936 San Vicente earthquake*

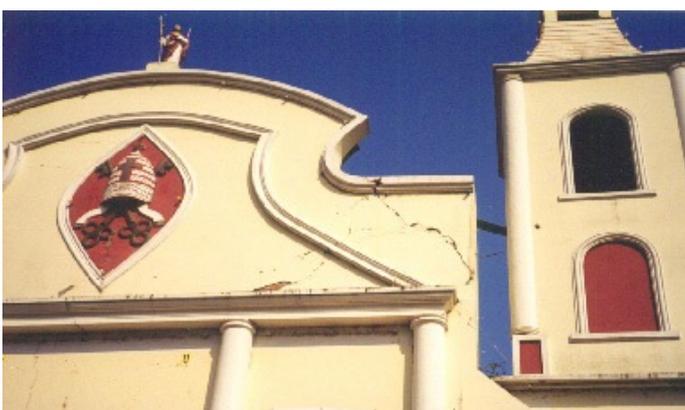
*Wall damage (corner separation) in*

**the 1999 Apastepeque earthquake**

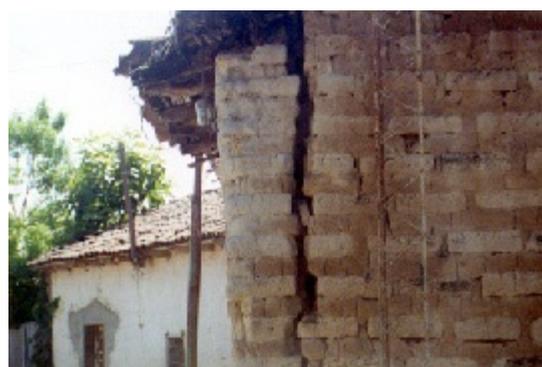
**Damage to an adobe church in the 1999 Apastepeque earthquake**

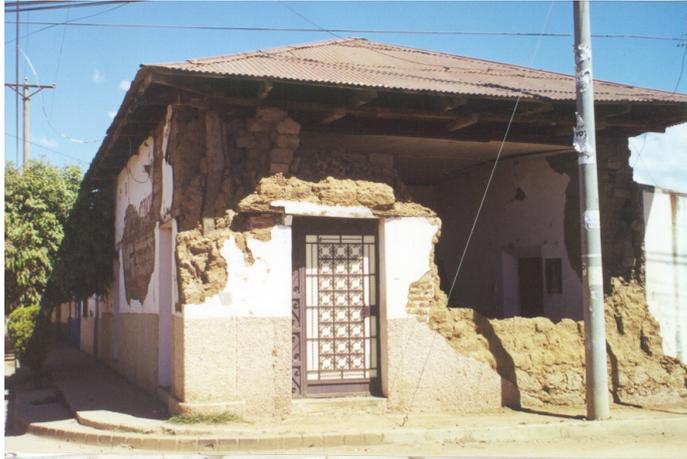
**Damage in the town of Juayua due to the January 13, 2001 earthquake**

El Salvador had two big EQ at the beginning of 2001. The first one was on 13 January 2001 with ITS epicenter located in the Pacific Ocean and with magnitude  $M_w=7.7$ , with a maximum estimated intensity of VIII (MMI). The second one happened on 13 February 2001 with epicenter at San Juan Tepezontes and  $M_w=6.5$ ; the estimated intensity was VIII in some places, however in many of the affected areas its intensity was VII (MMI). One of the most important features of these two EQ is that they destroyed adobe housing in many places throughout El Salvador.

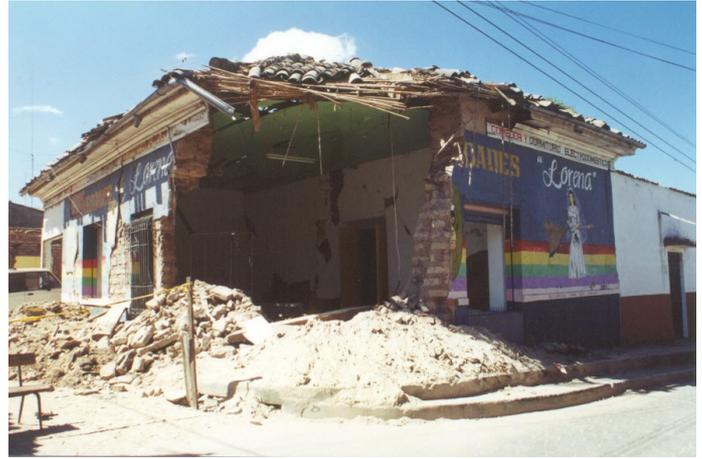
**Damage in the city of Cojutepeque due to the February 13, 2001 earthquake**

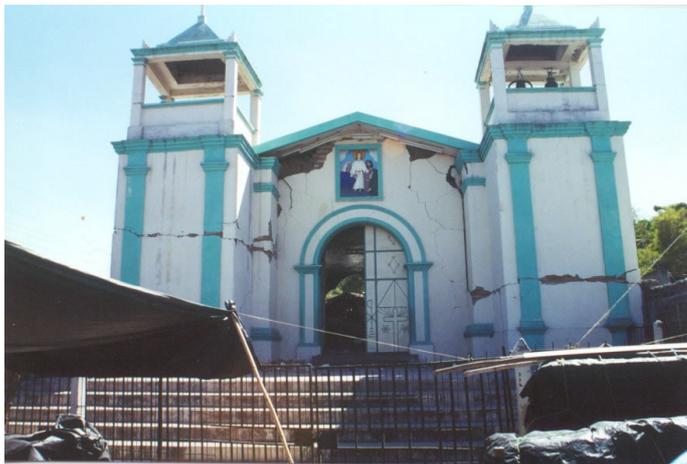
**The San Jose church, Cojutepeque, damaged in the 13 February 2001 earthquake**

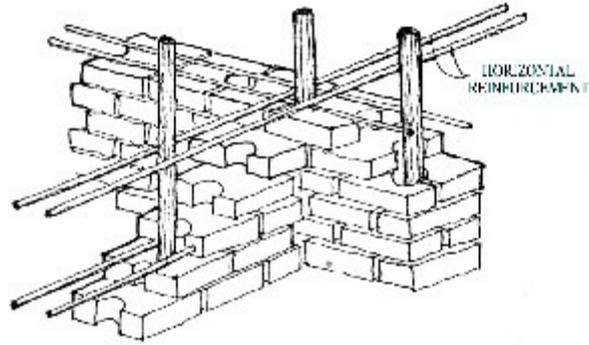
**Seismic Strengthening: Vertical and Horizontal Reinforcement**

Collar Beam or Lintel Band: This feature ties the walls together. Buttresses: This feature helps to retain the integral action of walls and facilitate the connection of collar beams with each other. Vertical and Horizontal Reinforcement using bamboo: This feature tries to provide reinforcement similar to that for concrete structures. Adobe bricks have to

be molded appropriately to use this kind of strengthening technique.

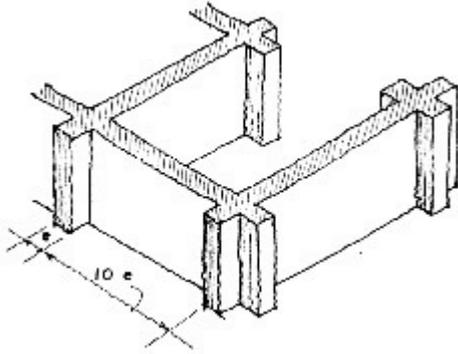
**Seismic Strengthening: Wall Buttresses**
