World Housing Encyclopedia

HOUSING REPORT

Multi-story reinforced concrete frame building

Report#	15
Last Updated	
Country	Greece
Author(s)	T. P. Tassios, Kostas Syrmakezis, ,
Reviewers	Craig D. Comartin,

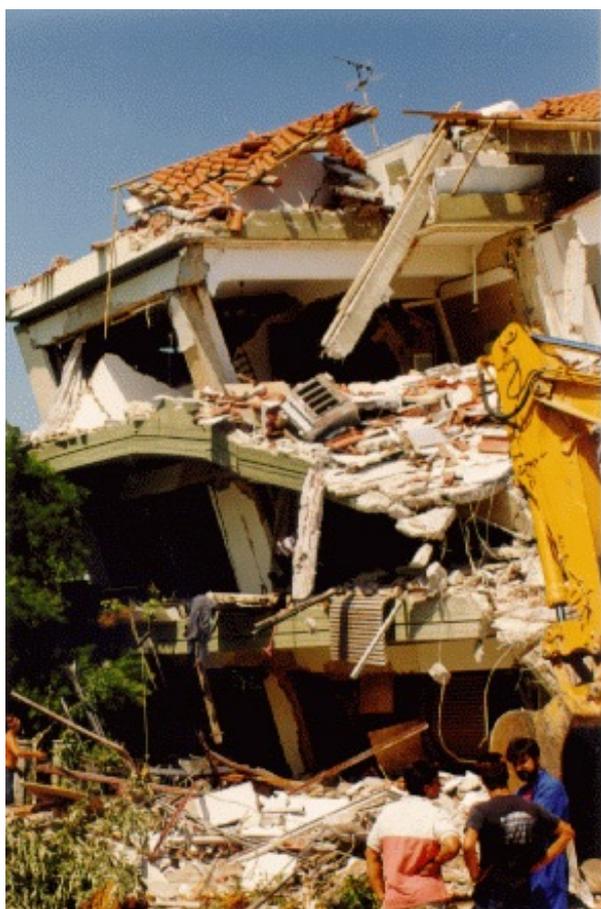
Typical Earthquake Damage (1999 Athens earthquake)

Cracking in shear walls of the elevator shaft (1999 Athens earthquake), see Figure 9. Joint failure in poorly constructed structures. Damage to column-beam joints due to bad concrete quality and insufficient reinforcement was observed in the 1999 Athens earthquake (EERI). In many cases, stirrup reinforcement was almost nonexistent (see Figures 7 and 8). Soft ground floor (where there is an absence of infill walls at the ground floor) may cause damage, leading to the development of collapse mechanisms. In the 1999 Athens earthquake, the damage occurred mainly to the joints, which were totally destroyed in a number of cases. As a result, the structural system became a mechanism, and large permanent horizontal displacements were observed. In some cases, collapse of the soft story was occasioned by P-d effect, combined with high vertical accelerations.

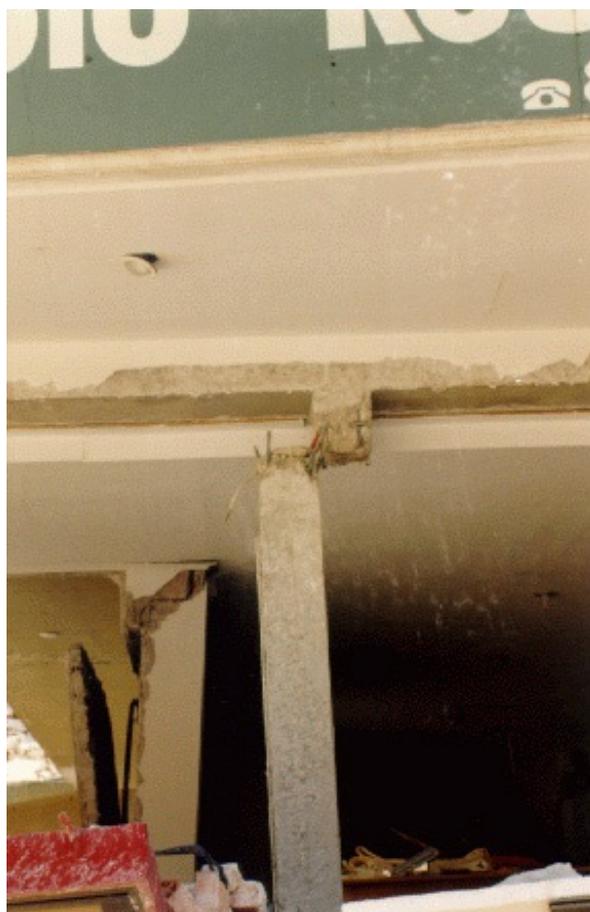
Building Collapse in the 1999 Athens earthquake

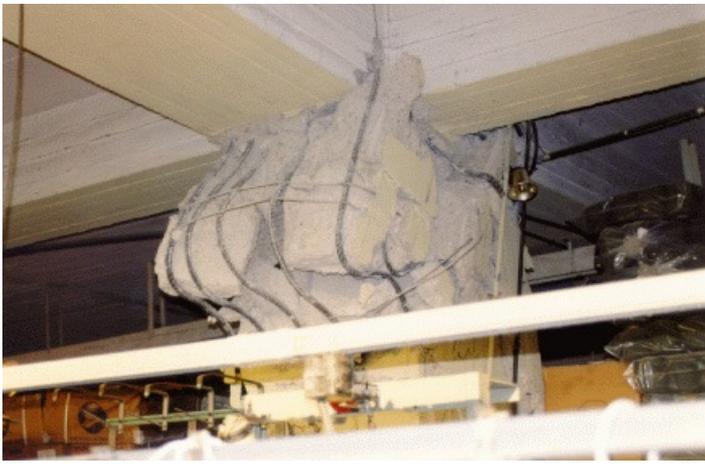
Earthquake Damage - Dislodged Column due to Soft Ground Floor Effect (1999 Athens earthquake)

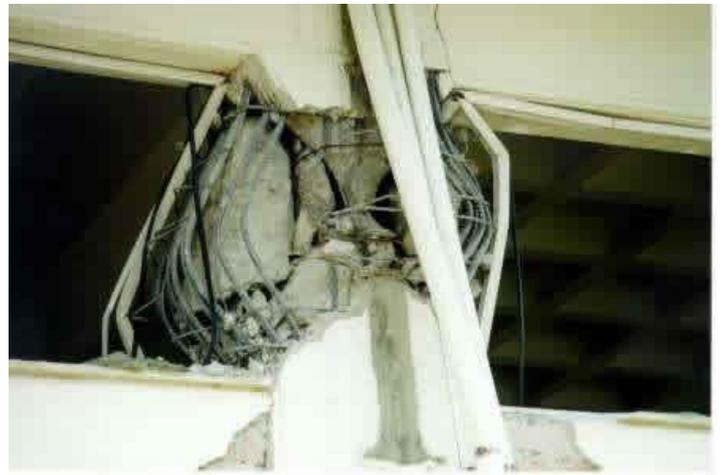
Typical Earthquake Damage-Column Failure (1999 Athens Earthquake)

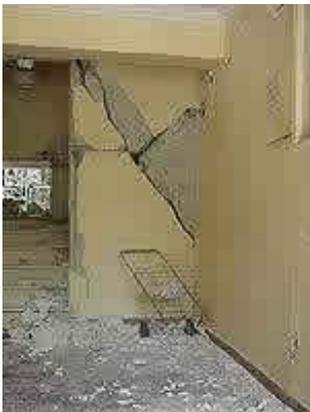
Failure of column, due to short column effect, of a 5-story building in Ano Liosia, which was built in 1997 according to the new Greek Seismic Code (1999 Athen earthquake); Source: ITSAK

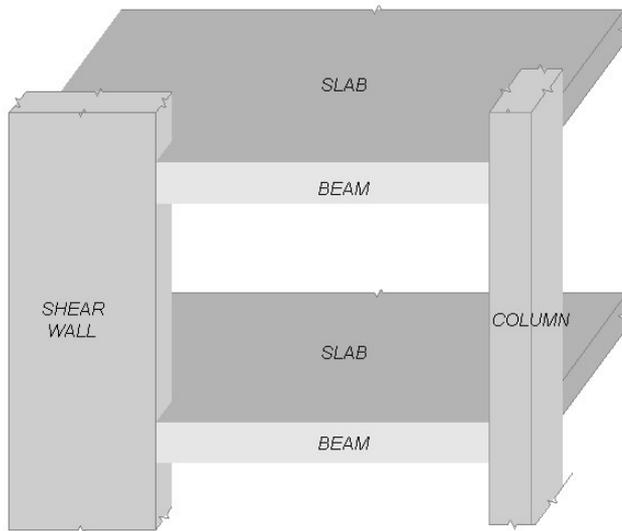
Illustration of Seismic Strengthening Techniques

Structural Deficiency	Seismic Strengthening
Reinforced concrete columns: deficient reinforcement and concrete strength	Installation of reinforced concrete jackets For the construction of reinforced concrete jackets, concrete quality (strength) must be greater or equal to the existing concrete. New and existing reinforcement must be connected at least at the corners of the columns by using steel plates at 500 mm spacing. Connection between reinforced concrete jackets and existing columns is provided by steel dowels (about 5 dowels

Strengthening of damaged concrete columns using the reinforced concrete jackets was used in Greece after the 1981 Athens earthquake. More details on this technique can be found in UNIDO (1983).
