World Housing Encyclopedia

HOUSING REPORT

Base isolation of confined masonry

| Country | Argentina |

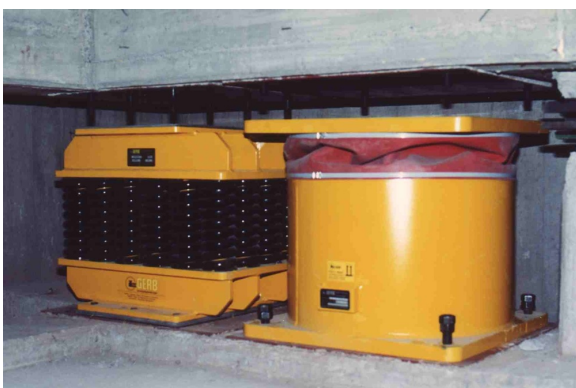
View of System of Isolation in BSI Building

independent of temperature, and have no creep and not residual displacements. They have the disadvantage of low damping (2% of critical), and therefore it is necessary to use additional devices for increasing the damping. Because the load capacity of an individual helicoidal spring is limited, for moderate or large loads, the use of packages of springs is required. The number of springs per isolator depends on the static and dynamic demand imposed by service and seismic loads. In this case, because of asymmetry of loads, two isolators are composed of 30 springs, with a load capacity of 921 kN and the other two are composed of 28 springs for a force capacity of 860 kN. The structural system with isolators has natural horizontal frequencies between 1 and 2 Hz and natural vertical frequencies of 3 to 3.5 Hz. For earthquake input excitation the isolation system allows a dynamic motion composed of vertical, horizontal and swaying and rocking motions. Part of the horizontal excitation is transferred to swaying and rocking modes and it is dissipated by the isolation system thus reducing the seismic demands on the superstructure. The viscous damper comprises a container of viscous material. A piston attached to the upper part is immersed into the viscous material generating viscous forces in three orthogonal directions. The isolation system formed by spring isolators and viscous dampers has linear stiffness in all directions and an almost linear damping as a function of velocity. The design of the viscous damper is a function of maximum and minimum velocity demand that can be expected at the location. The maximum velocities of the selected records are in the range of 0.20 to 1.70 m/s. Viscous damping can be modified easily by changing the number of internal cylinders. In this case, due to the impulsive characteristic of anticipated earthquakes, large damping ratios have been selected in order to control displacements, 26% in horizontal direction and 13% in vertical direction. With these values the horizontal displacements are limited to 150-200 mm and the vertical ones to 30-50 mm, which are compatible with the displacements the springs and dashpots are capable of undergoing.

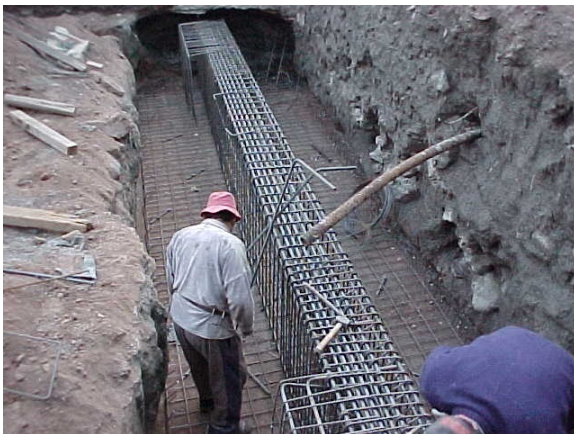
Construction of Reinforcement of Footings of BS1 Building (B1x and B2X)

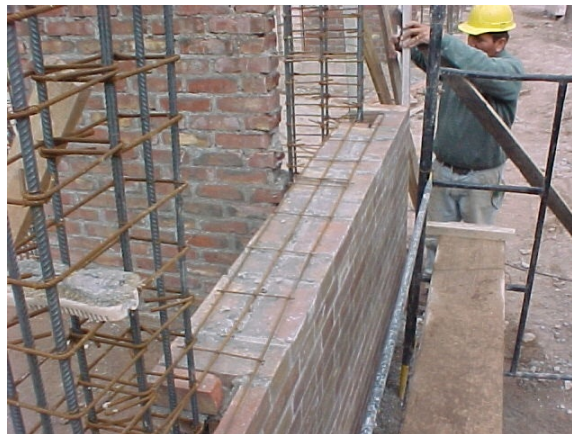
Construction of Reinforced Masonry

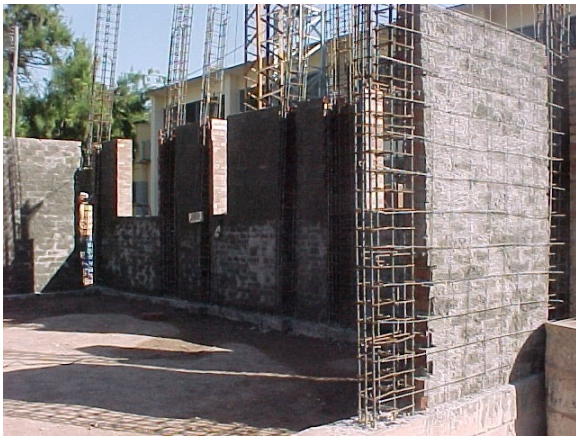
***Details of Confined Masonry Walls.
Note the layer of reinforcing mesh
on the wall that will be covered with
concrete in order to improve
wall strength and ductility.***

| Structural Element | Building Material (s) | Comment (s) |
|---|---|--|
| Wall/Frame | Walls: clay brick and artisan brick and some reinforced concrete. Although not standard practice in Argentina, masonry walls are lined with mesh and then a layer of concrete to increase their strength and ductility. | Reinforced concrete: H17 (17MPa) Clay brick: Compressive strength 2.50MPa Masonry mortar mix: 1:3 (cement:sand) Concrete mix: 1:2:3 (cement:sand:gravel) Dimensions of masonry units: 130x80x60 for walls of 30 cm of thickness and 260x170x80 for walls of 20 cm of thickness. The internal divisions are of plaster plate. The wall and floor coverings are ceramic materials. |
