World Housing Encyclopedia

HOUSING REPORT

Loadbearing stone masonry building

Report#	16
Last Updated	
Country	Greece
Author(s)	T. P. Tassios, Kostas Syrmakizis, ,
Reviewers	Craig D. Comartin,

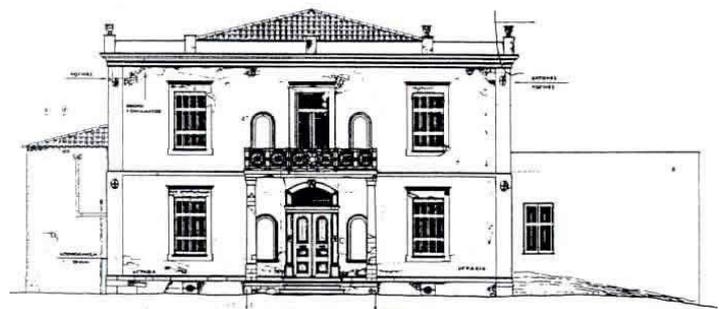
A View of a Typical Building

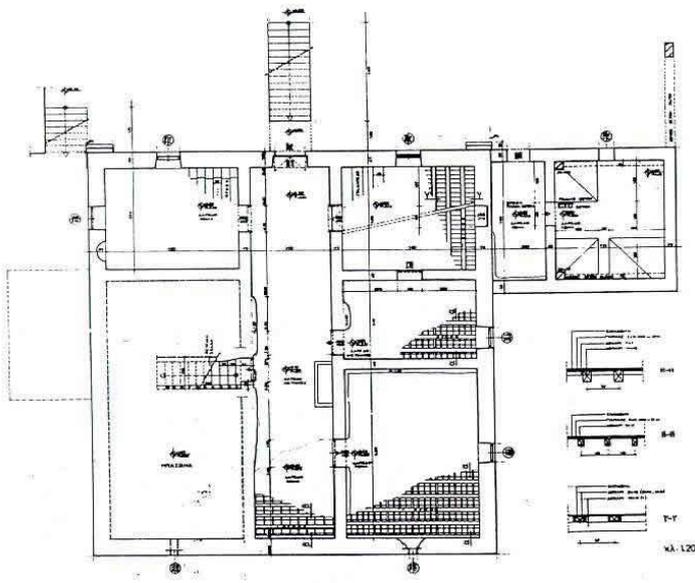
Plan of a Typical Building

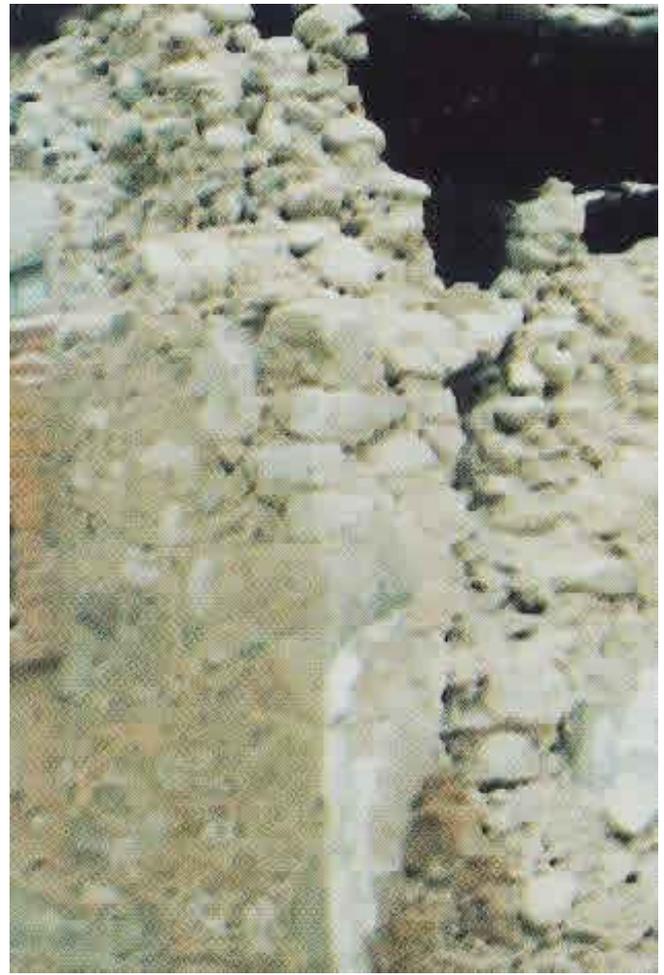
Critical Structural Details

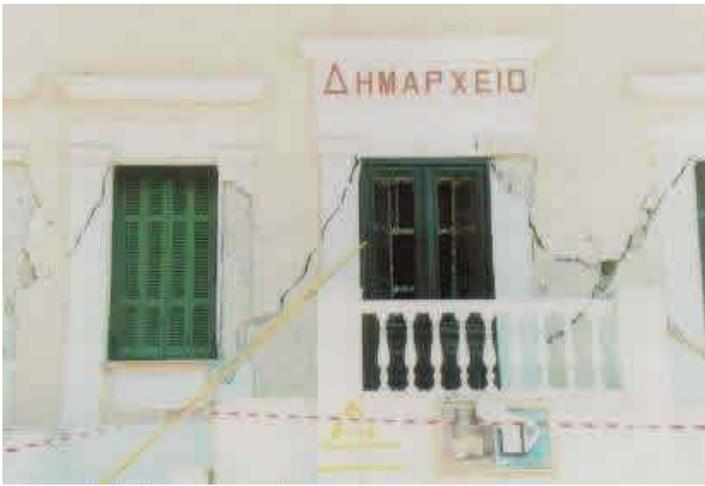
Typical Earthquake Damage - Shear Cracking of Masonry Walls (1999 Athens earthquake)

<p>Additional comments on earthquake damage patterns</p>	<p>Wall: Stone masonry walls were damaged in the 1999 Athens earthquake. The damage included partial collapse of external walls, collapse of corners, separation of the two walls converging at a corner, and extensive cracking (Source: EERI) Roof/floors: Extensive masonry cracking, due to low tensile and shear strength and unsatisfactory diaphragm action of the horizontal members.</p>

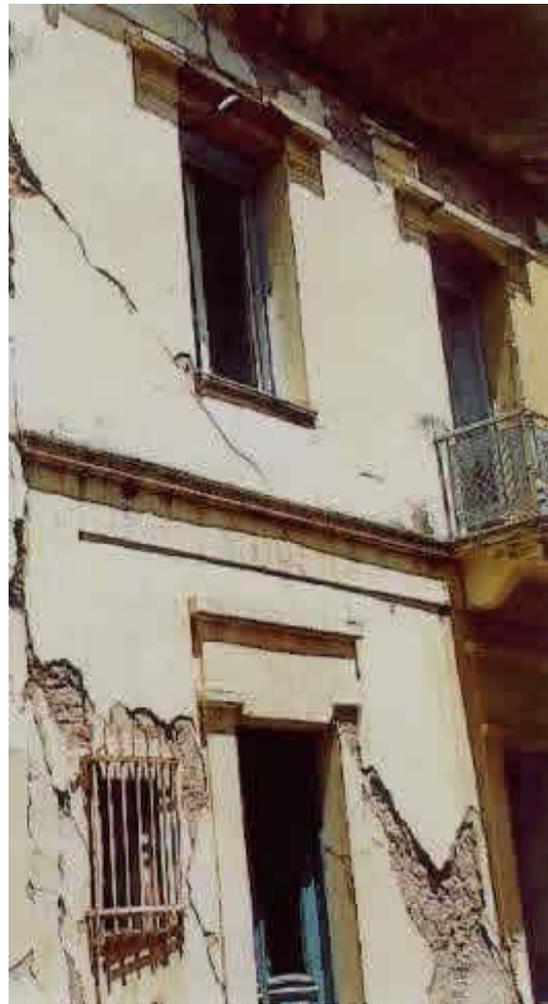
Typical Earthquake Damage - Falling of Plaster and Shear Cracking of the Walls (1999 Athens Earthquake)

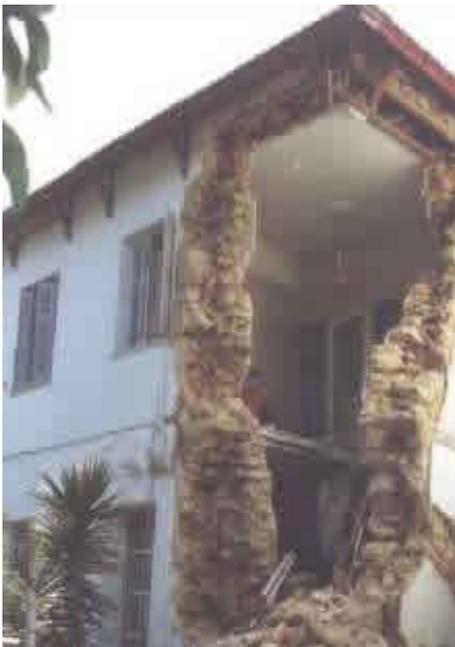
Partial Collapse of a Stone Masonry House in Nea Philadelphia (1999 Athens earthquake); Source: EERI

<p>Damage patterns observed in past earthquakes for this construction type</p>	<p>On September 7, 1999, at 14:56 local time, a strong earthquake occurred 18 kilometres northwest of the center of Athens. The earthquake was magnitude $M_s = 5.9$ and the coordinates of the epicentre were located at 38.12.-23.64., in the area of Parnitha mountain. This earthquake came as a surprise, since no seismic activity was recorded in this region for the last 200 years. According to strong-motion recordings, the range of significant frequencies is approximately 1.5-10 Hz, while the range of the horizontal peak ground accelerations were between 0.04 to 0.36g. The most heavily damaged areas lie within a 15 km radius from the epicentre. The consequences of the earthquake were significant: 143 people died and more than 700 were injured. The structural damage was also significant, since 2,700 buildings were destroyed or were damaged beyond the repair and another 35,000 buildings experienced repairable damage. According to the EERI Reconnaissance report (see References), in the meizoseismal area, most stone masonry structures with undressed stones, constructed in the first half of the century, suffered significant damage. This included partial collapse of external walls, collapse of corners, separation of the two walls converging at a corner, and extensive cracking.</p>

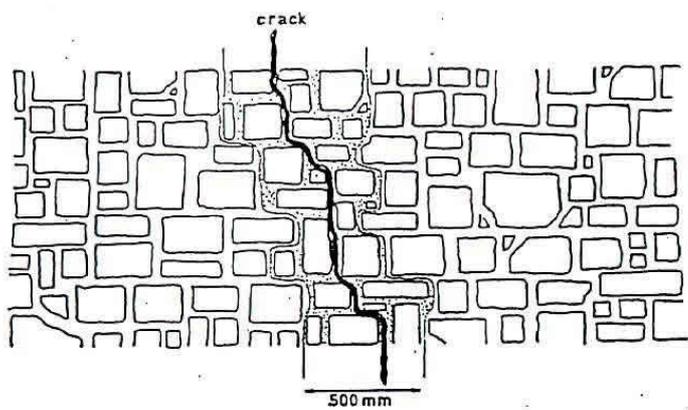
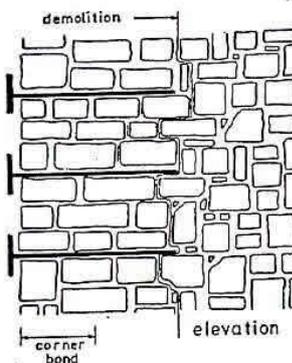
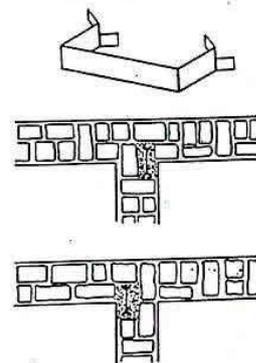
Seismic Strengthening of Wall Intersections

demolition or taking-off of blocks

1,2 : old adjacent blocks
3 : new connecting block (use of rich mortar)

full rebuilding and use of long ties

carefull rebuilding (use of rich mortar)

use of steel elements (plates, special ties)

taking off of blocks (in turns) and rebuilding, using steel ties

Illustration of Seismic-strengthening Techniques

Structural Deficiency	Seismic Strengthening
Roofs/floors	- Strengthening of wall-floor connections; - Strengthening of diaphragms;
Stone masonry walls	- Crack repair (see Figure 9); - Installation of RC belts or ties; - Deep repointing and installation of RC jackets (see Figure 11); - Strengthening of wall intersections (see Figure 10)
Additional comments on seismic strengthening provisions	The first step in the seismic strengthening is the deep repointing of the wall. This technique improves the tensile strength of the wall (up to 10 times). Subsequently, cement-mortar injections are applied (if required) for the further improvement - homogenization of the wall. Finally, RC jacket is applied on the wall surface (Figure 10). The overall structural resistance is greatly improved since the reinforcement (provided in concrete jacket) is activated at the critical cracking point.
Has seismic strengthening described in the above table been performed?	Yes, to a great extent.

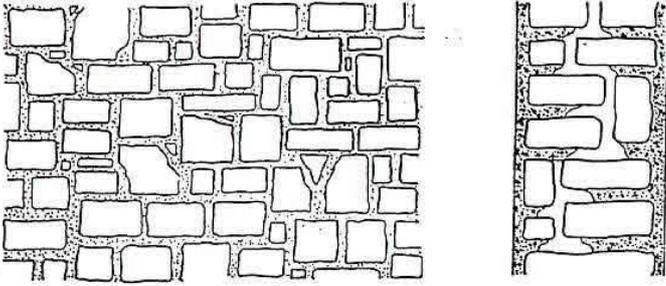
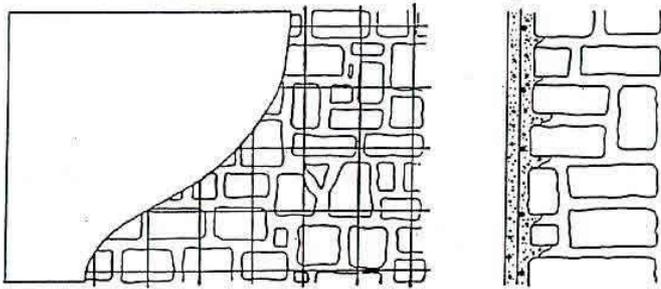
***Seismic-strengthening Techniques -
A detail of repointing and the
installation of RC jacket***
