World Housing Encyclopedia

HOUSING REPORT Timber stilt homes

Report#	165
Last Updated	
Country	Belize
Author(s)	Laura Redmond, Reginald DesRoches ,
Reviewers	Sugeng Wijanto ,

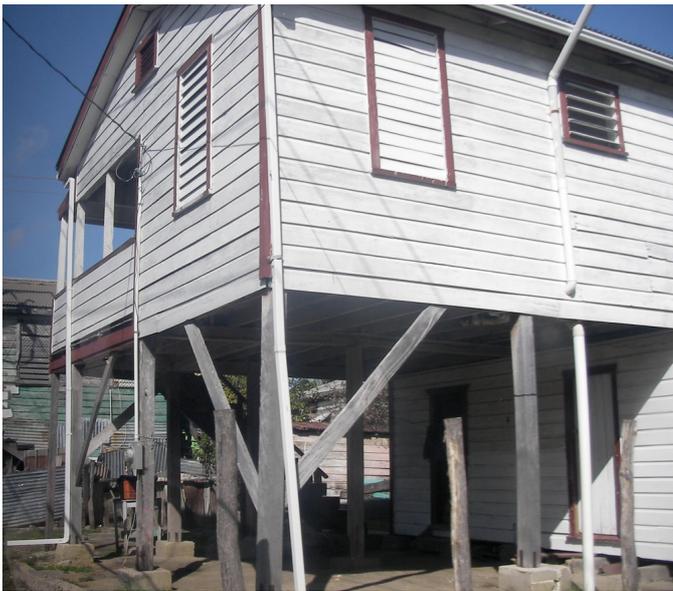
Close up of wood stilts

Structural Element	Building Material (s)	Comment (s)
Wall/Frame	The walls are made of plywood or press board with wood siding. The frames and columns are timber posts and beams.	Building data is unknown and in poor families the materials may be reclaimed.
Foundations	The foundations are timber posts attached to un-reinforced concrete footings.	
Floors	The floor is a plywood sheeting nailed into

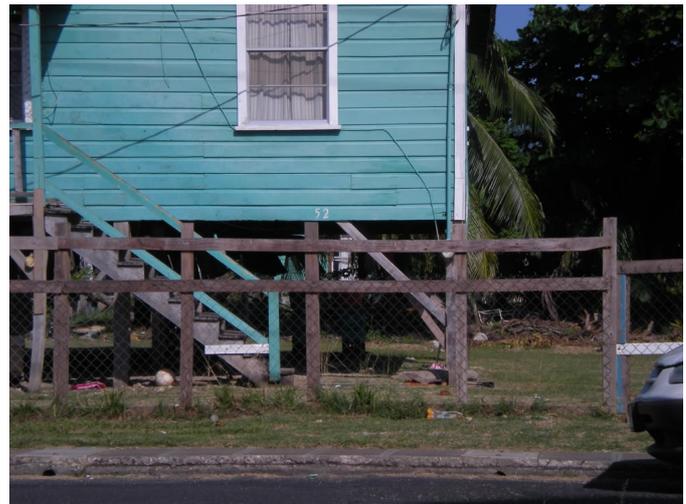
Typical wooden stilt home with a shed added underneath

Plan Shape	Rectangular, solid
Additional comments on plan shape	Buildings are regular in plan, but have an open first story, which could produce a soft-story mechanism.
Typical plan length

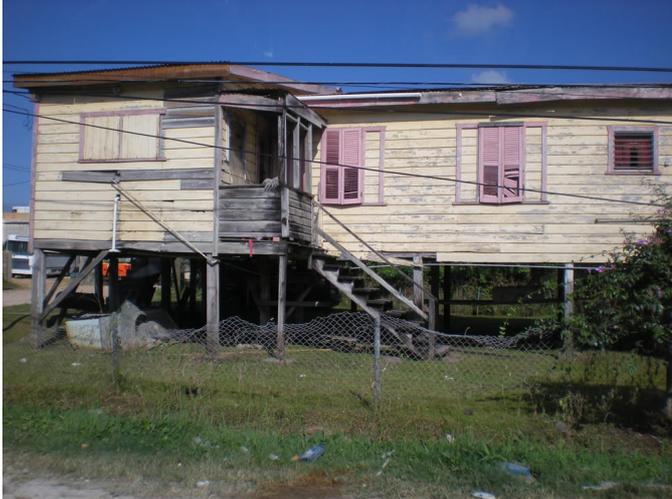
Wooden stilt houses may be poorly maintained, but still occupied

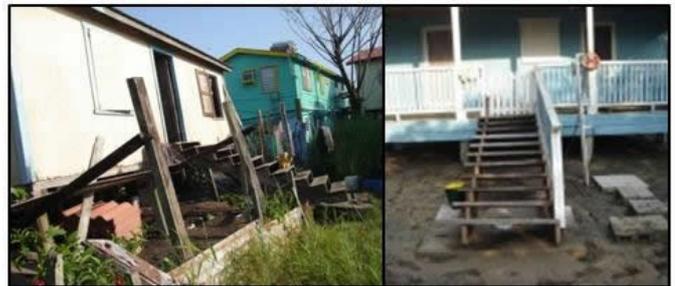
Stilt houses fell off their timber posts during the 2009 earthquake

Additional comments on structural and architectural features for seismic resistance	1) Lateral Load Path: The lateral load system is designed for wind loads but does not have seismic connections. The buildings are not designed for earthquake forces. 2) Building Configuration: The houses are regular in plan but not in elevation (soft story). 3) Roof Construction: Roofs are not designed for earthquakes and about 50% have adequate tie-downs for hurricanes. 4) Quality of Workmanship: Often inexperienced laborers build their own homes, and no special connections are used.	
Vertical irregularities typically found in this construction type	No irregularities	
Horizontal irregularities typically found in this construction type	Soft/weak story	
Seismic deficiency in walls		
Earthquake-resilient features in walls		
Seismic deficiency in frames	(wood frame system) : They are not designed for earthquake forces, and no special connections are used. Soft story mechanisms are likely because the bottom level is often left open.

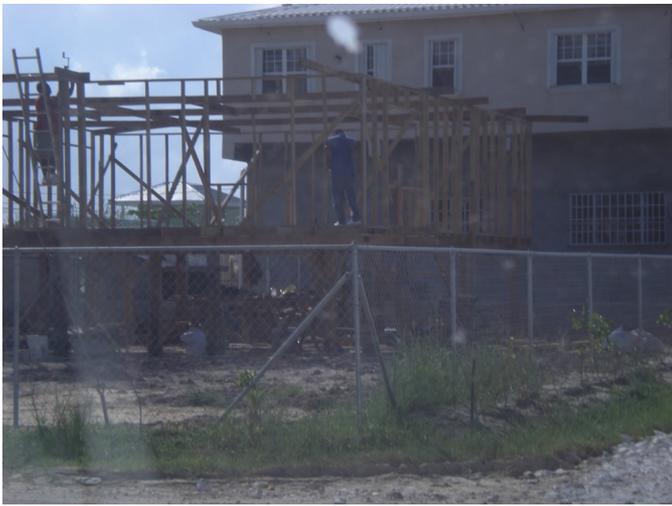
Construction of a timber stilt home
