HOUSING REPORT

Reinforced concrete frame building with an independent vertical extension

Report#	17
Last Updated	
Country	Greece
Author(s)	Vlasis Koumousis,
Reviewers	Kostas Skliros,

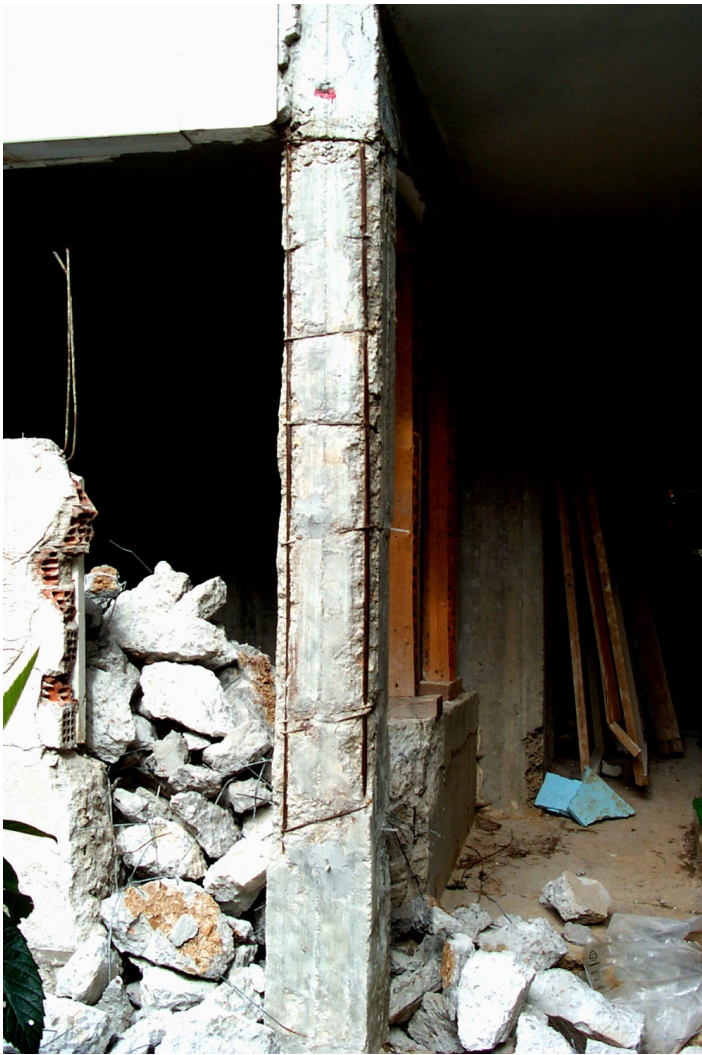
Typical Earthquake Damage to a Column of the Older 1960 Astructure (1999 Athens Earthquake)

- Minor cracks in the walls. -Minor cracks in the columns of the 1980 portion. -Moderate cracks in the columns of the 1960 portion -Incompatible dynamic characteristics of the old and new portion of the building were the major cause of the damage in the

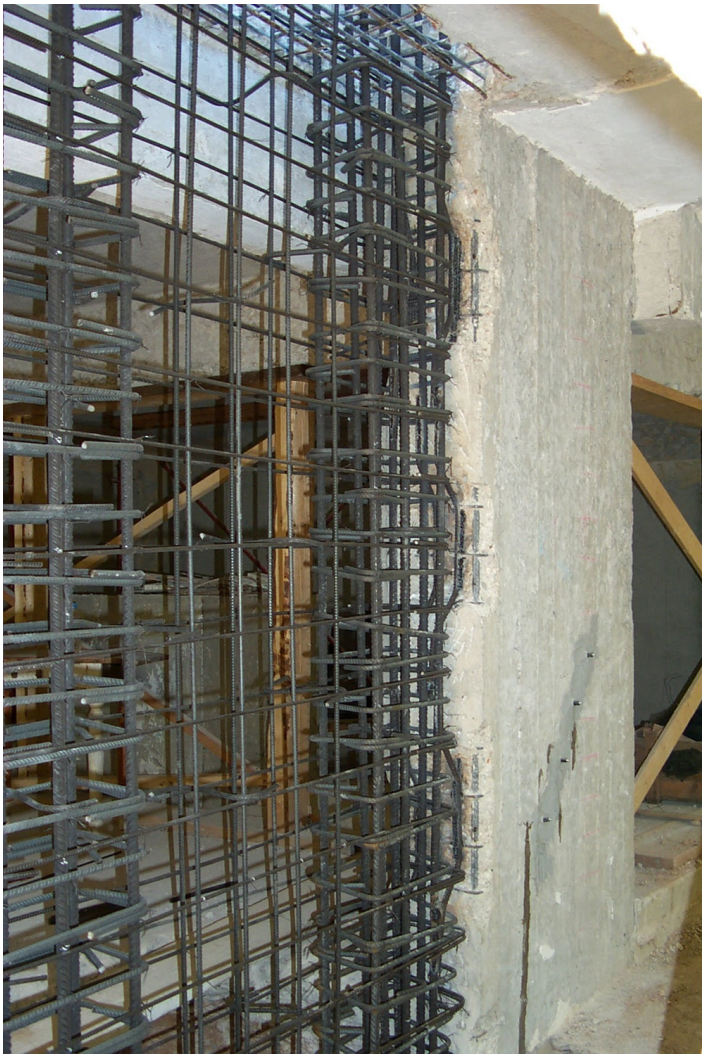
***Seismic-strengthening Techniques -
Installation of a New Shear Wall***

Structural Deficiency	Seismic Strengthening
Minor cracks in concrete columns and shear walls	Sealed with epoxy resins following standard practice
Strengthening of the footings	Anchoring of the new reinforcement, installation of dowels in the interface, preparation of the concrete interface for improved bonding, cast in situ concrete (see Figure 10)
Installation of new shear walls	Welding of new reinforcement to the existing reinforcement at several (3 to 5) locations within a storey-height, preparation of concrete surface for improved bonding, pouring of

concrete in-situ (see Figures 8, 9 and 13).

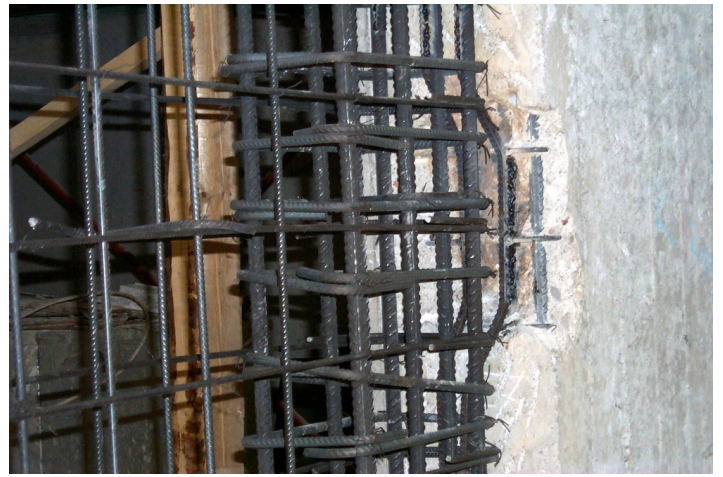
***Seismic Strengthening - Connection
of the Old and New Concrete
(Welding of Rebars)***

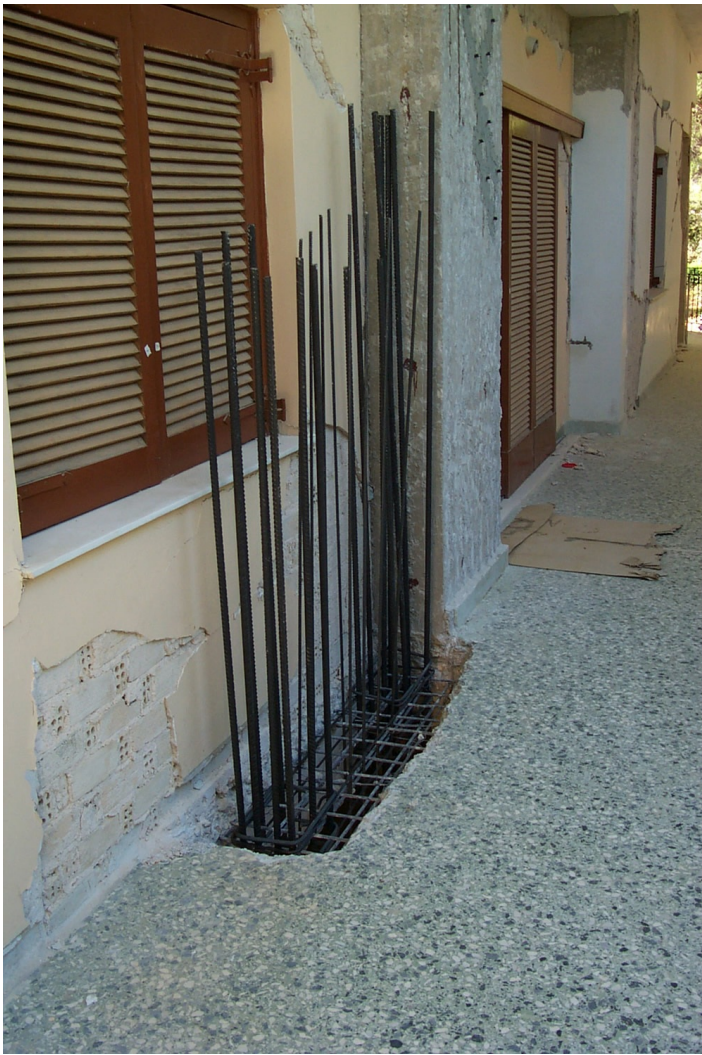
Seismic Strengthening - Extension of the New Shear Wall Through the Floor Slab

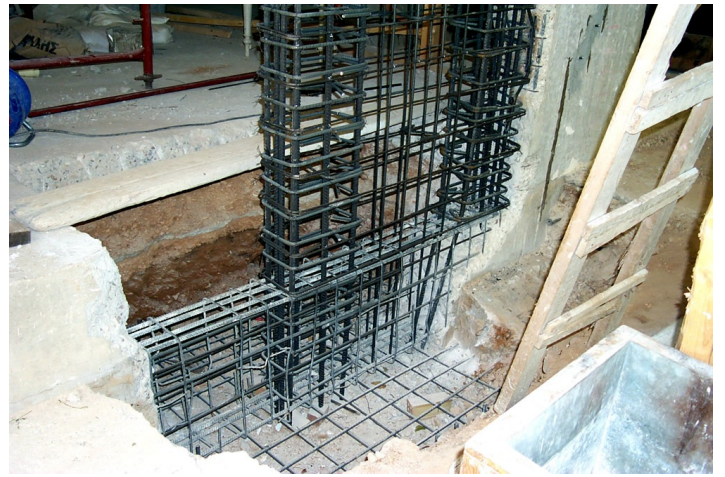
Seismic Strengthening of the Footing

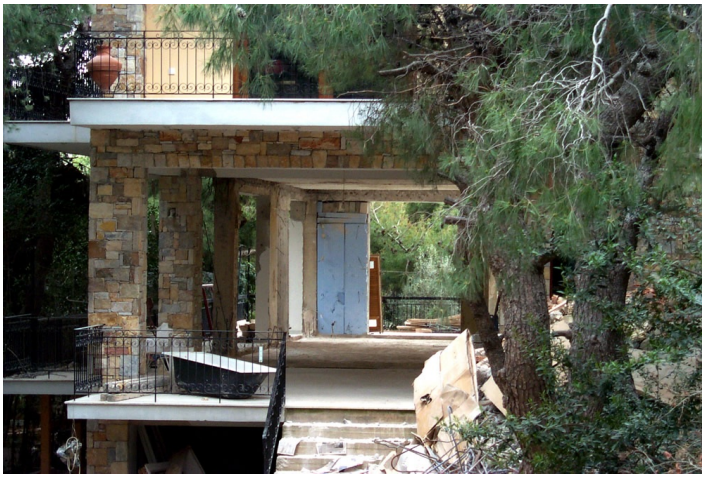
Demolition of the Damaged Infill Walls at the Ground Floor Level
