World Housing Encyclopedia

A Resource on Construction in Earthquake Regions

HOUSING REPORT Mud wall construction in Spiti Valley (Himachal Pradesh)

Summary:	This report describes a building type found in Himachal Pradesh, a northern state in India. It is concentrated in the upper reaches of the state in the Lahaul and Spiti districts, which are located in a cold-desert area with very hot days and chilling nights. Precipitation usually only occurs in the form of snowfall with almost no to very little rainfall. This dryness of the local climate is reflected in the architecture of this construction typology which consists of thick mud walls with small openings in order to insulate the interior from the harsh outside climate. This style of construction which is predominantly used for residential houses and temples is still being practiced though it shows high seismic vulnerability.
Length of time practiced:	More than 200 years

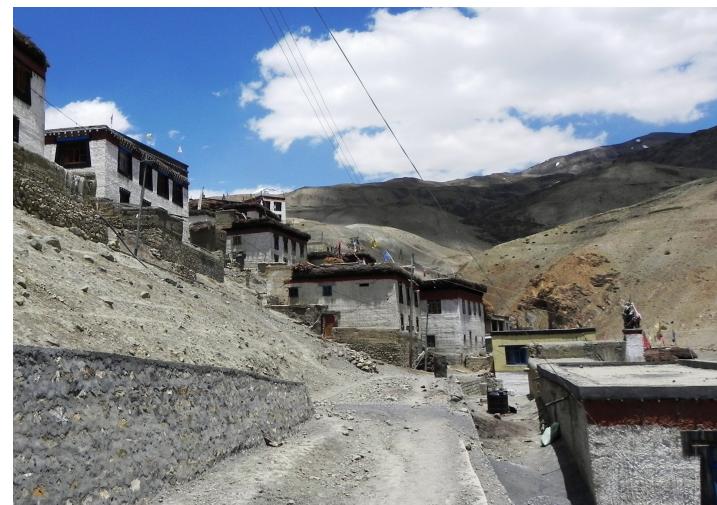
Houses located on slopes.

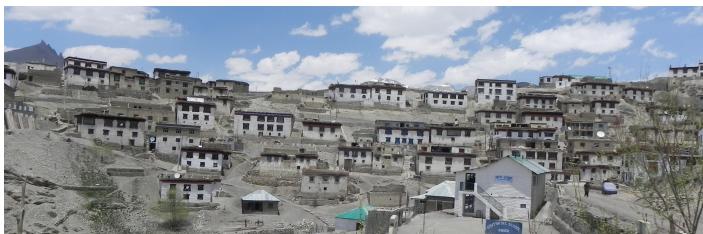
Houses built on hilly slopes in the village Kibber.

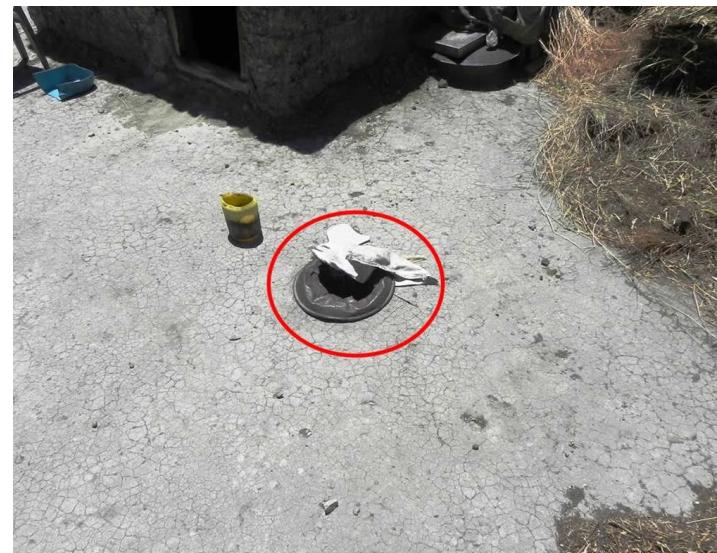
Sky-light as seen from terrace.

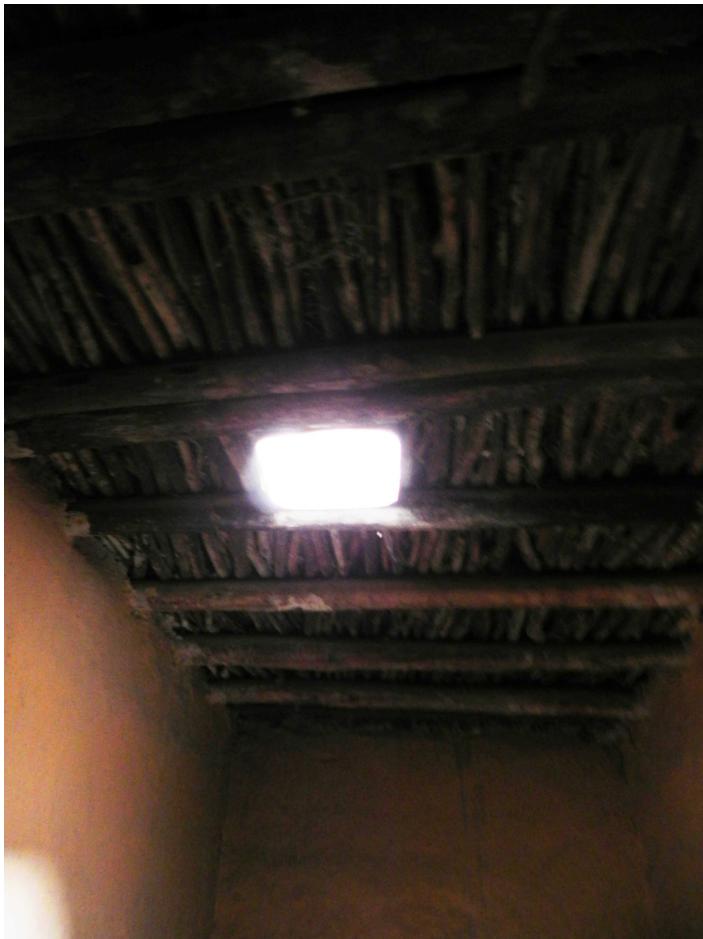
Light pouring in through sky-light above.

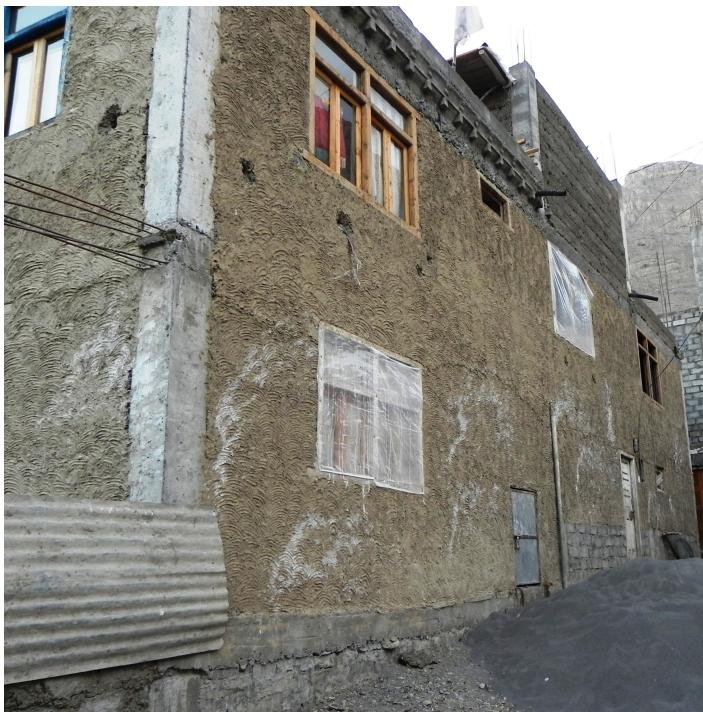
RC framed structure with mud walls infill and mud roof.

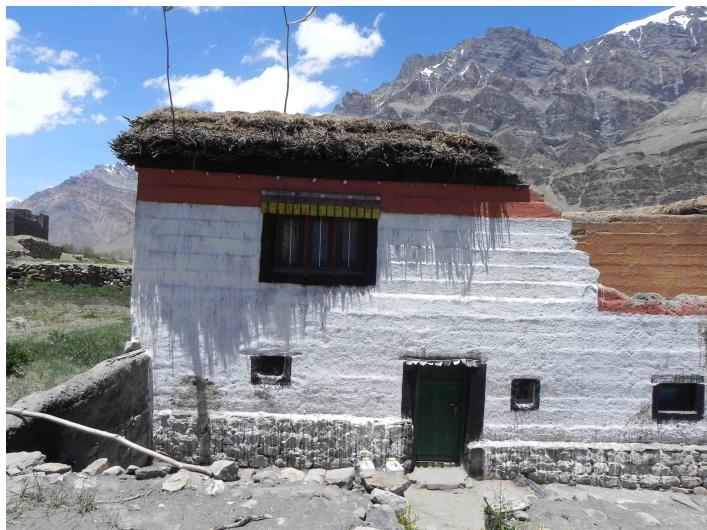
Lower portion of the wall made up of field stones. The front door is arranged at ground floor level without any plinth.

Type of Foundation	Shallow Foundation: Rubble stone, fieldstone strip footing
Additional comments on foundation	<p>Locally available stone is used for foundation. A trench is dug about 300 mm in depth and 500 mm in width. Courses of stones with mud mortar are then laid in the trench up to the ground level. The same courses are then taken up to 600 to 900 mm above the ground in order to form the lower portion of the walls. Through this procedure the walls are protected from direct rain water splashes and snow. Generally, there is no plinth in these houses (Figure 13).</p>
Type of Floor System	Other floor system

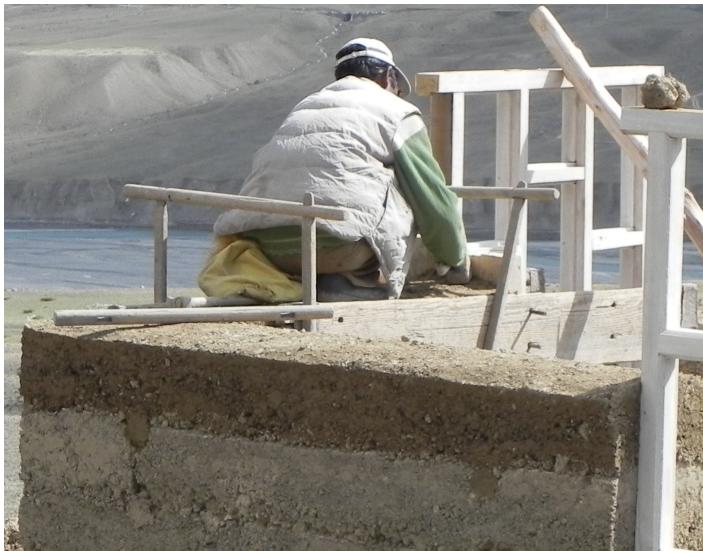
Wooden formwork to lay courses of mud.

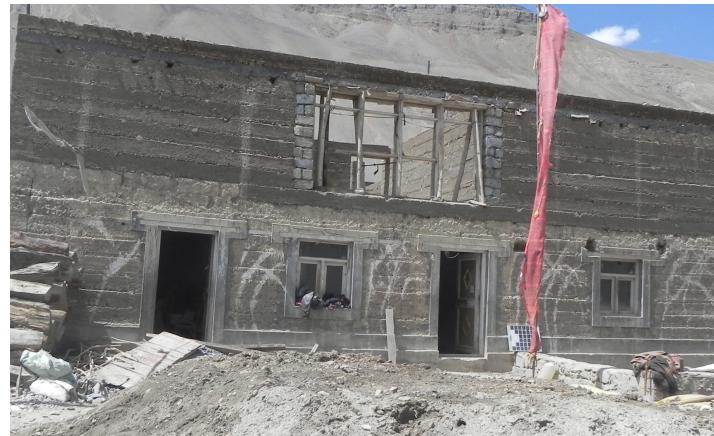
Marks can be seen on the wall of the upper floor where windows have to be cut. Lintel beams have already been provided during the wall construction process.

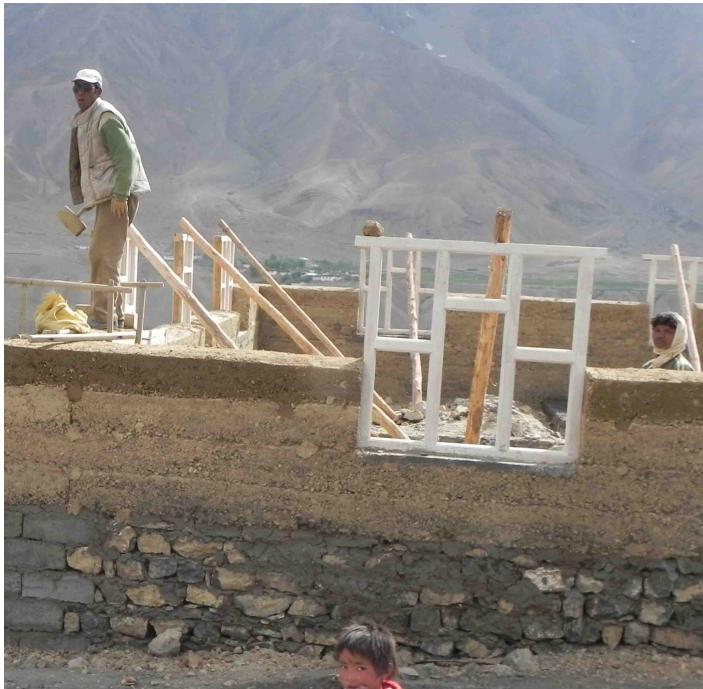
Walls with already placed window frames.

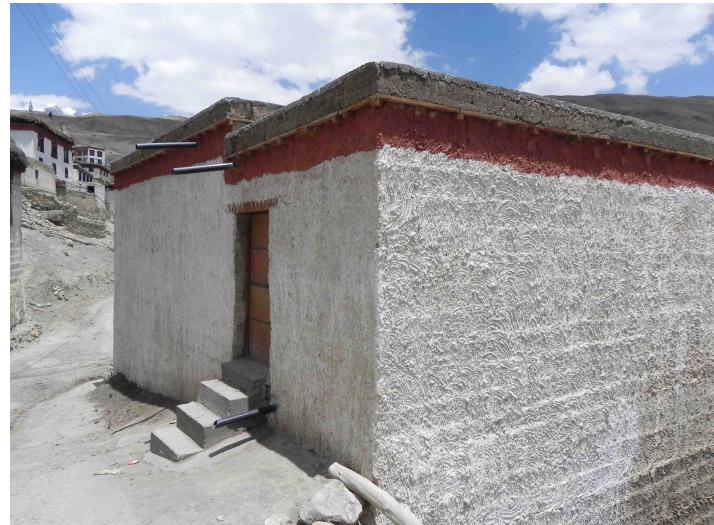
Patterns made to the outer walls with mud slurry for finishing.

Expertise of those involved in the design process	Architects and engineers are not involved in the design or construction of this housing type.
Construction Process	
Who typically builds this construction type?	Other
Roles of those involved in the building process	Construction is carried out under the surveillance of the owner himself
Expertise of those involved in building process	Local masons are involved in the construction of these buildings, inheriting their skills from their fathers. Architects and engineers are not involved in the design or construction of this housing type.
Construction process and phasing	<p>Wall System: Houses of Spitian architecture have a load-bearing wall system. The 300 - 500 mm thick mud walls take up the entire load.</p> <p>Construction materials: The foundations and walls up to 600 to 900 mm height above the ground level are made of local available field stones. Above this base, the walls are entirely constructed of rammed earth.</p> <p>Construction methodology of walls: Step 1 - A wooden formwork is assembled and kept at place over the stone courses of the wall. This formwork has two wooden planks laid parallel to each other at a distance of either 300 or 500 mm and is secured at place by wooden screws and members (Figure 17). The height of the planks is generally 300 mm. Step 2 - In order to lay the first course of the mud wall, the formwork is filled with mud and rammed properly with a mallet. Once the mud sets at place, the formwork is slid further in order to make the other portions of the wall. The same procedure is repeated until the whole course of all four walls is finished. Thus a course of about 300 mm height has been prepared. Through the same procedure courses are laid one over the other in order to construct the entire wall. During the summer, it is possible to do two courses per day. In winter, only one course is laid per day and then allowed to dry/harden overnight. The horizontal borderline between two individual courses can be clearly seen on the walls. Lintel beams are placed at appropriate height during the wall construction. Step 3 - Once the walls are made and dried properly, windows of appropriate and desired size can be cut into them (Figure 18). In case of scarcity of mud, window frames are arranged in place while laying the courses (Figure 19). Step 4 - The walls are finished with a mud slurry allowing for organic design</p>

patterns and finally are white washed. The lines of individual courses are still visible after finishing (Figure 20). The walls of these houses are thicker at the bottom and thinner at the top. This is not done intentionally but since one course is laid over the other before fully drying, the lower courses of the wall spread out a bit under the weight of the upper courses. Thus the bottommost course is widest while the course at the top is thinnest. This phenomenon results in somewhat better stability of the walls. Floor system and roof typology: Ground floor - The flooring at ground floor level consists of only an earth fill which is finished with mud slurry. Upper floors - Wooden beams are laid across the walls in one direction only. These are secured in place with mud only. The distance between the beams is kept small considering the strength and weight of the overlaying material. Tree branches and wooden planks are densely laid over them and then a 50 mm thick layer of mud is spread over it (Figure 21). Roof - As the area has very little or no rainfall, the roofs are flat and constructed in the same way as the floors. Nowadays, with somewhat improved connectivity for transportation, poplar tree logs or steel sections are sometimes used for the beams as well (Figure 22). Parapets - To construct the parapets, a 300 mm thick and 300 mm high course of mud is laid at the periphery of the terrace. On top of it, dried bushes are packed densely (Figure 23). These bushes are projecting to the outside and hence also act as a sunshade (Figure 24). The construction of this type of housing takes place in a single phase. Typically, the building is originally designed for its final constructed size.

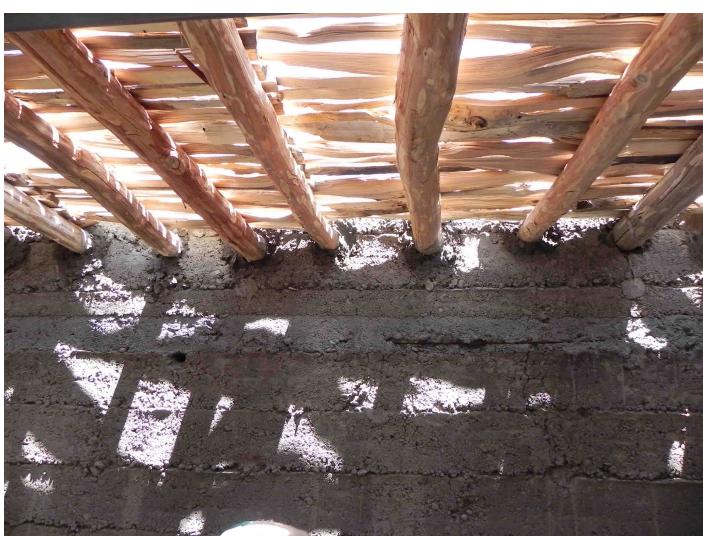
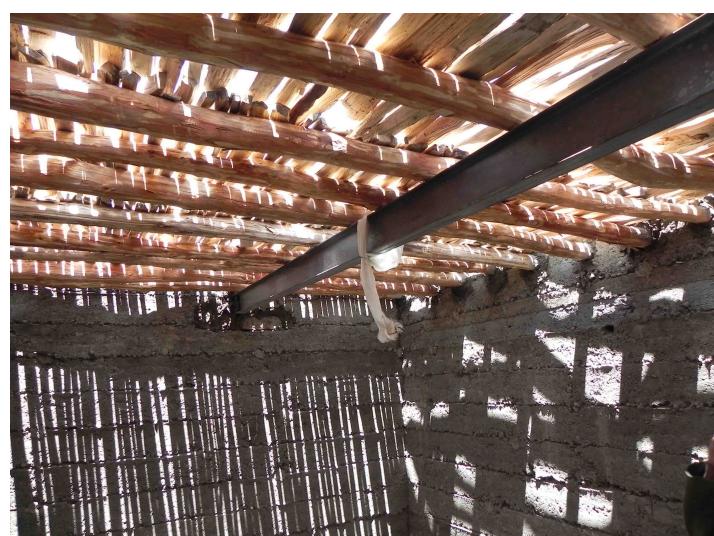
Branches are densely laid over poplar tree logs (beams).

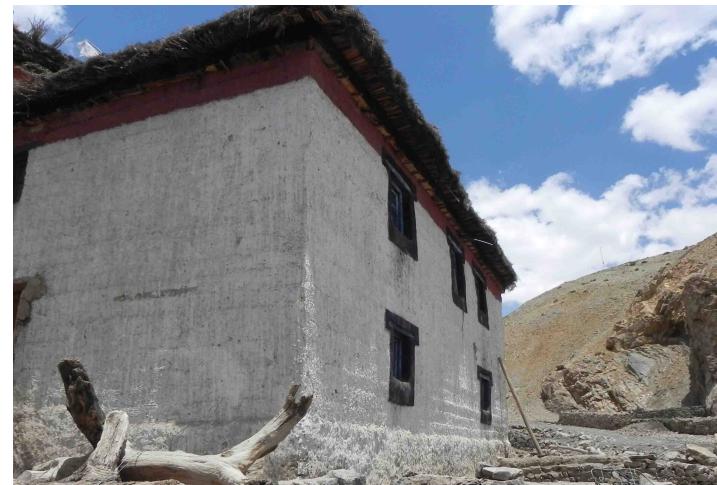
Bushes projecting outwards, hence forming a type of sunshade/roof projection.
