# World Housing Encyclopedia

## HOUSING REPORT Adobe Arched-Roof

<b>Report#</b>	177
<b>Last Updated</b>	
<b>Country</b>	Iran
<b>Author(s)</b>	Mohammad Yekrangnia, Ali Bakhshi, Mohammad Ali Ghannad, Arash Khosravifar, Ebrahim Mousavi Eshkiki, Hamid Masaeli,
<b>Reviewers</b>	,

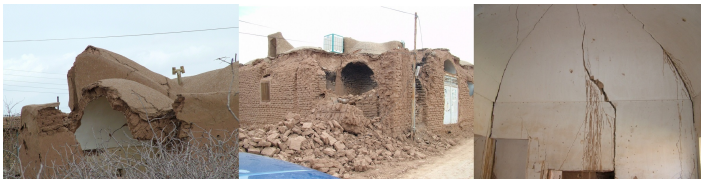
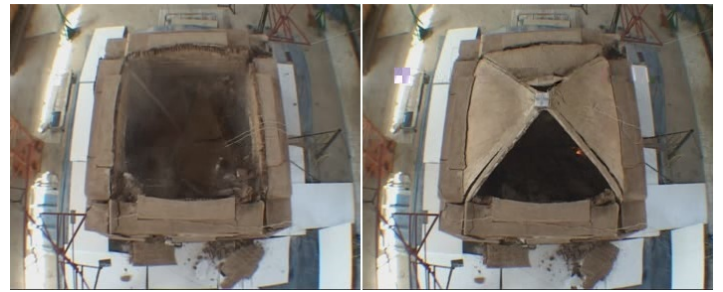
**Figure 5. Partial and complete collapse of arched roofs: (a) Zarand Earthquake**

**Figure 5. Partial and complete collapse of arched roofs: (b) shake-table tests by Bakhshi et al. (2009)**

<b>Typical plan width (meters)</b>	4
<b>Typical story height (meters)</b>	3
<b>Type of Structural System</b>	Masonry: Earthen/Mud/Adobe/Rammed Earth Walls: Adobe block walls
<b>Additional comments on structural system</b>	<p>These buildings were constructed considering gravity loads only, and thick adobe walls can reliably transfer these loads to the ground. The arched roofs, although considered as heavy roof systems, can safely transfer their weight to the supporting walls. The arching mechanism of these roofs helps their stability against either gravity or seismic lateral forces as well. Although in some cases, deterioration of the shallow foundations was observed, no damages due to inadequate foundation capacity were reported. Adobe buildings in Iran possess no lateral load-resisting system and are therefore classified as 'non-engineered' houses. Although thick and squat walls have great in-plane and out-of-plane seismic capacity, they also induce considerable seismic demands due to their huge mass. On the other hand, since no special provisions have been given for load-transfer mechanisms between roof and walls and also between perpendicular walls, compromised structural integrity usually results in partial or complete collapse of these buildings (Figure 5).</p>

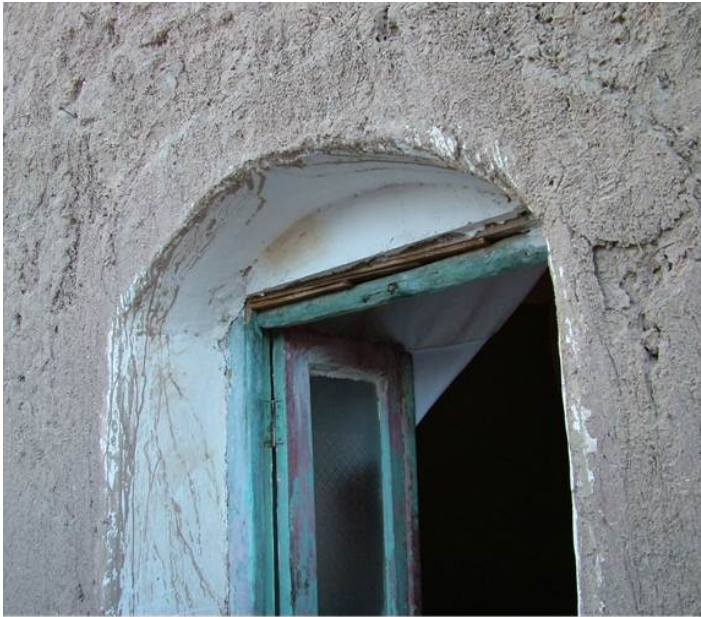
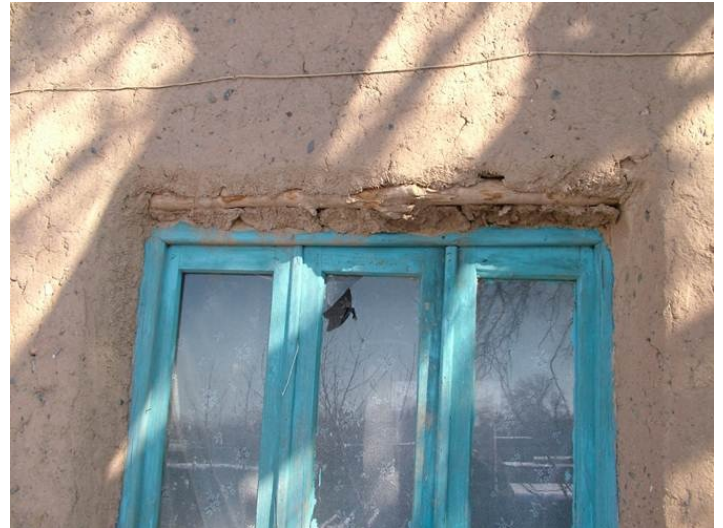
**Figure 6. Different types of opening: (a) arched without lintel**

**Figure 6. Different types of opening: (b) rectangular with wooden lintel**

arch (more common in arched roof adobe buildings) are provided above openings (Figure 6).

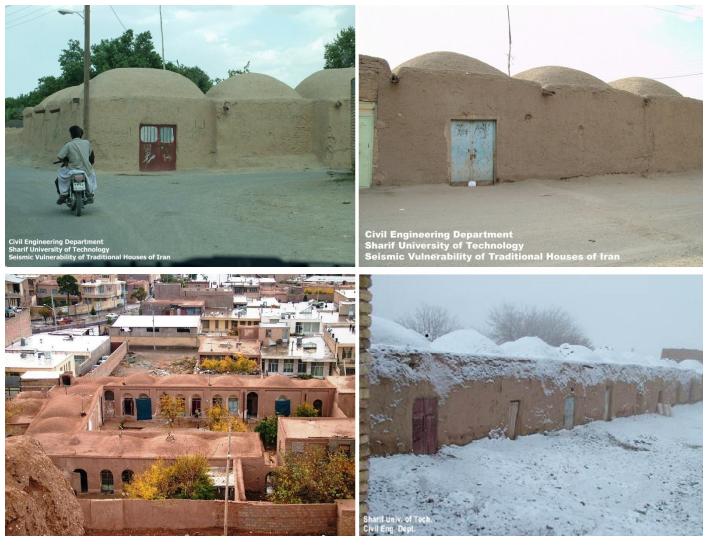
**Figure 10. Examples of a cluster of arched-roof adobe buildings in arid areas**

<b>Patterns of occupancy</b>	Since these buildings are found in arid and semi-arid areas (deserts), they are often found in the form of cluster houses concentrated around a main yard. A housing unit is typically occupied by a single family, or sometimes by an extended family (two generations of the same family). In general, there may be up to 20 housing units in each building (Figure 10).
<b>Number of inhabitants in a typical building of this construction type during the day</b>	<5
<b>Number of inhabitants in a typical building of this construction type during the evening/night</b>	10-May
<b>Additional comments on number of inhabitants</b>	Since a considerable number of adobe houses in Iran are in the form of cluster houses, the total number of inhabitants in one complex can reach up to 100 persons. However, the average number of inhabitants in each housing unit is 5 people. Moreover, in case of an earthquake, the entire cluster behaves as a single building since there are common walls between these housing units.

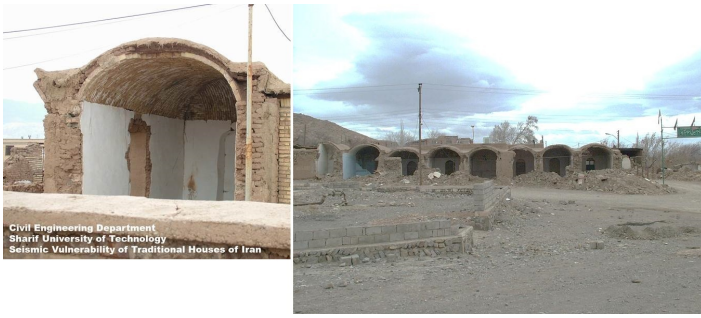
**Figure 11. Out-of-plane collapse of non-load-bearing walls in barrel adobe roofs**

In 2003, the Bam earthquake struck Bam and the surrounding Kerman province of south-eastern Iran with a moment magnitude Mw 6.6. The earthquake was particularly destructive, with a death toll amounting to 26,271 people and injuring an additional 30,000. The effects of the earthquake were exacerbated by the use of mud bricks as the standard construction material. The earthquake left an estimated 100,000 people homeless. An important regional center during the 16th and 17th centuries, Bam contained many buildings that were not constructed to survive earthquake effects. Many houses in Bam were owner-built, and the owners did not use the help of skilled labor or proper building materials to resist earthquakes in the construction. The Bam Citadel was considered to be one of the most significant existing mud citadels before the event. Most of it was demolished in the earthquake, including a large square tower (Wikipedia.org). In 2005, the Zarand earthquake hit the city of Zarand and several villages in Kerman province of Iran. The earthquake was measured at 6.4 on the Richter scale. The quake lasted for 11 seconds and at least 61 aftershocks were reported with magnitudes between 3.3 and 4.8. The maximum recorded peak ground acceleration was 0.51g at Shirinrud Dam. Though ISNA reports, 790 dead and 1,423 injured according to officials in Kerman University of Medical Sciences. Four villages, each having around 1,000 inhabitants, were reported completely destroyed, and 30 to 70% of buildings in more than 40 villages were reported damaged (Wikipedia.org). As for adobe houses which formed the majority of the housing in rural and suburban areas in the both aforementioned regions, the common failure mode was destabilization of the arched roof due to poor connection of the perpendicular walls as shown in Figure 2-1, Figure 4-a, Figure 5-a and Figure 11.

<b>Additional comments on structural and architectural features for seismic resistance</b>	<p>In many cases, there is no foundation in these buildings (Figure 11). In some cases, rubble stones are found at the base of the walls and in some cases under the ground level in order to act as moisture insulator. Deterioration of the walls and wall bases have been observed due to weathering and moisture (Figure 12) as stated by Webster et al. In some cases, especially those found in suburban areas, the maintenance of the houses is acceptable. Moreover, those which have been constructed recently are kept in good condition. However, in rural areas, the quality of the existing arched-roof houses are poor due to deterioration of adobe mainly because of weathering and also cracks in the walls and the dome from previous earthquakes.</p>
<b>Vertical irregularities typically found in this construction type</b>	Torsion eccentricity

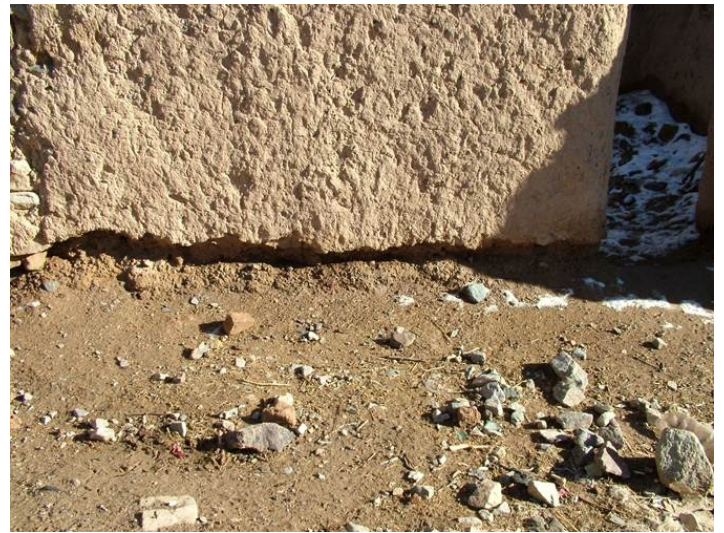
**Figure 12. Wall slippage due to lack of proper foundation**

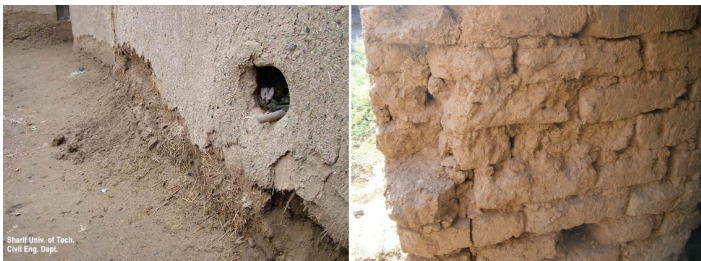
**Figure 13. Deterioration of adobe walls due to weathering and lack of/improper foundation insulation**

Walls experience detachment from each other and from the roof. Sliding in the form of bed-joint and diagonal is common. For barrel, crescent and complex arched roofs where two walls are load-bearing, the other two usually experience out-of-plane overturning (Figure 13).

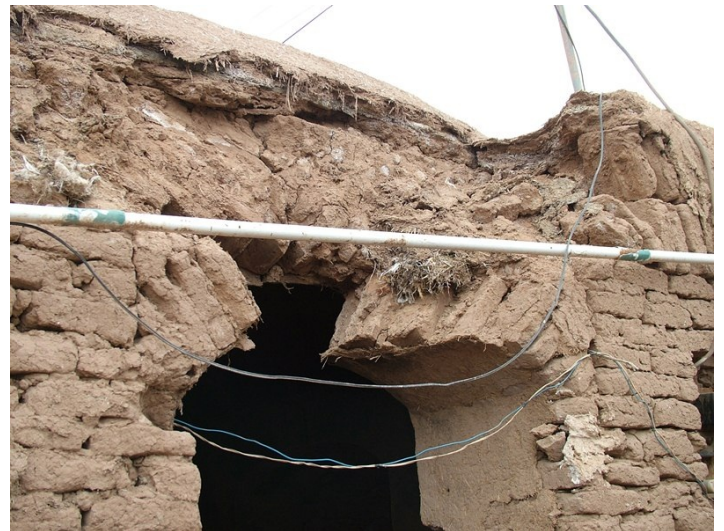
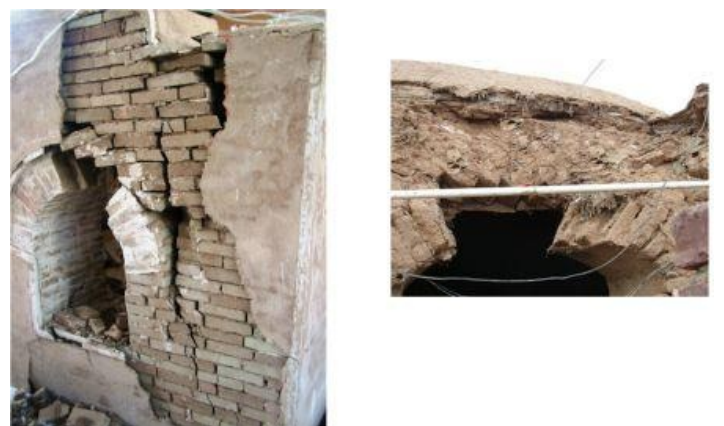
**Figure 14. Common cracking around adobe arched openings in past earthquakes: (a) Zarand earthquake (2005), (b) Unknown, (c) shake-table tests by Bakhshi et al. (2009)**

**Figure 14. Common cracking around adobe arched openings in past earthquakes: (c) shake-table tests by Bakhshi et al. (2009)**

<b>Horizontal irregularities typically found in this construction type</b>	Other
<b>Seismic deficiency in walls</b>	<p>Walls have a great potential in tolerating seismic forces both in in-plane and out-of-plane directions because of their low height/length aspect ratio and height/thickness slenderness ratio. However, since no special attention has been given to ensure the connection of perpendicular walls, these walls separate from each other during an earthquake and this results in partial or complete roof collapse.</p>
<b>Earthquake-resilient features in walls</b>	<p>In rare cases, parallel walls are connected by means of steel rods. This provision was found to be very effective in preventing detachment of walls and hence maintaining 'box-like' behavior. Adobe walls are thicker and shorter than their brick counterparts and hence possess greater load-bearing capacity. Also, considering high surcharges, their in-plane behavior is governed by friction due to low cohesion of mud mortar, hence their response is more ductile than brick walls with sand-cement mortar. Also, since in many cases the openings are arch-shaped (no lintel is used), no diagonal cracks are initiated at the openings (Figure 14).</p>

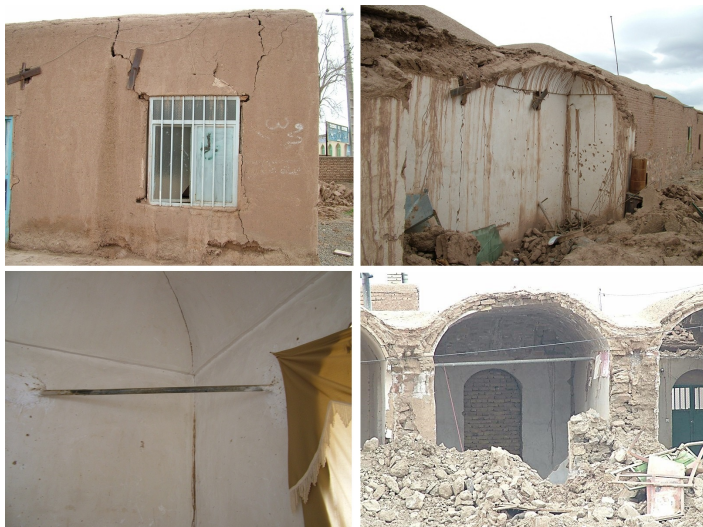
**Figure 15. Using steel rods and welded steel mesh for enhancing the seismic performance of adobe walls in out-of-plane and in-plane directions: (a) Zarand Earthquake**

**Figure 15. Using steel rods and welded steel mesh for enhancing the seismic performance of adobe walls in out-of-plane and in-plane directions: (b) shake-table tests by Bakhshi et al. (2009)**

<b>Structural Deficiency</b>	<b>Seismic Strengthening</b>
Detachment of perpendicular walls	Using four steel rods in each direction to attach parallel walls. These rods were used in a few retrofit projects and proved to be effective in past earthquakes (Figure 15). The rods can easily pass through the drilled holes in the walls.
Cracking in walls (in-plane)	Installing steel welded mesh on the exterior faces of walls. The mesh is attached with through-wall connections bolted on the other side of the wall. Also it is enough to place the mesh only on the upper half of the wall and without any shotcrete; only a proper coating is needed in order to prevent the deterioration of the steel (Figure 15). This strengthening technique is also very simple to implement since it does not require any concrete covering.
<b>Additional comments on seismic strengthening provisions</b>	
<b>Has seismic strengthening described in the above table been performed?</b>	Retrofitting of adobe houses was practiced on few pilot examples throughout the country as a pilot project. The final goal was to execute a major retrofitting project for similar rural houses and several thousand school buildings of Iran by the State Organization of Schools Renovation Development and Mobilization. As of this writing (2014), this project is underway under supervision, and technical and financial assistance of the Housing Foundation of Islamic Revolution.

The seismic performance of the retrofitted adobe houses has not yet been observed in earthquakes. However, shake-table studies performed in Iran proved that the proposed retrofitting system is very effective in preventing collapse of the model building even against Maximum Considered Earthquake (MCE) with a PGA of 0.92g based on Bakhshi et al. (2009).
