# World Housing Encyclopedia

## HOUSING REPORT

### **Rubble stone masonry walls with timber frame and timber roof**

<b>Report#</b>	18
<b>Last Updated</b>	
<b>Country</b>	India
<b>Author(s)</b>	Svetlana Brzev, Marjorie Greene, Ravi Sinha,
<b>Reviewers</b>	Ravi Sinha ,

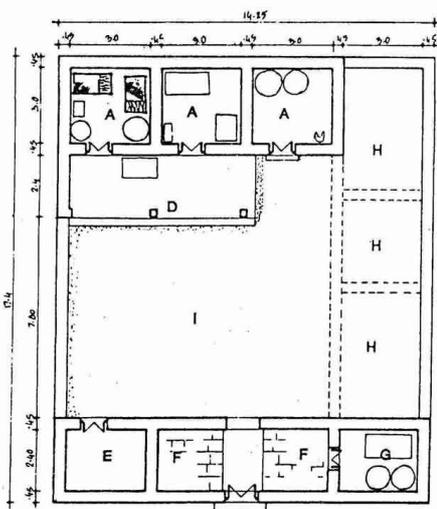
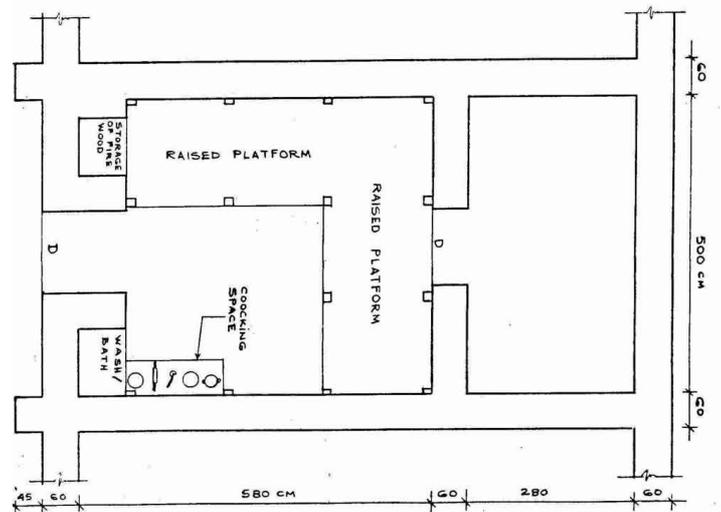
**Plan of Typical Building**

All dimensions are in metres

- A : Room
- D : Verandah
- E : Toilet / Bath
- F : Baitnak
- G : Store
- H : Future Rooms
- I : Open to Sky

**Plan of a Typical Building**

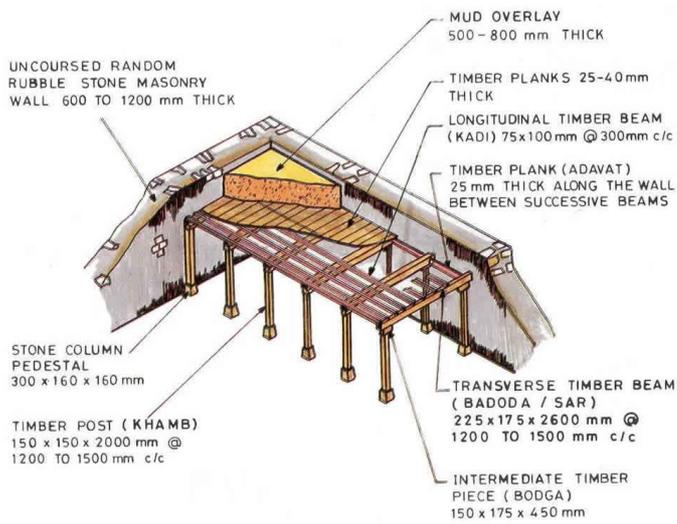
**Critical Structural Details - Wall-to-Roof Connection**

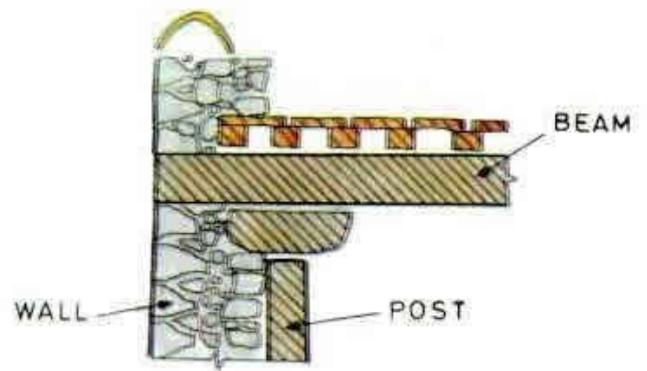
**Key Load-bearing Elements (Source: GOM 1998)**

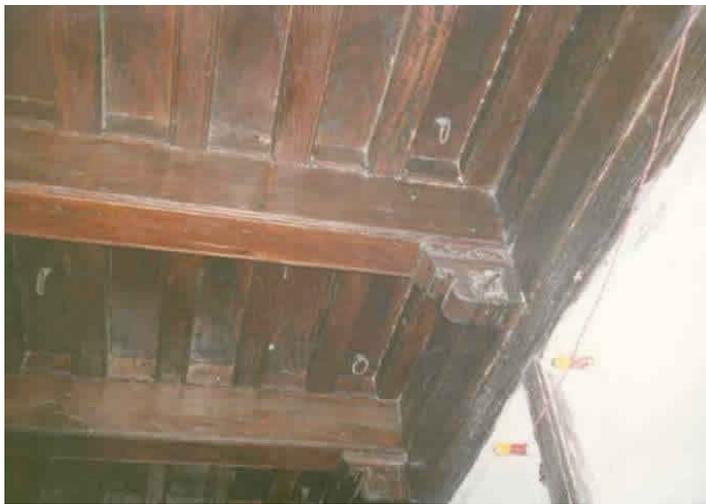
**Critical Structural Details - Good Quality Timber Roof Structure**

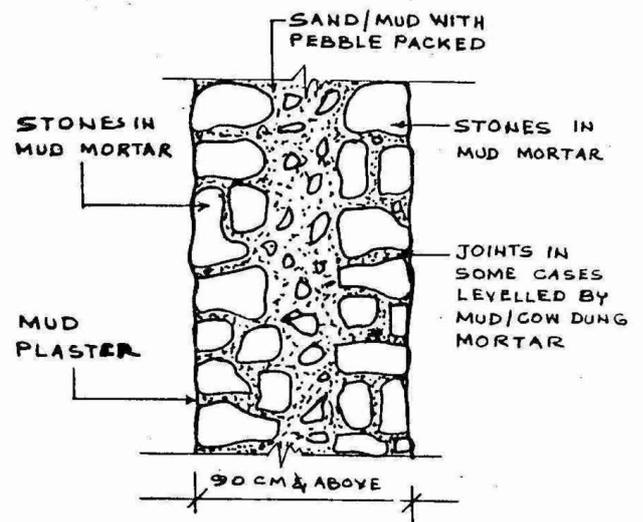
**Detail of an UCR Stone Masonry Wall**

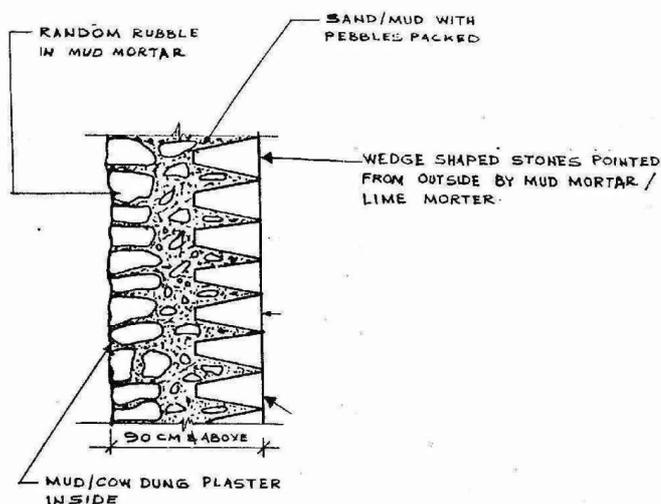
**Detail of an UCR Stone Masonry Wall**

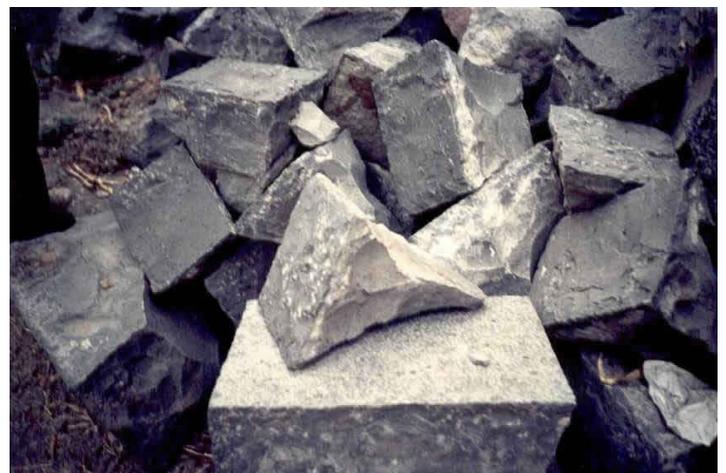
**A Typical Wedged-Shape Stone Used for the Exterior Wall Wythe**

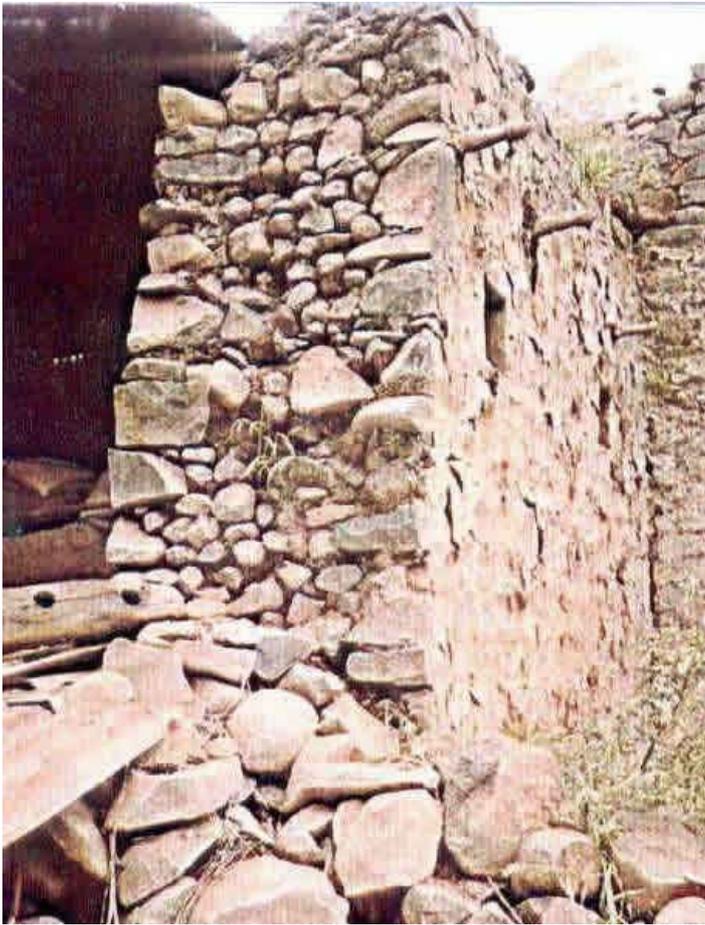
***Key Seismic Deficiency - Extremely Thick Stone Walls***

<b>structural and architectural features for seismic resistance</b>	
<b>Vertical irregularities typically found in this construction type</b>	Other
<b>Horizontal irregularities typically found in this construction type</b>	Other
<b>Seismic deficiency in walls</b>	-Extremely large thickness; -Absence of through-stones; -Unshaped boulders used in construction; - Absence of header stones at corners and junctions; -Vertical separation joints at wall corners and junctions.
<b>Earthquake-resilient features in walls</b>	
<b>Seismic deficiency in frames</b>	-Ambiguous system of vertical load transfer: transverse timber beams supported simultaneously by timber posts and stone masonry walls; - Inadequate post-to-beam connection; -Poor quality of timber frame construction; -Poor maintenance of timber elements,
<b>Earthquake-resilient features in frame</b>	- Provided that post-to-beam connections in timber frames are adequate, the frames could serve as restraint and prevent the inwards collapse of the walls (an observation made after the 1993 Maharashtra earthquake).

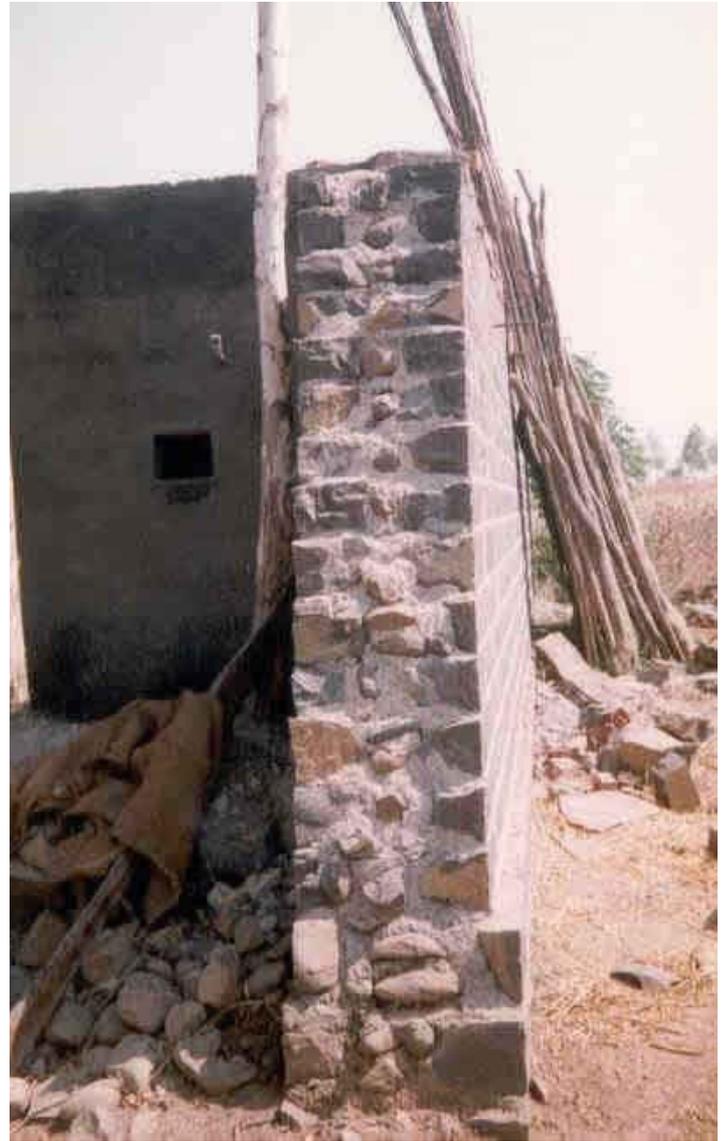
***Seismic Resilient Feature - Well Constructed Stone Wall***

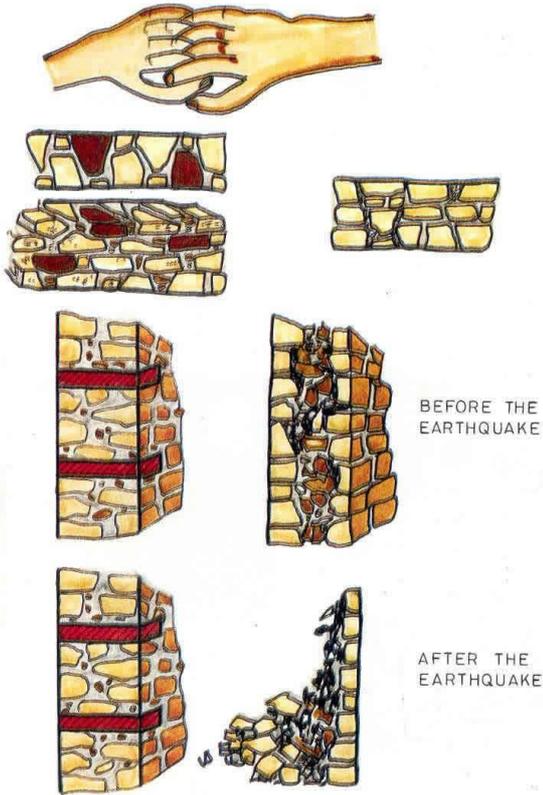
**Seismic Resilient Feature - Importance of Through Stones and Interlocking (Source: GOM1998)**

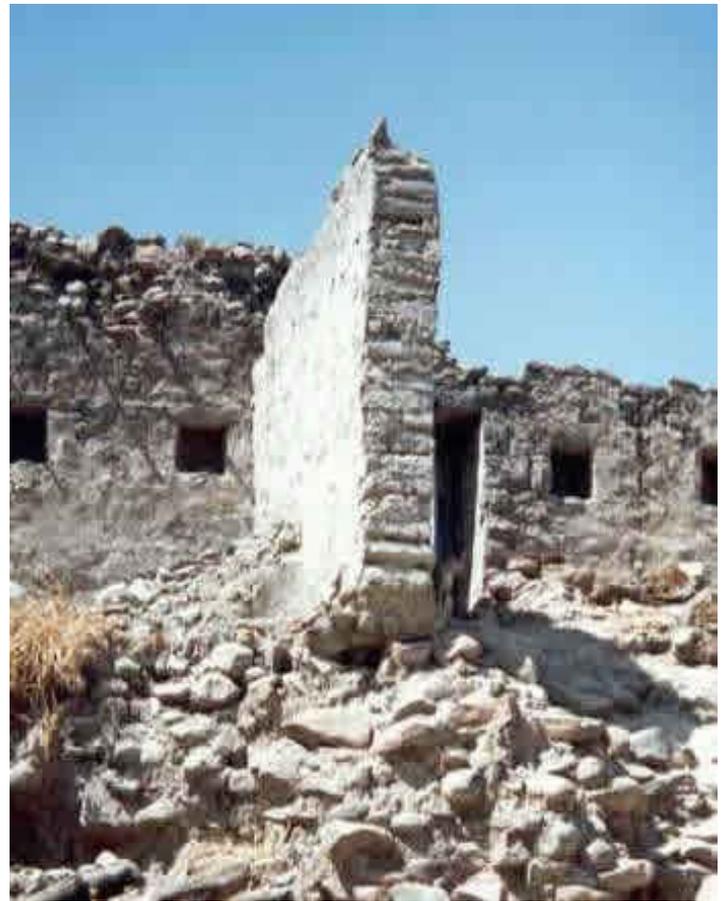
**Structural Deficiency - Absence of Foundations**

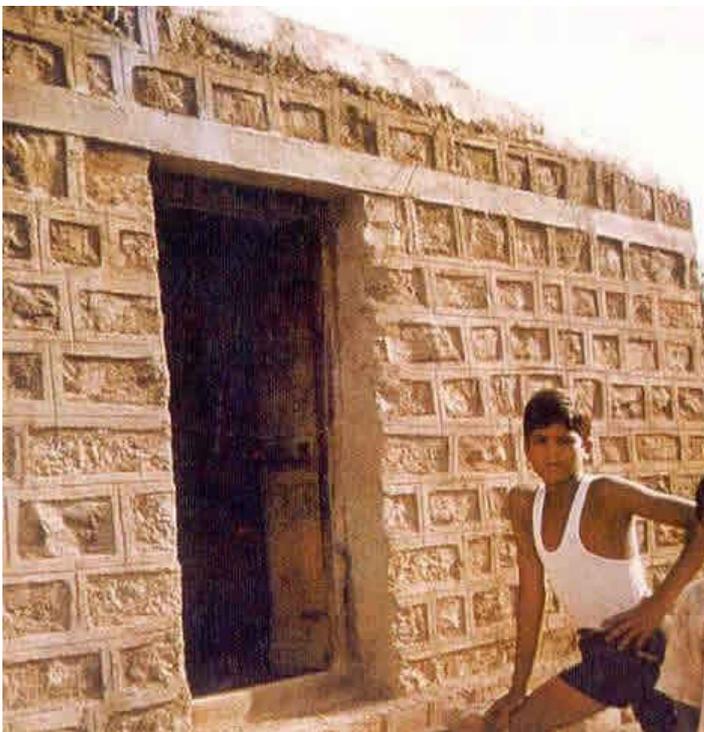
**Earthquake-Resistant Feature - RC Lintel Band**

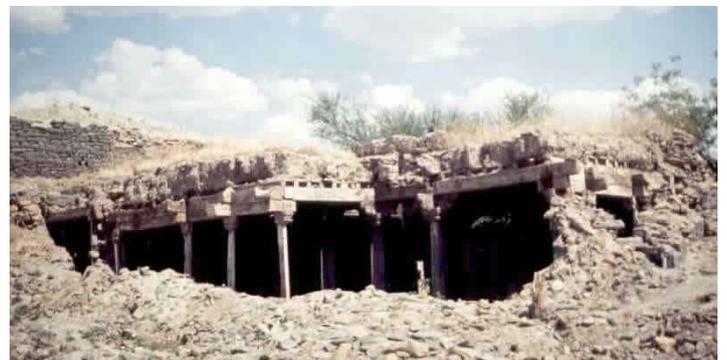
**Seismic Deficiency - Excessive Mud Overlay Atop the Roof**

<b>Seismic deficiency in roof and floors</b>	Excessive weight of mud overlay atop the roof, thickness ranging from 50 to 80 cm
<b>Earthquake resilient features in roof and floors</b>	
<b>Seismic deficiency in foundation</b>	
<b>Earthquake-resilient features in foundation</b>

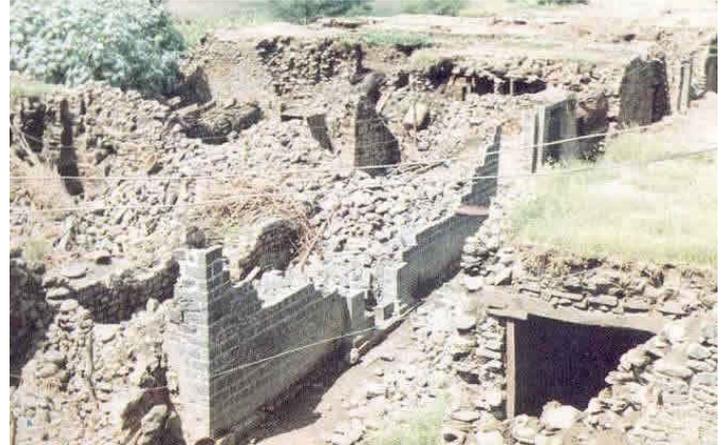
***Massive Collapse of Stone Masonry Buildings in the 1993 Killari Earthquake (Yelvat Village, Source: GSI 1996)***

Buildings of this construction type suffered substantial damage in the 1993 Maharashtra earthquake. Close to 30,000 houses of this type collapsed, and other 200,000 houses were damaged. Typical patterns of earthquake damage and failures reported in the 1993 earthquake were: delamination and failure of stone masonry walls (out-of-plane) separation of the walls at corners and junctions lateral swaying of timber frames due to heavy roof weight and inadequate post-to-beam connections.

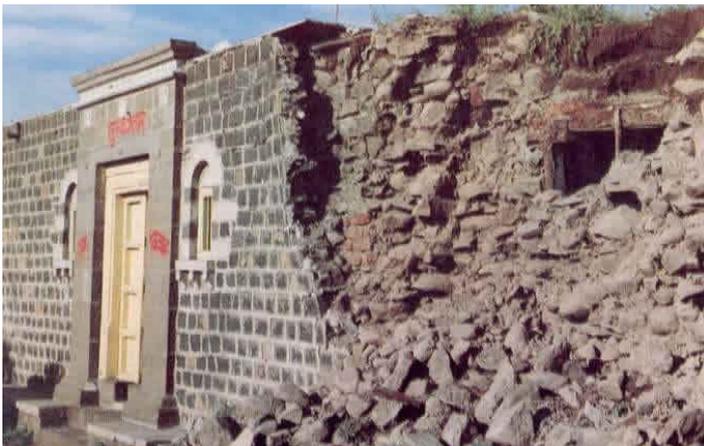
***Typical Earthquake Damage - Partial Collapse of the Exterior Wall in the 1993 Killri earthquake (Salegaon Village, Source: GSI 1996)***

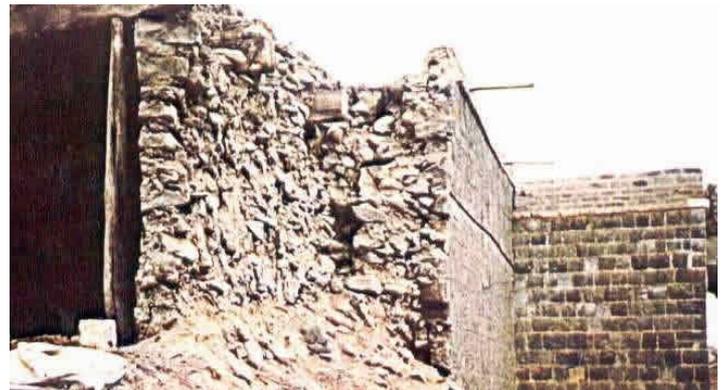
***Typical Earthquake Damage - Delamination of the Exterior Wall Wythe (the interior wythe remained undamaged due to restraint provided by timber posts), 1993 Killari Earthquake***

<b>Additional comments on seismic strengthening provisions</b>	Structural Deficiency: Delamination of exterior wall wythe - Description of a typical seismic strengthening provision used: Pointing of exterior walls in cement mortar
<b>Has seismic strengthening described in the above table been performed?</b>	Several thousand buildings of this type have been retrofitted using the above methodology after the 1993 Maharashtra earthquake.
<b>Was the work done as a mitigation effort on an undamaged building or as a repair following earthquake damages?</b>	The work was done as a post-earthquake rehabilitation effort following the 1993 Maharashtra earthquake.
<b>Was the construction inspected in the same manner as new construction?</b>	In this case, the same extent of inspection was made for the new construction and for the retrofitted buildings.
<b>Who performed the construction: a contractor or owner/user? Was an architect or engineer involved?</b>	The work was performed by the contractors (masons) contracted by the owners. Financial and technical resources were provided by the Government of Maharashtra. In some cases, owners subsidized the construction. In other cases, construction was sponsored by NGOs.

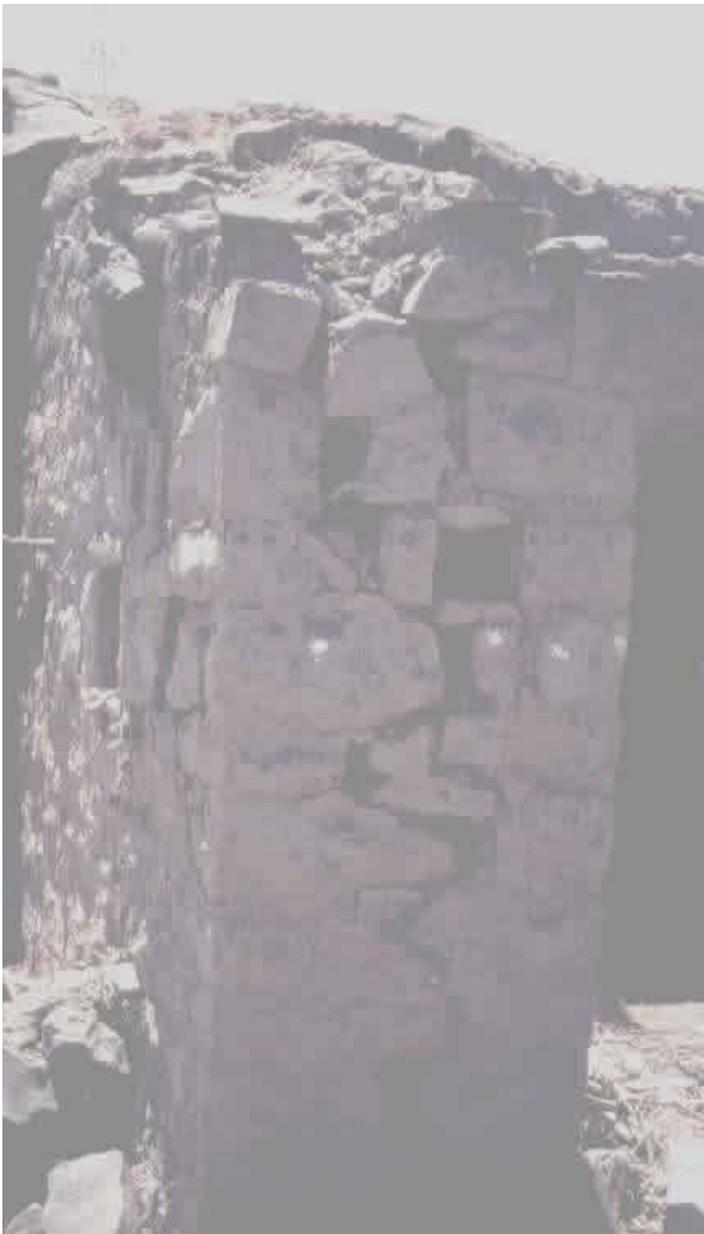
***Typical Earthquake Damage - Delamination of Stone Wall Wythes due to the Absence of Through Stones (1993 Killari earthquake)***

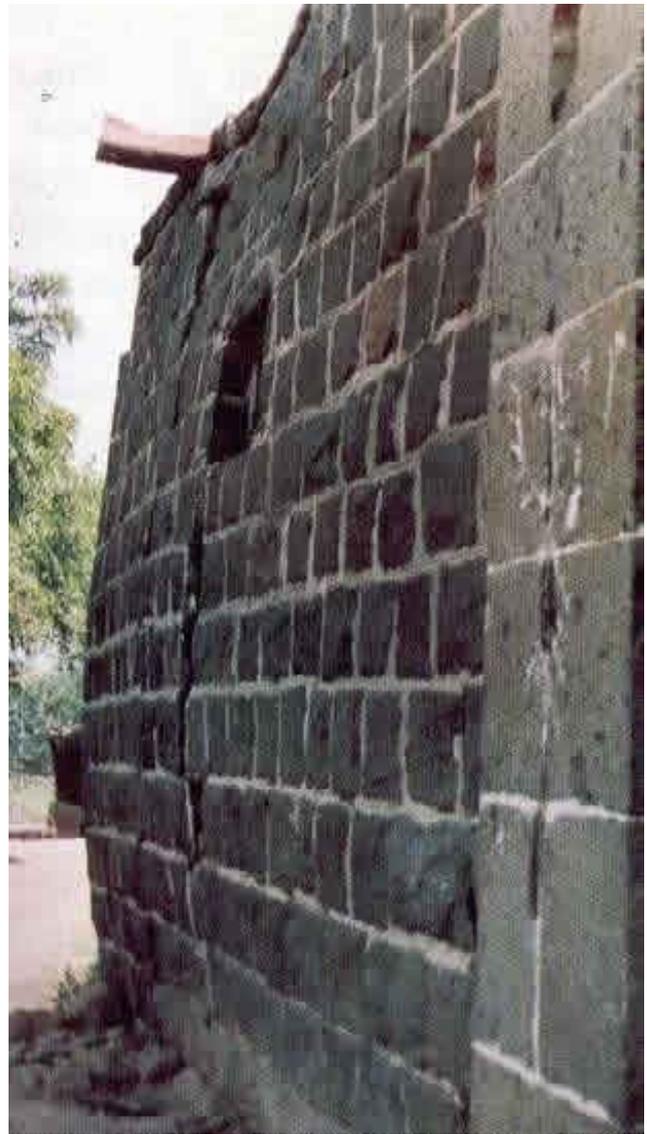
***Typical Earthquake Damage - Building and Cracking of a Thick Stone Wall in the 1993 Killari Earthquake (Source: GSI 1996)***

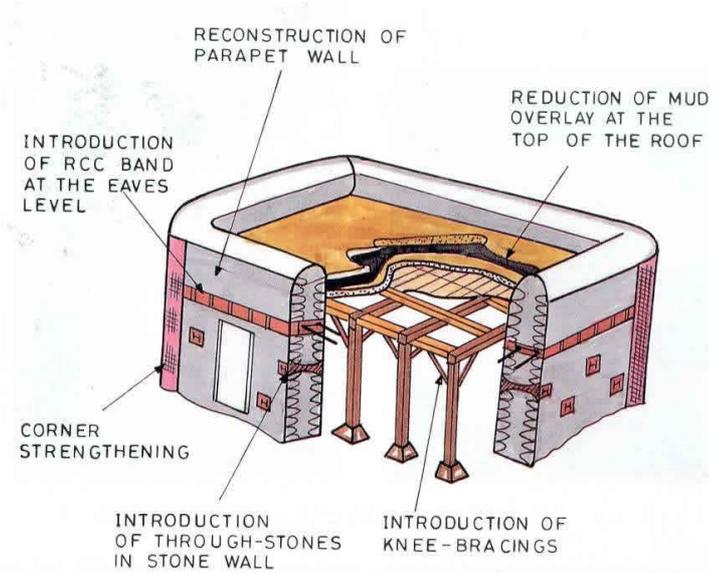
***Seismic Strengthening Technologies for Stone Masonry Buildings (Source: GOM 1998)***

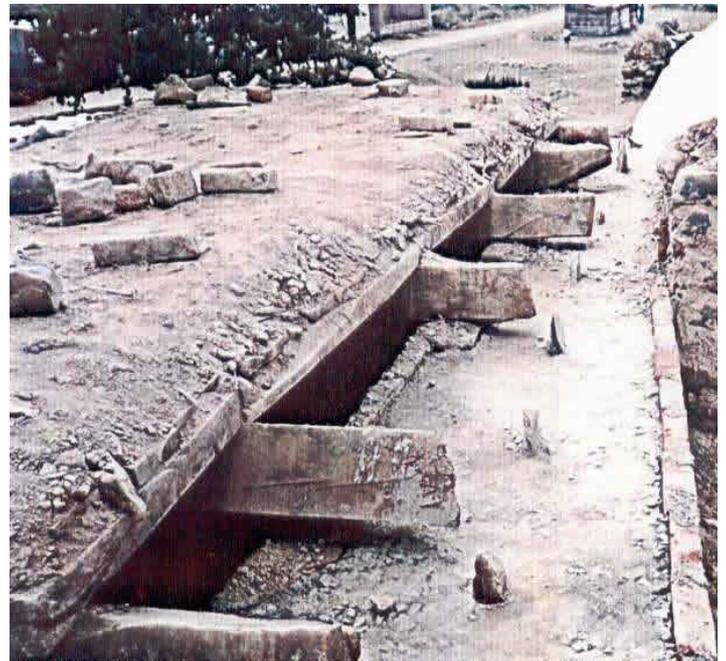
**Seismic Strengthening - Field Application of RC Lintel Band**

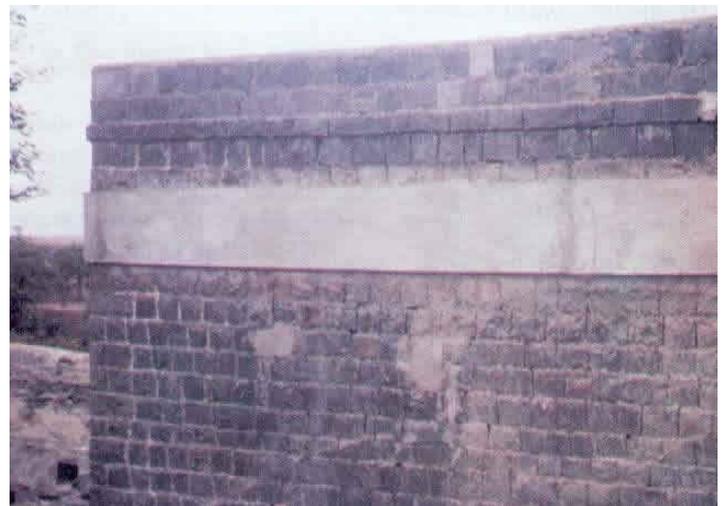
**Seismic Strengthening - A Field Application of Bandage (Source: GOM 1998)**

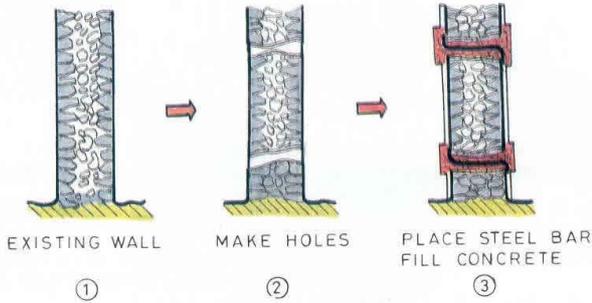
PROCEDURE FOR INSTALLATION OF THROUGH-STONES

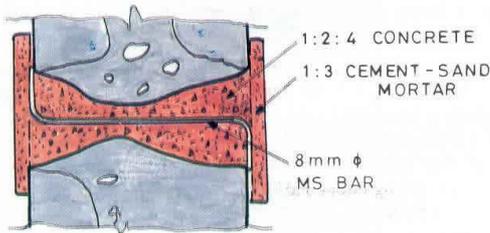
CROSS SECTION OF A THROUGH-STONE

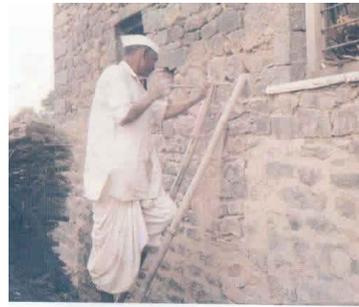
REMOVE A STONE WITH A CROWBAR

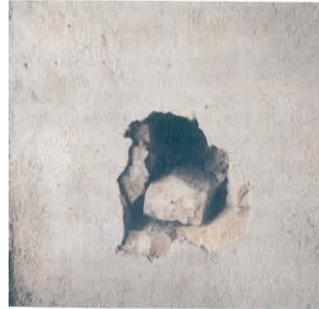
PROVIDE HOLES IN A WALL

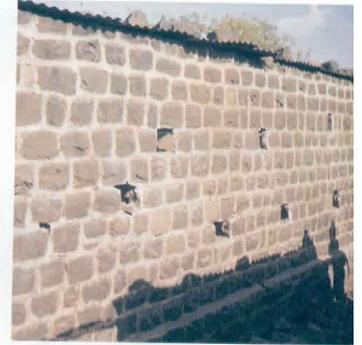
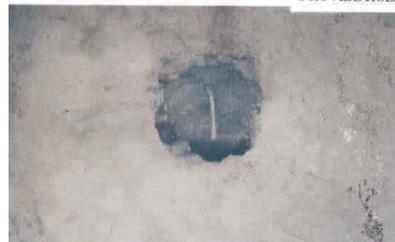
INSTALL A STEEL BAR AND FILL A HOLE WITH CONCRETE, COVER WITH CHICKEN WIRE MESH (OPTIONAL)

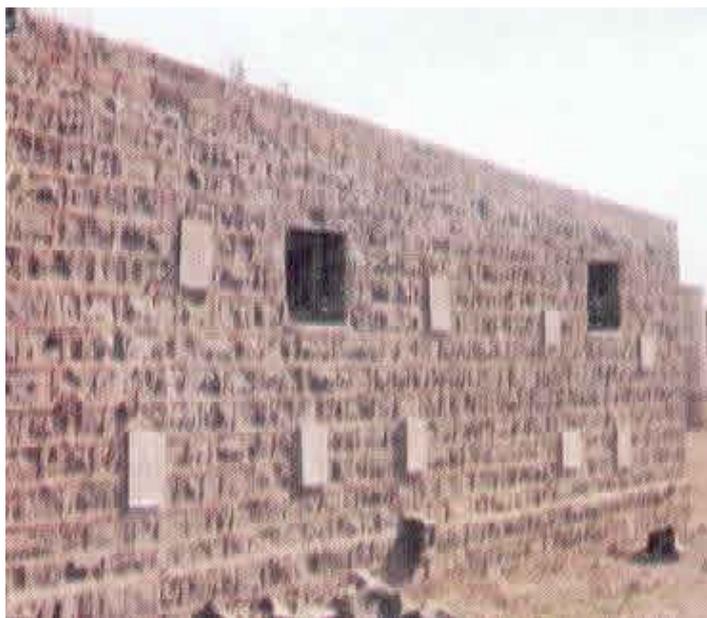
**Seismic Strengthening - An Example of a Retrofitted Building (note through-stones and RC lintel band)**

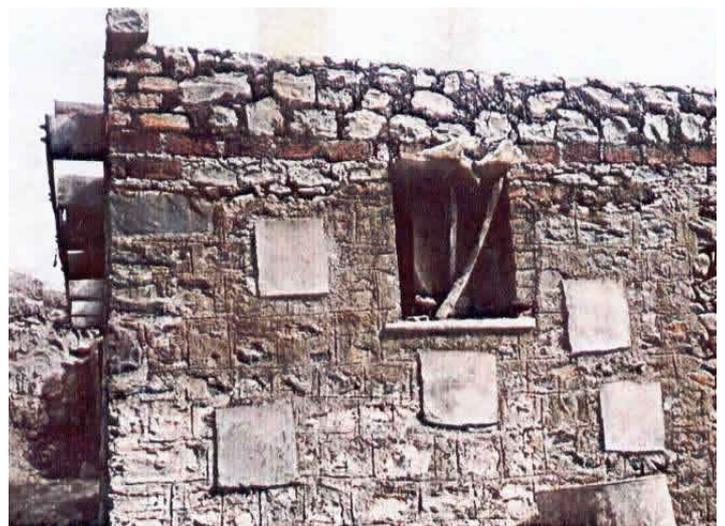
**Seismic Strengthening - An Illustration of Corner Strengthening Technique (Source: GOM 1998)**
