World Housing Encyclopedia

HOUSING REPORT Non-ductile RC frame buildings (C3L, C3M)

Report#	184
Last Updated	01/26/2016
Country	Cuba
Author(s)	Grisel Morejon Blanco, Kenia Leyva Chang, Dario Candebat Sanchez, Zulima Rivera Alvarez, Yelena Berenguer Heredia, Madelin Villalon Semanat, Dominik H. Lang, Abdelghani Meslem,
Reviewers	Jaiswal, Kishor,

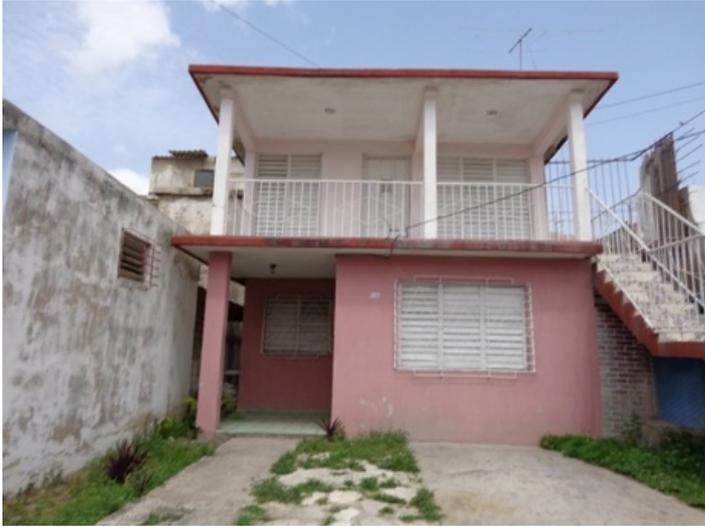
Figure 2. Two story, low-rise RC building

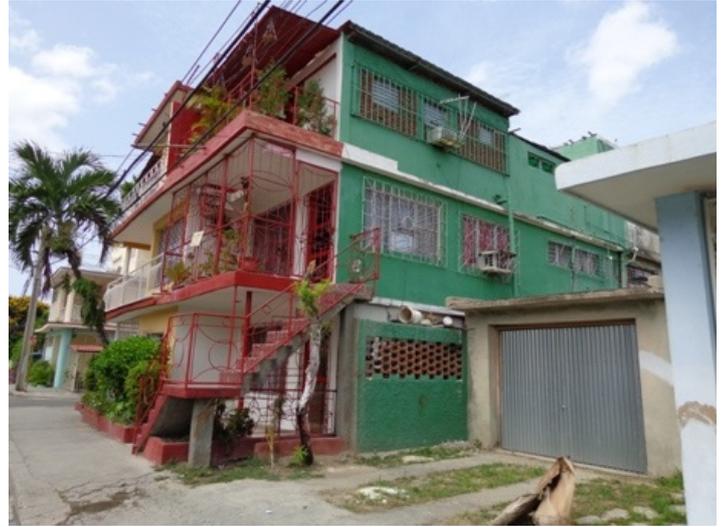
Figure 3. Three story, low-rise RC building

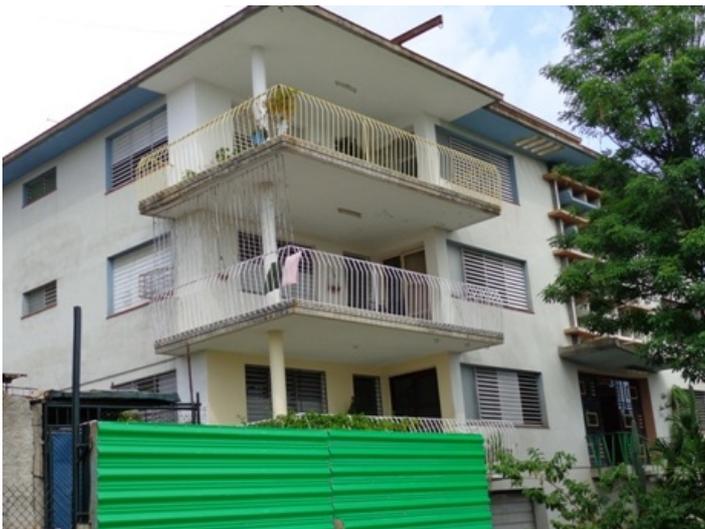
Figure 4. Four story, mid-rise RC building
