World Housing Encyclopedia

HOUSING REPORT Non-ductile RC frame buildings (E-14)

Report#	186
Last Updated	01/26/2016
Country	Cuba
Author(s)	Grisel Morejon Blanco, Kenia Leyva Chang, Dario Candebat Sanchez, Zulima Rivera Alvarez, Yelena Berenguer Heredia, Madelin Villalon Semanat, Dominik H. Lang, Abdelghani Meslem,
Reviewers	Jaiswal, Kishor,

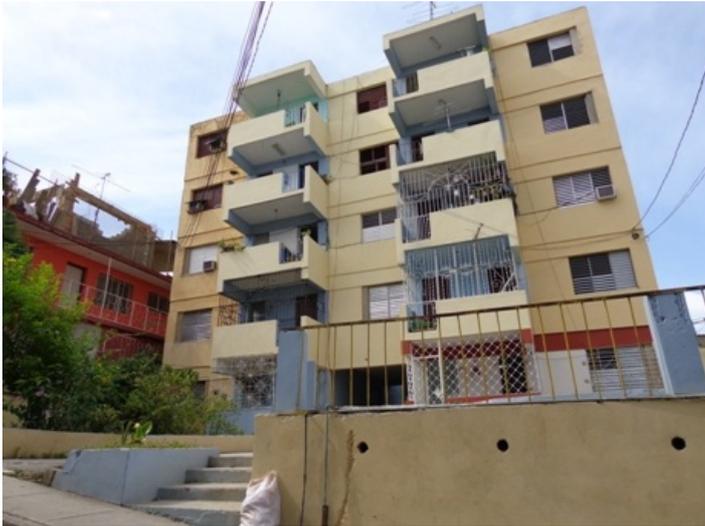
Figure 2. E14 residential building

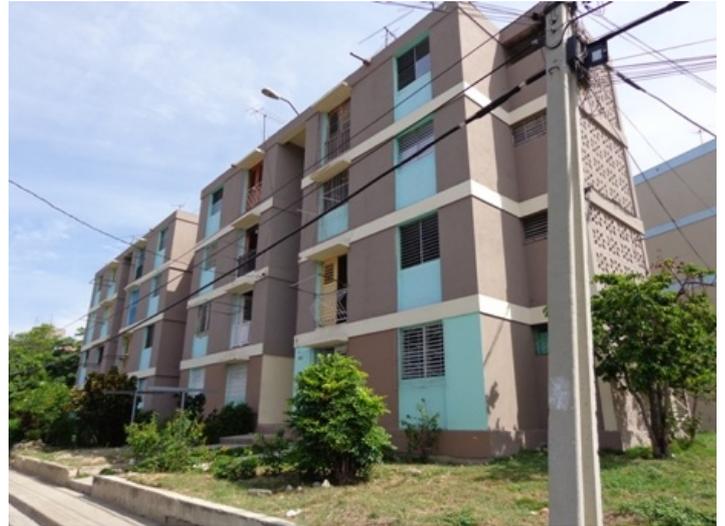
Figure 3. E14 residential building
