# World Housing Encyclopedia

## HOUSING REPORT RC shear wall buildings (FORSA)

| <b>Country</b> | Cuba |

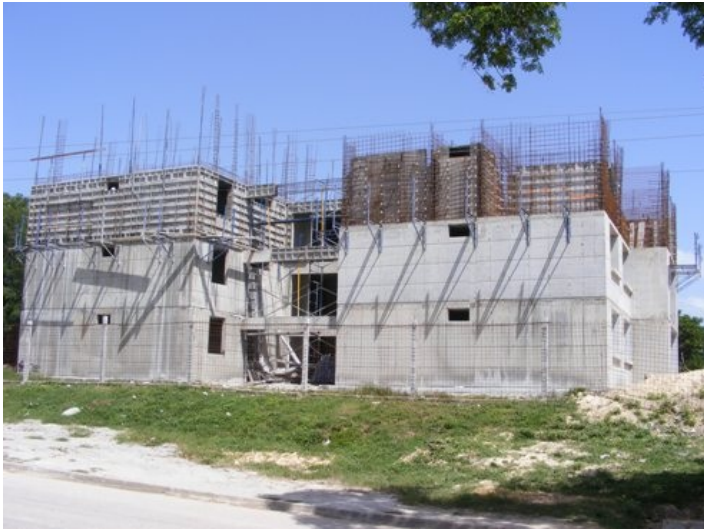
**Figure 2. Construction of FORSA building**

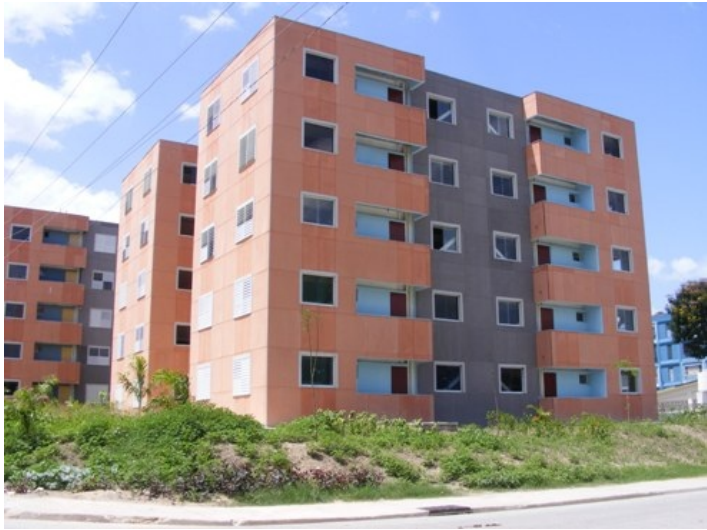
**Figure 3. RC shear walls**

| <b>Additional comments on structural system</b> | Gravity: RC slabs, transferring the gravity loads to the walls and finally to the foundation mat<br>Lateral: RC walls |
| <b>Gravity load-bearing &amp; lateral load-resisting systems</b> | Cast-in-situ monolithic concrete walls and slabs |
