World Housing Encyclopedia

HOUSING REPORT

Reinforced concrete frame building with masonry infill walls designed for gravity loads

Report#	19
Last Updated	
Country	India
Author(s)	Kishor S. Jaiswal, Ravi Sinha, Alok Goyal,
Reviewers	Craig D. Comartin,

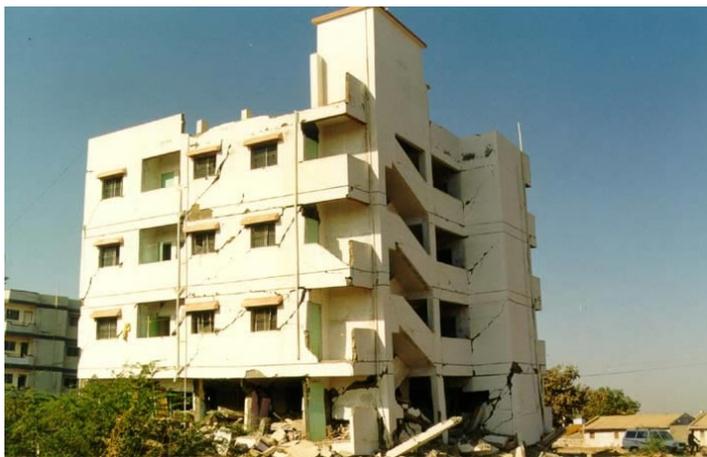
Perspective View Showing Key Structural Load-Bearing Elements of a Damaged Building

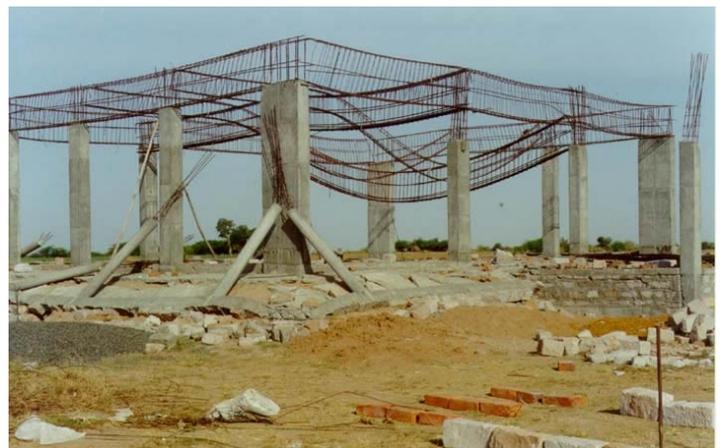
Photograph Illustrating Building Under Construction with Improper Reinforcement Detailing Practice

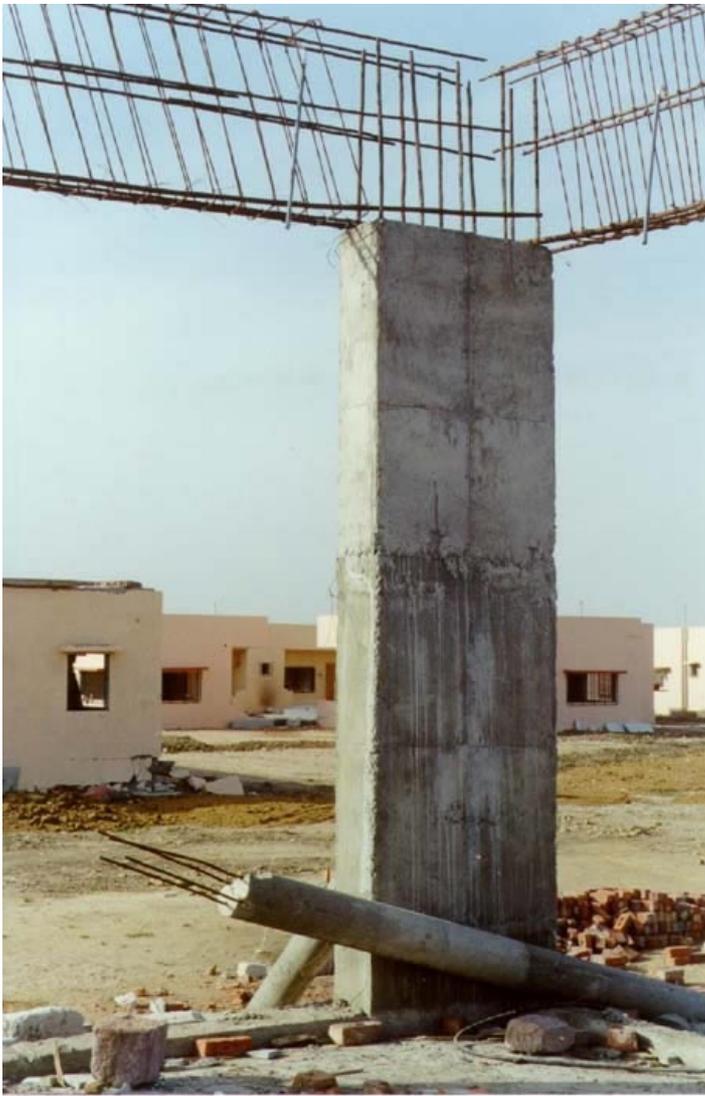
A Close up View of Building Under Construction with Improper Reinforcement Detailing of Beam-Column Joint

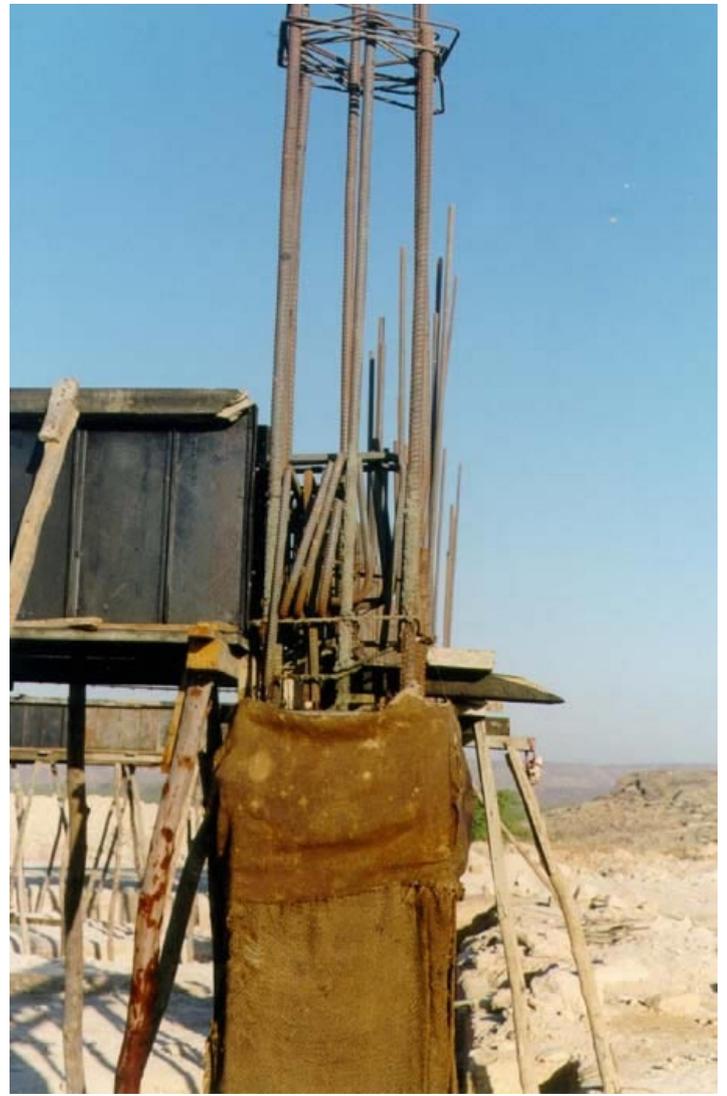
Beam-Column Junction with Congestion of Reinforcement Illustrating Improper Construction Practice

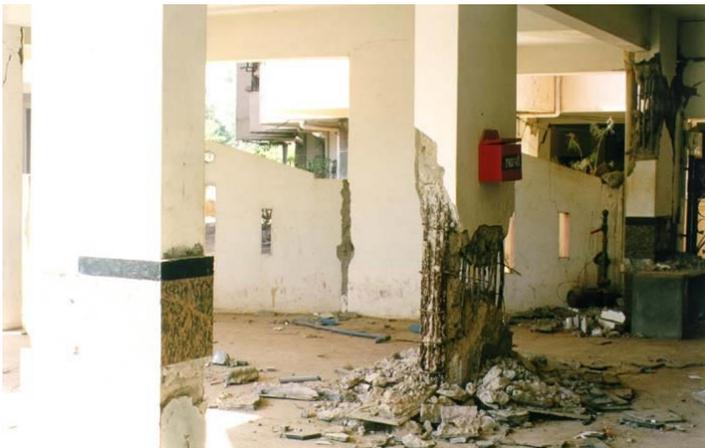
Severe Damage and Plastic Hinging of Ground-Floor Column Due to Improper Confinement of Concrete and Lapping of Large Number of Longitudinal Bars

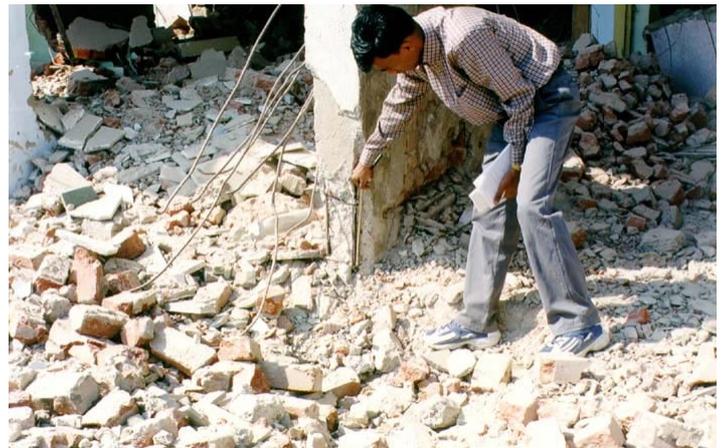
Damage to Ground Floor Columns Due to Inadequate Lateral Confinement of Reinforcement Bars

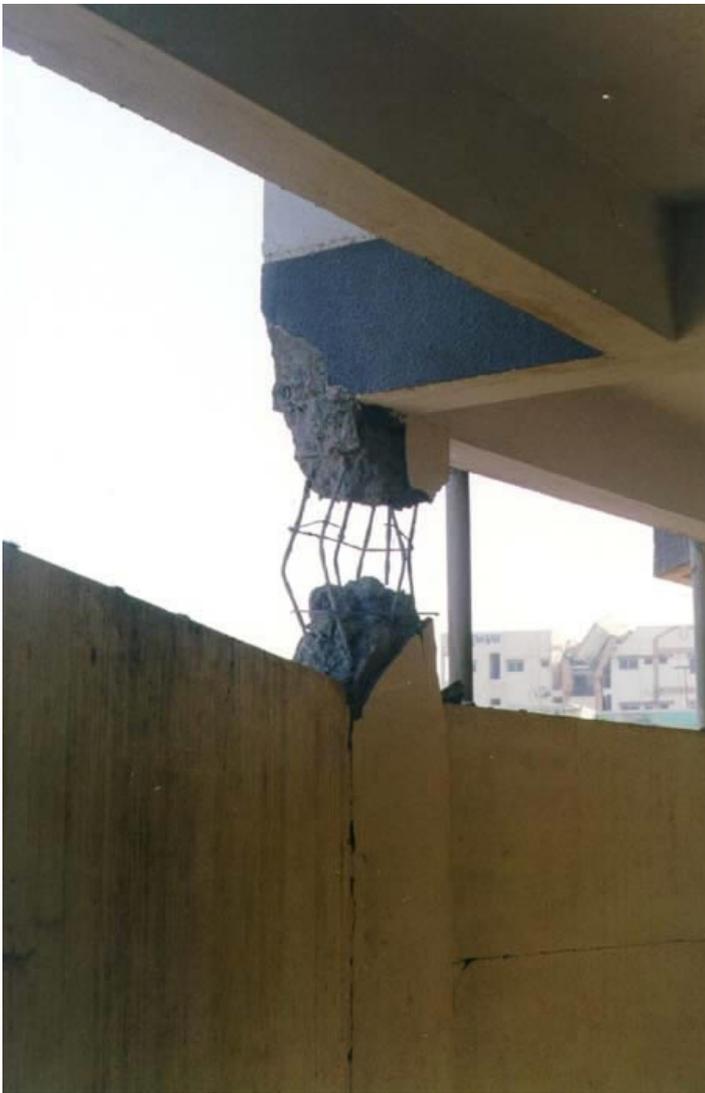
Failure of Column Below the Beam-Column Joint Due to Short Column Effect

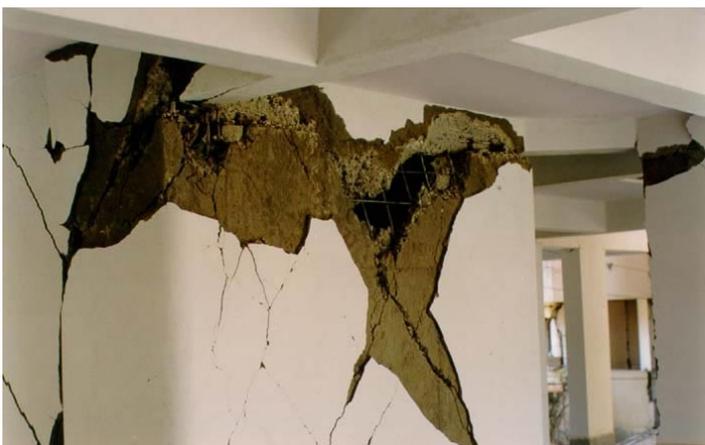
View of Shear Damage of an Elevator Core (2001 Bhuj Earthquake)

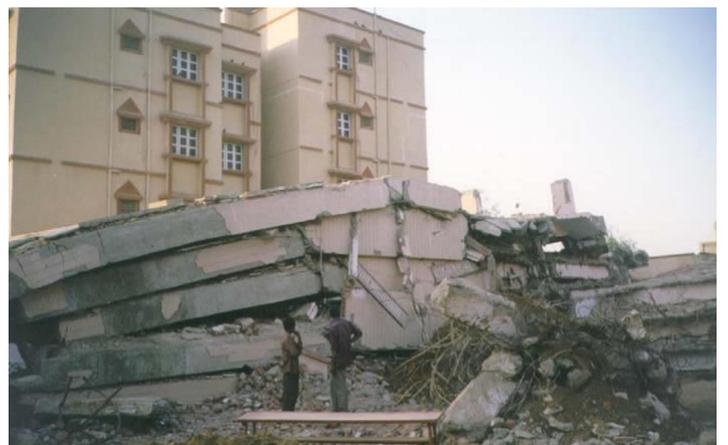
Pancake Collapse of a Multistory Building Due to Weak Column-Strong Beam Design (2001 Bhuj Earthquake)

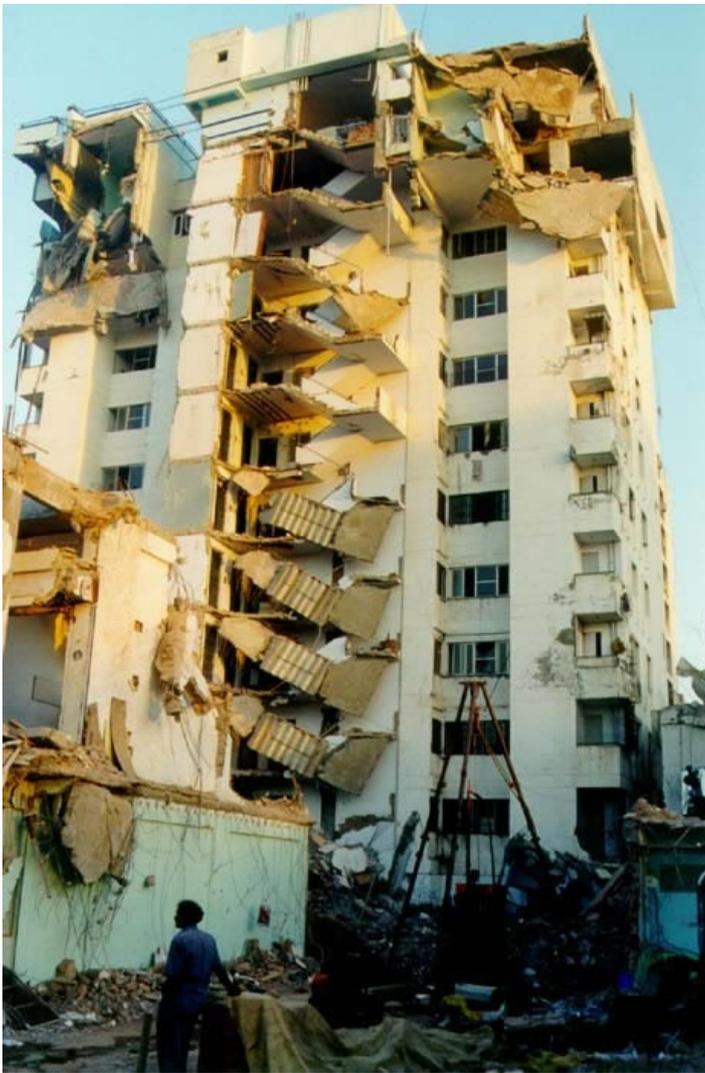
A Photograph Illustrating Typical Earthquake Damage

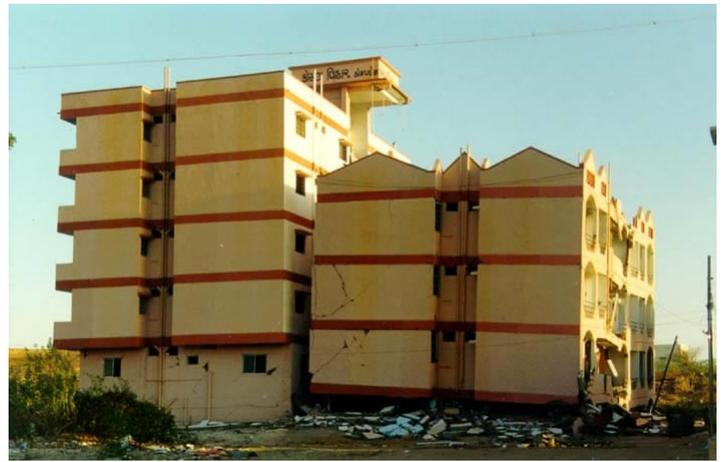
Failure of Lower Two Stories of the Right Wing of an Apartment Building With Soft Story. Note that the Left Wing Without Soft Story is Apparently Undamaged (2001 Bhuj Earthquake).

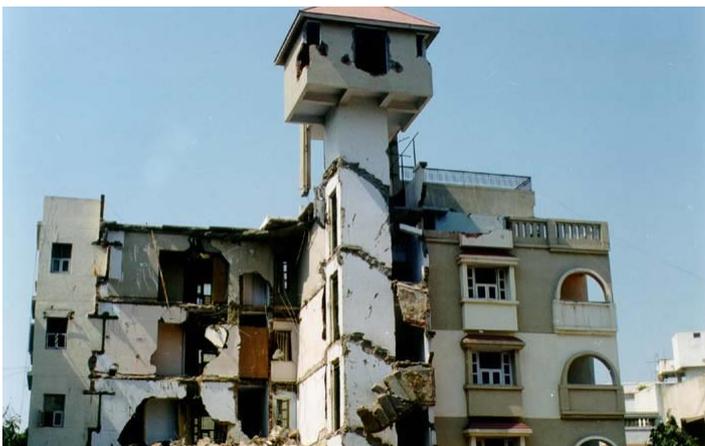
Underutilization of Shear Capacity of Elevator Core Due to Improper Diaphragm Action of Slabs Resulted in Failure of an Apartment Building (2001 Bhuj Earthquake)

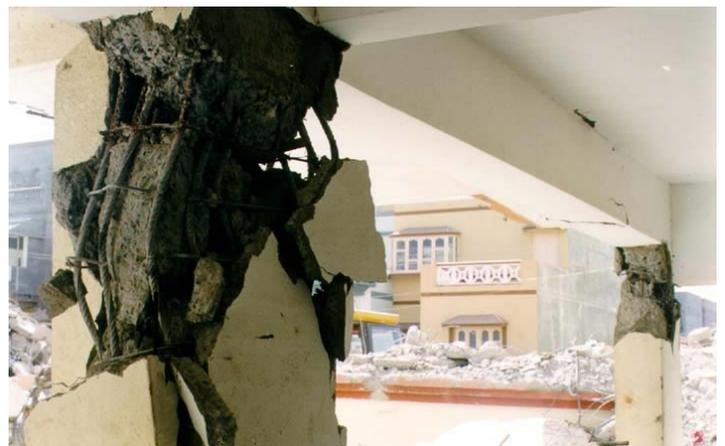
Shear Failure of Column Just Below the Beam-Column Junction Due to Poor Construction Material and Insufficient Lateral Reinforcement (2001 Bhuj Earthquake)

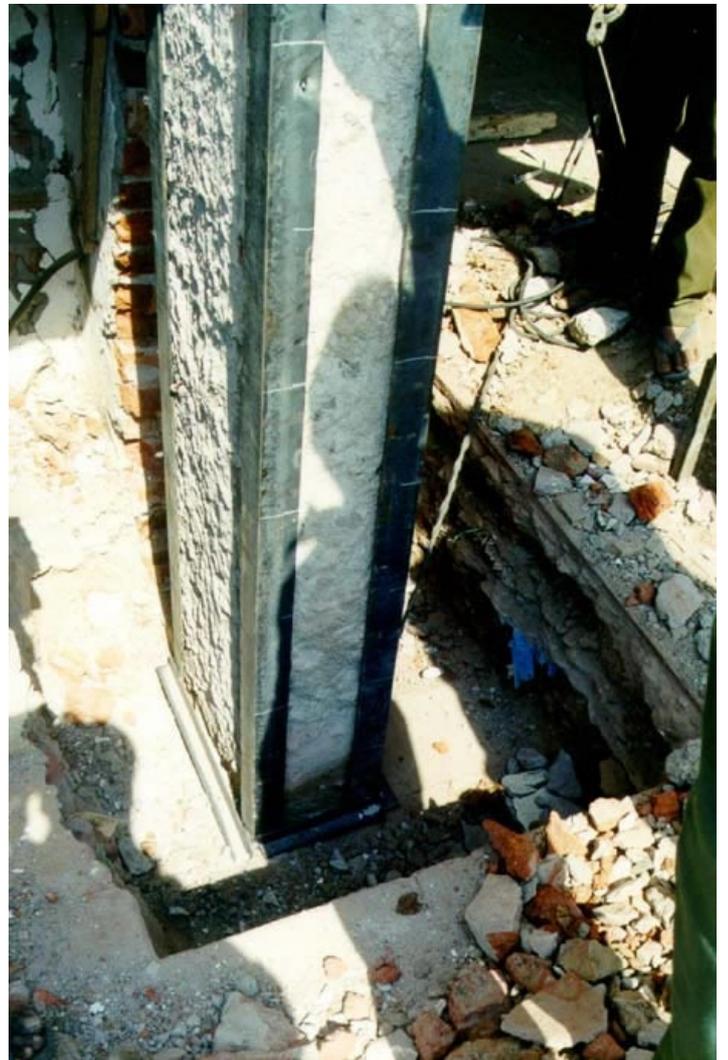
Seismic Strengthening of Columns by Jacketing from Top of Footing - Correct Technique (2001 Bhuj Earthquake)

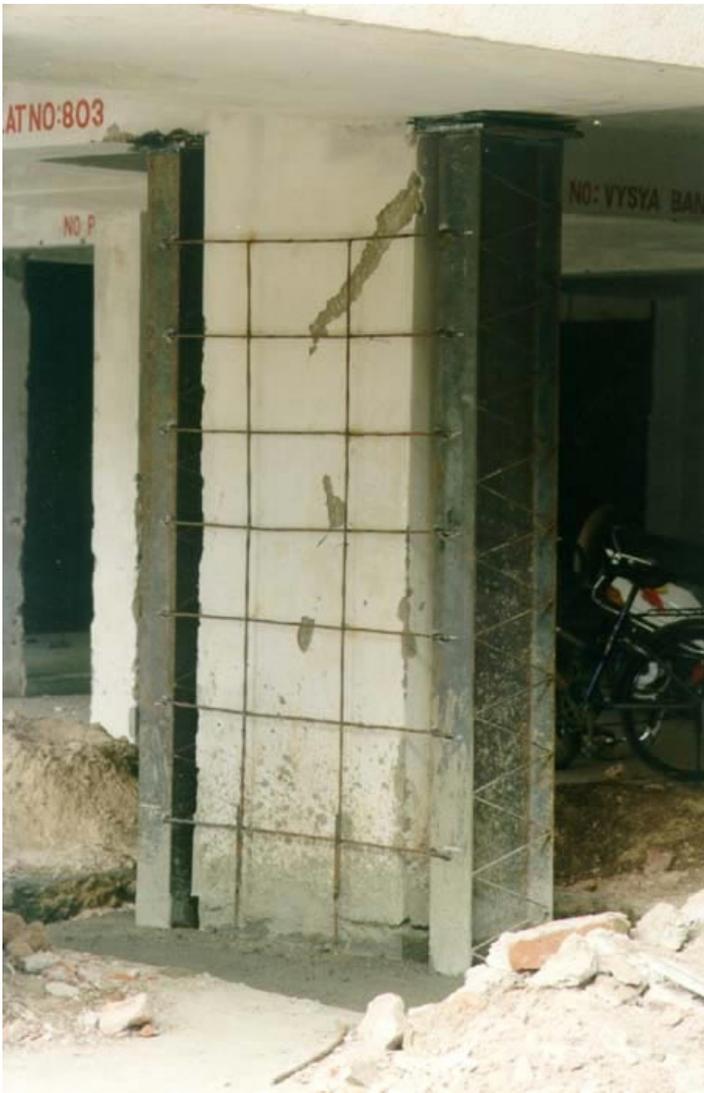
Seismic Strengthening of Columns by Jacketing from Floor Level - Improper Technique (2001 Bhuj Earthquake)

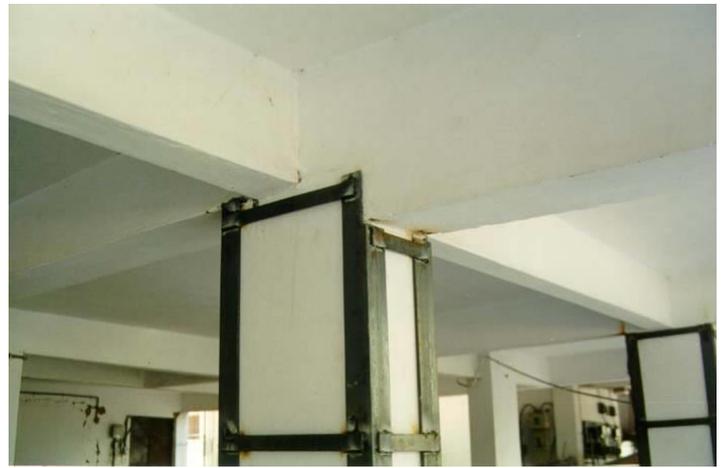
Termination of Column Jacket Steel at Beam Soffit Level Resulting in No Increase in Moment Capacity of Column (2001 Bhuj Earthquake)
