World Housing Encyclopedia

HOUSING REPORT **Unconfined masonry**

Report#	197
Last Updated	01/26/2016
Country	Cuba
Author(s)	Grisel Morejon Blanco, Kenia Leyva Chang, Dario Candebat Sanchez, Zulima Rivera Alvarez, Yelena Berenguer Heredia, Madelin Villalon Semanat, Dominik H. Lang, Abdelghani Meslem,
Reviewers	Jaiswal, Kishor,

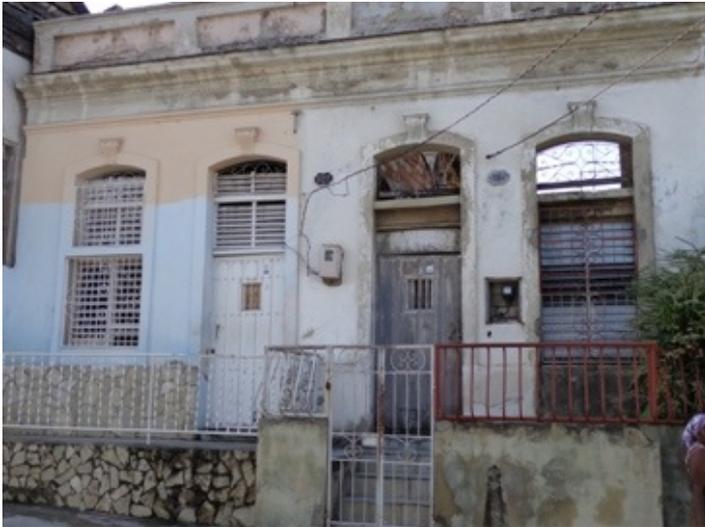
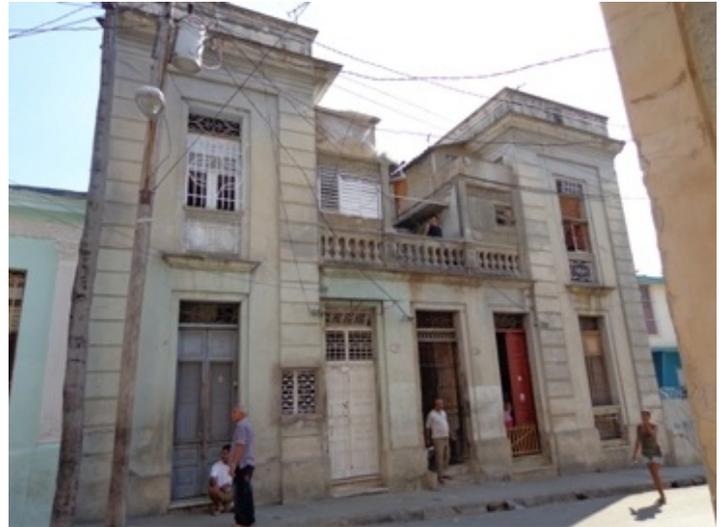
plan shape	
Typical plan length (meters)	
Typical plan width (meters)	
Typical story height (meters)	
Type of Structural System	Masonry: Unreinforced Masonry Walls: Brick masonry in mud/lime mortar
Additional comments on structural system	Gravity: Unreinforced masonry walls; the loads from the roof are transferred to the walls and to the foundations; there is generally no proper connection between the walls; no reinforcement or bands are used Lateral: Unreinforced masonry walls; the walls have a very low resistance to out-of-plane forces; in most cases, there is no proper connection between the roof and the walls
Gravity load-bearing & lateral load-resisting systems	
Typical wall densities in direction 1	>20%
Typical wall densities in direction 2	>20%
Additional comments on typical wall densities	
Wall Openings	
Is it typical for buildings of this type to have common walls with adjacent buildings?	
Modifications of buildings

Type of Roof System	Wooden structure with light roof covering
Additional comments on roof system	Wood planks or beams that support clay or zinc tiles
Additional comments section 2
