World Housing Encyclopedia

HOUSING REPORT

Unreinforced masonry houses made of fired clay bricks

Report#	205
Last Updated	
Country	Malawi
Author(s)	Viviana Novelli, Panos Kloukinas, Ignasio Ngoma, Innocent Kafodya, John Macdonald, Katsu Goda,
Reviewers

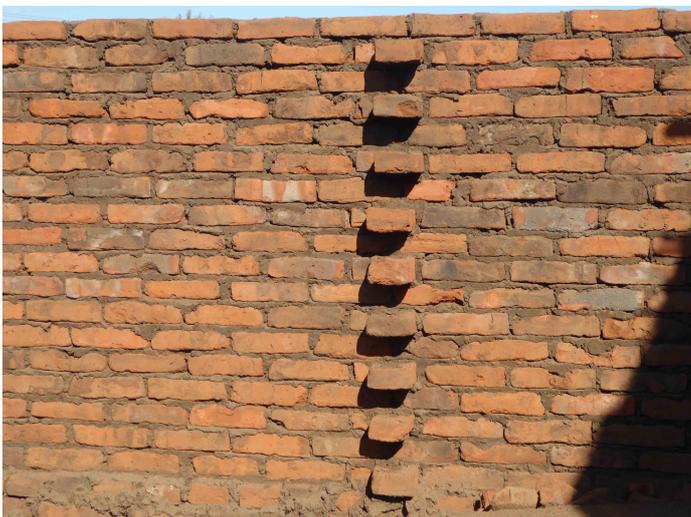
Figure 9. Typical structural detailing

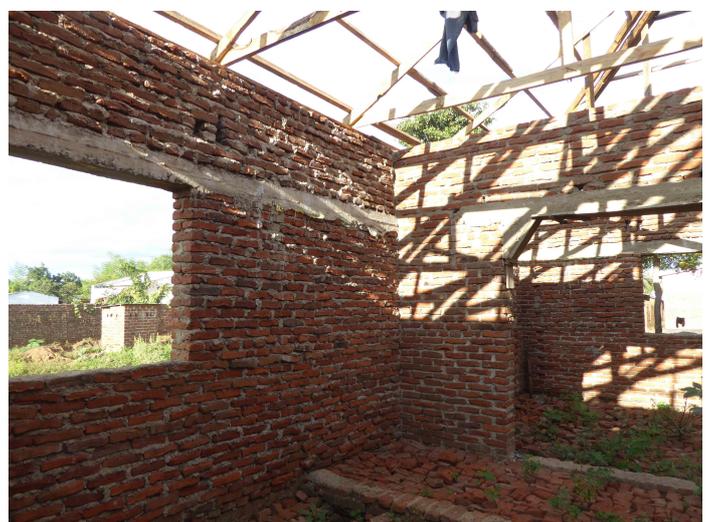
Figure 10. Internal walls are

orthogonal and parallel to the external facades.

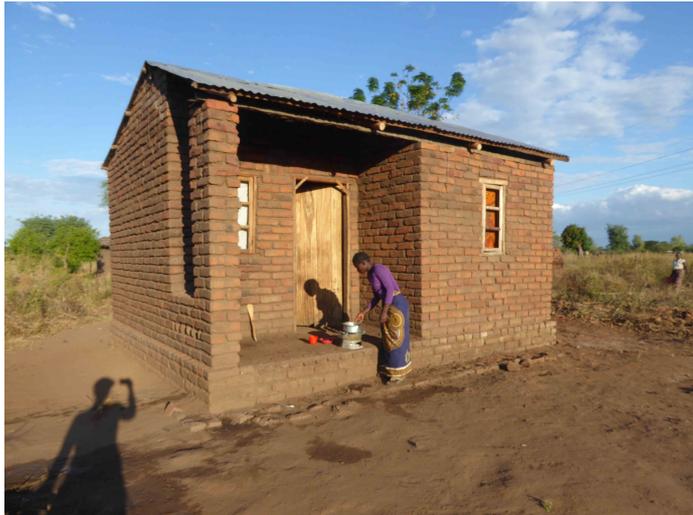
Figure 11. Typical example of house with a re-entrant corner located on the longest external facade.

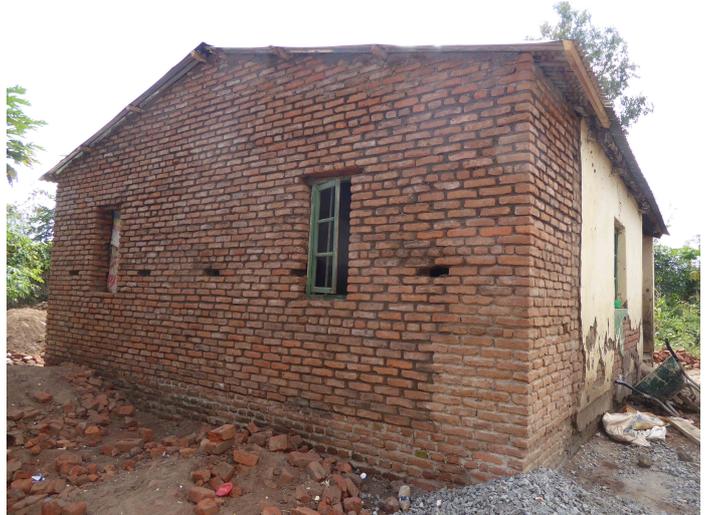
Figure 12. Unreinforced Masonry Walls: house with brick masonry and mud mortar.

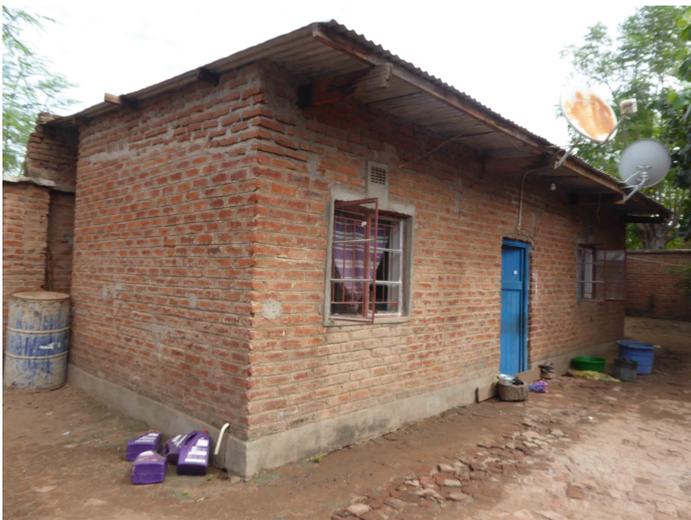
Figure 13. Unreinforced Masonry Walls: house with brick masonry and cement mortar.

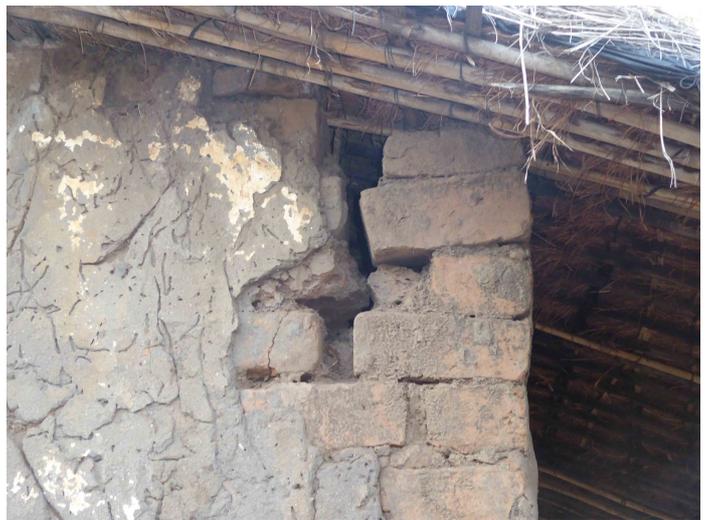
Figure 14. House in clay bricks and mud mortar with a lack of connections between walls. The front facade is completely detached from the side facade due to a weak mortar and presence of fragile bricks. Constructional materials are low quality.

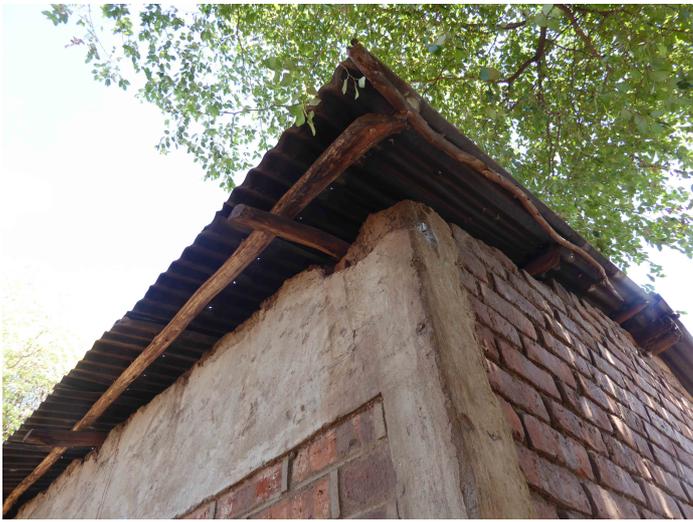
Figure 15. House in clay bricks and mud mortar with a lack of connections between walls and the roof made of a timber system supporting metallic corrugated sheets. Constructional materials are medium quality.

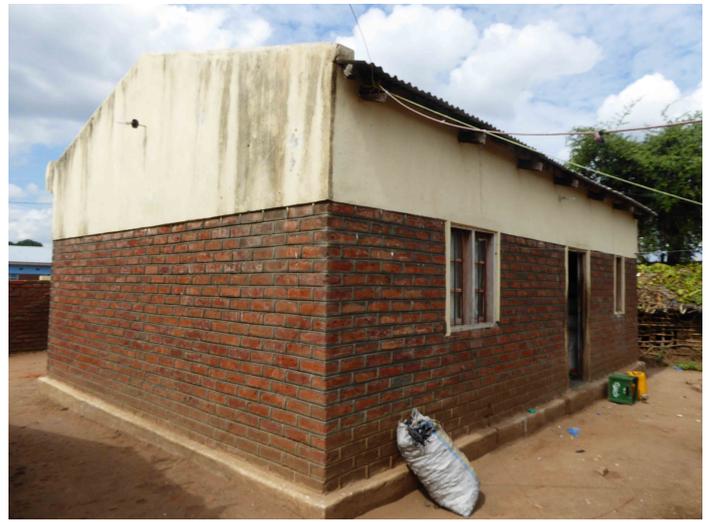
Figure 16. House in clay bricks and mud mortar built with constructional materials of good quality. Walls and roof are properly connected.

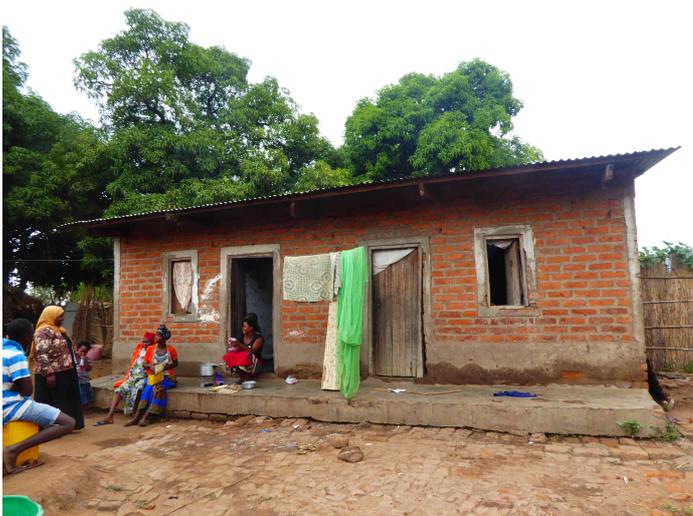
Figure 17a. openings: regular distribution of the windows/doors.

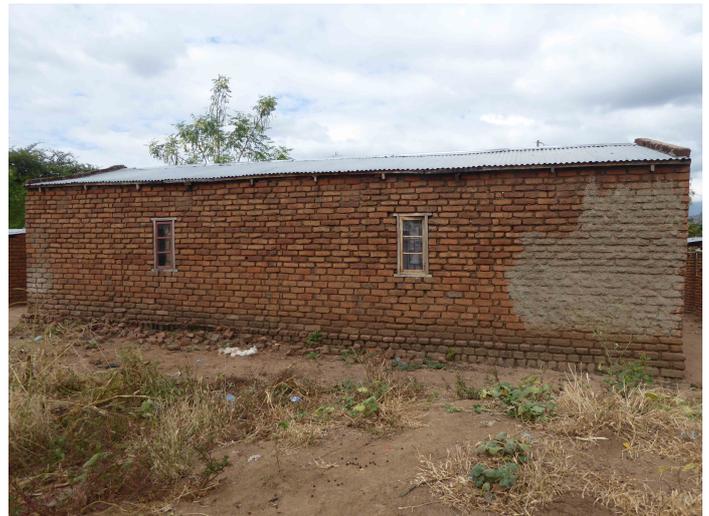
Figure 17b. openings: windows are in a central position.

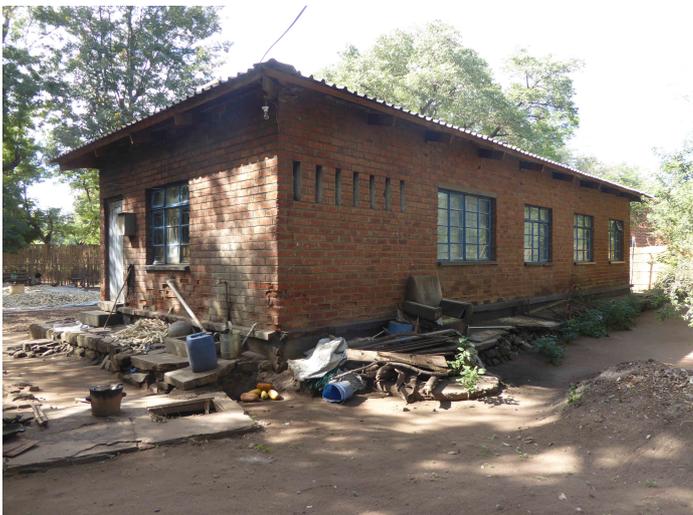
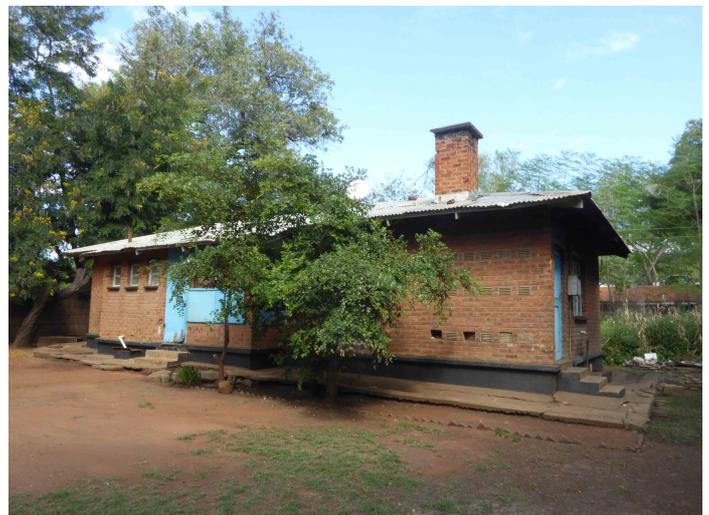
Figure 17c. openings: on the shortest facade windows/doors are distributed on the left side and on the longest facade windows/doors are distributed on the right side.

Figure 18. Presence of chimney. This is a seismic vulnerability element occasionally observed in big houses constructed with good quality construction.

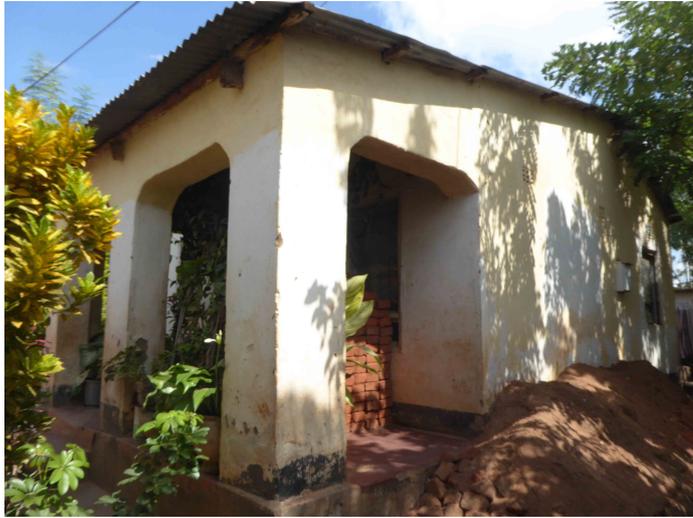
Figure 19. House with a small portico on the front facade, made of columns in bricks.

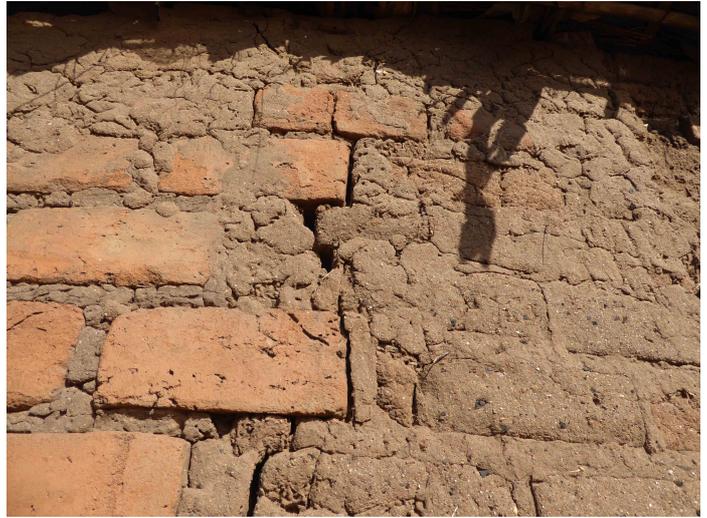
Figure 20. Use of unburnt bricks for the extension of a wall made of burnt bricks.

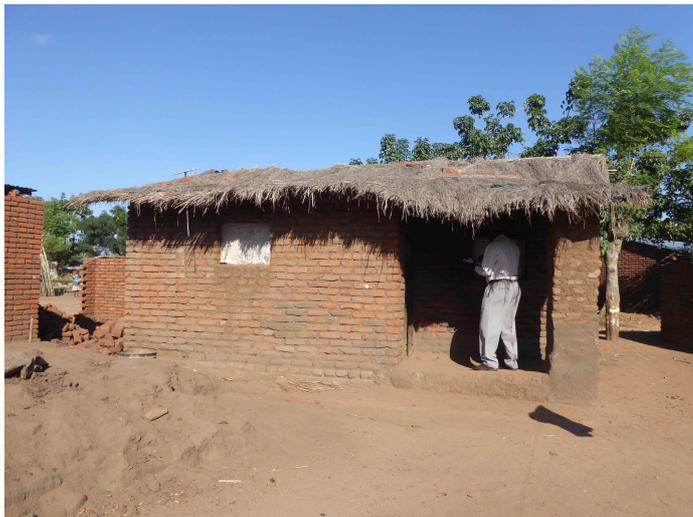
Figure 21. Platform of about 30 cm constructed under the house with bricks and mud mortar.

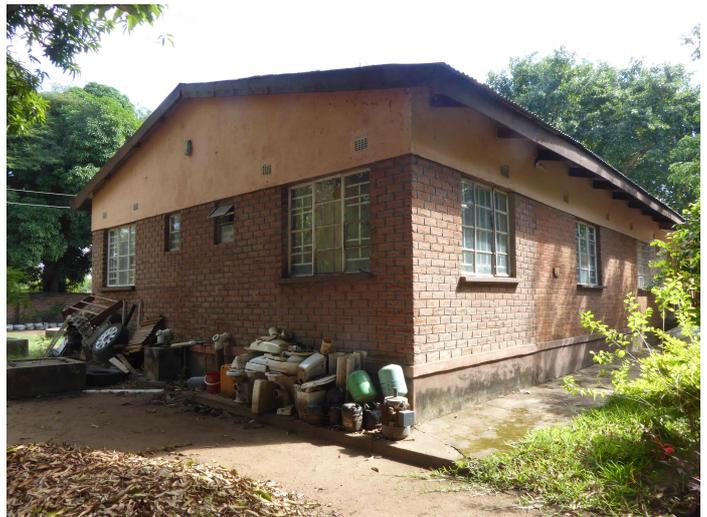
Figure 22. Platform of about 30 cm constructed under the house with bricks and cement mortar.

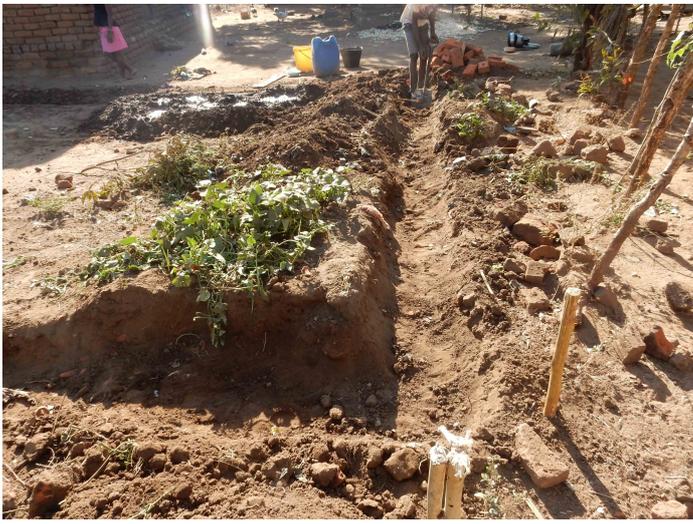
Figure 23. Shallow trench in the soil to embed the plinth wall.

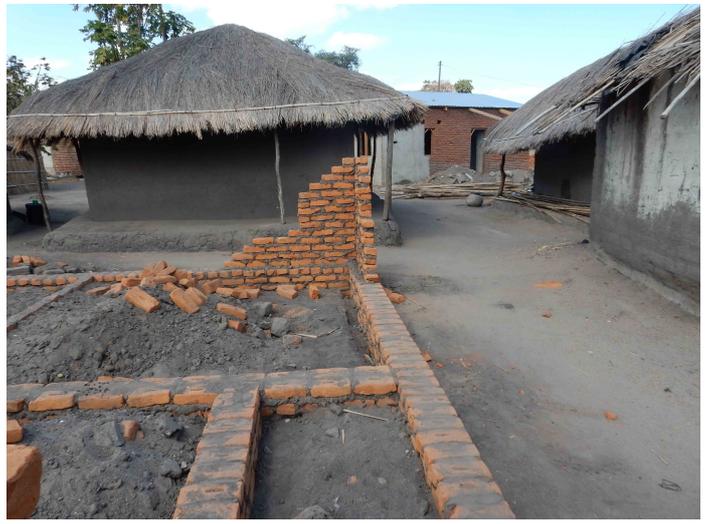
Figure 24. Double skin plinth wall to support a single skin masonry, to be filled with compacted soil.

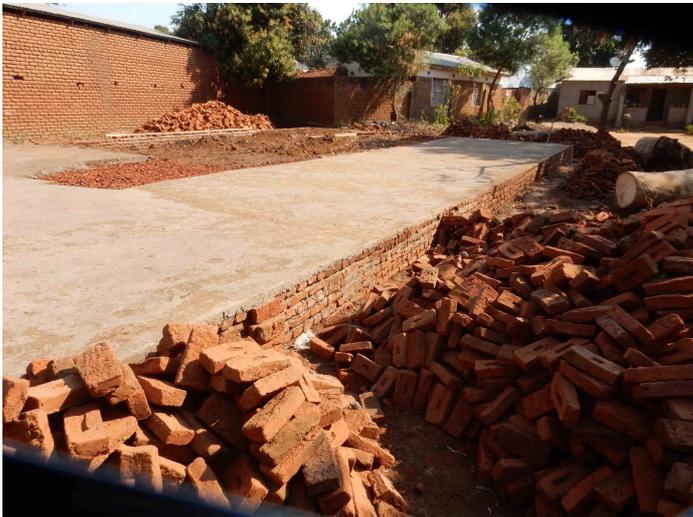
Figure 25. Triple skin plinth wall to support a double skin masonry, filled with crushed brick and finished with cement/sand screed.

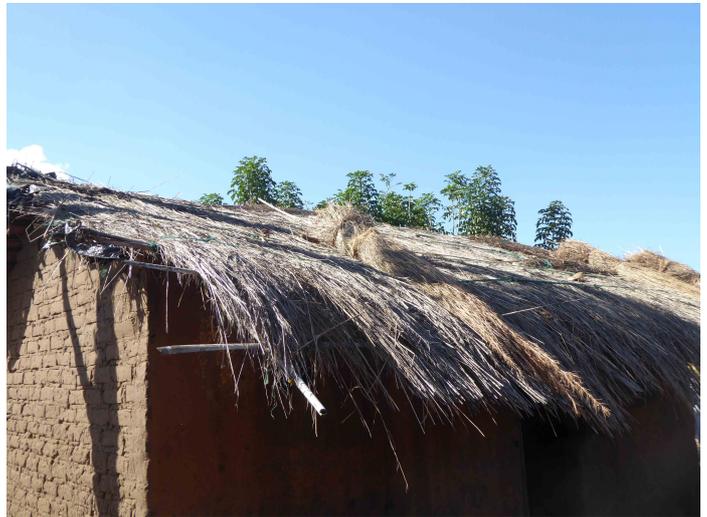
Figure 26. Typical roof made of light timber truss supporting thatch.

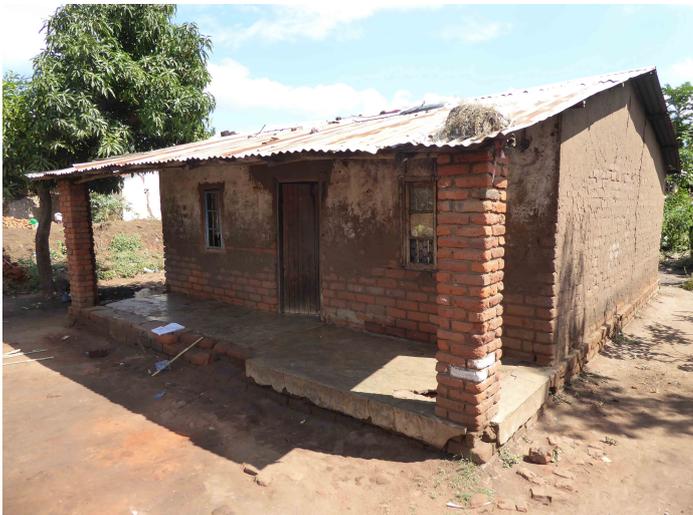
Figure 27. Typical roof made of light timber truss supporting

corrugated metallic corrugated sheets.

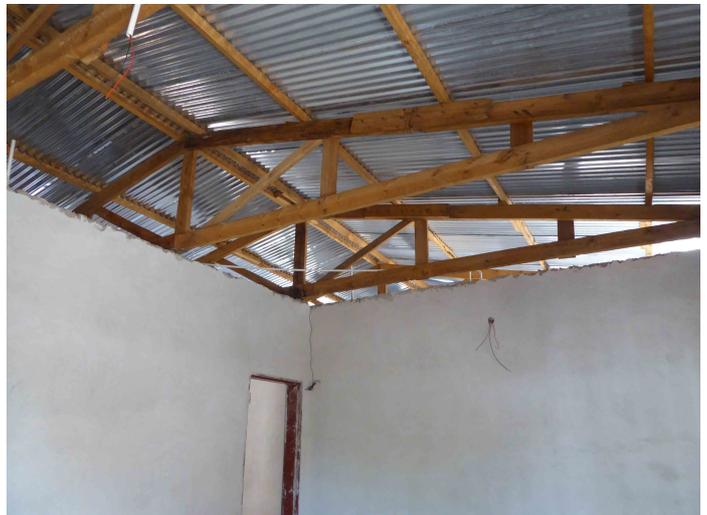
Figure 28. Internal view of a roof made of light timber truss

supporting corrugated metallic corrugated sheets. Timber truss does not sit on the internal walls.

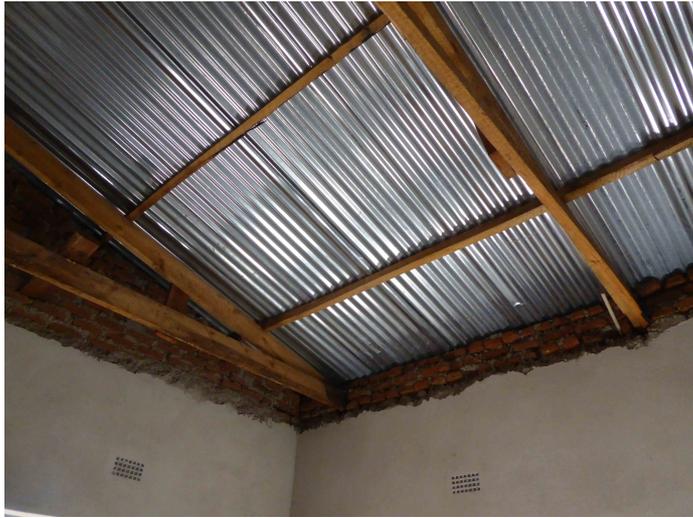
Figure 29. Timber structure of the roof sits directly on the walls. The use of ring-beams at the top of the walls is not part of the construction techniques.

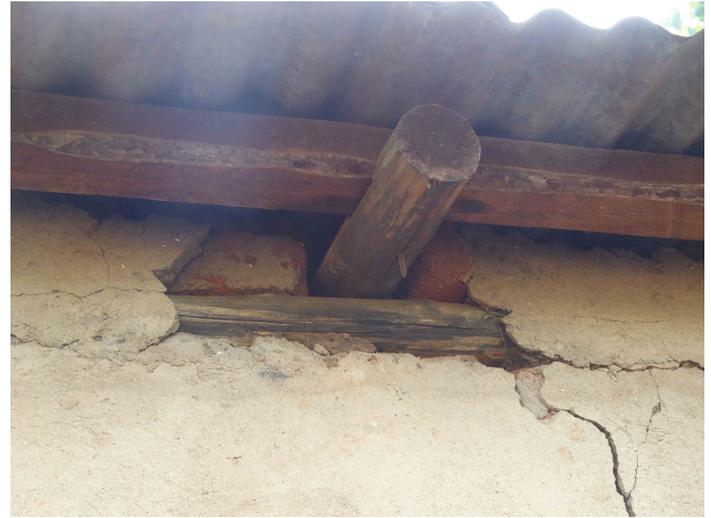
Figure 30. Example of wall plate, adopted underneath the rafters. Poor detailing is underlined by the presence of cracks and lack of maintenance is detected by loss of plaster.

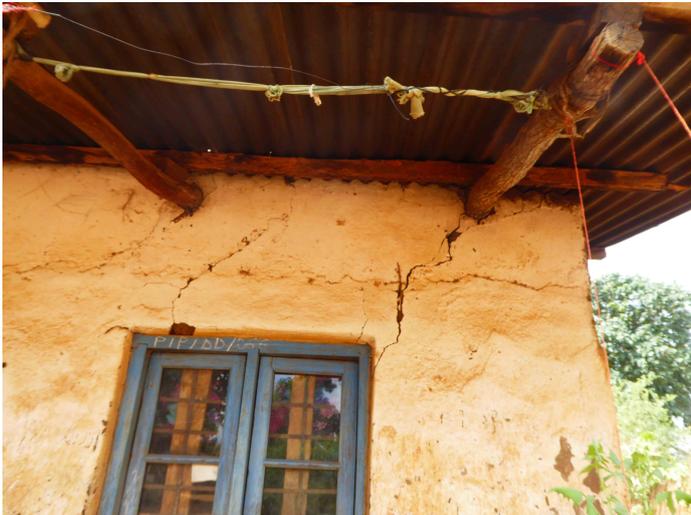
Figure 31. The lack of padstones underneath the purlins/rafters causes severe vertical cracks on the walls indicating an inappropriate distribution of the weight roof system.

Houses are often deteriorated due to weathering and externals/internal walls are often damaged by severe cracks indicating partial failures of the houses. Most of the cracks are located under the rafters of the timber roof, underling an inadequate distribution of the load, although roofs are of light weight and flexible. Cracks are also visible on gables, failing for overturning since they are

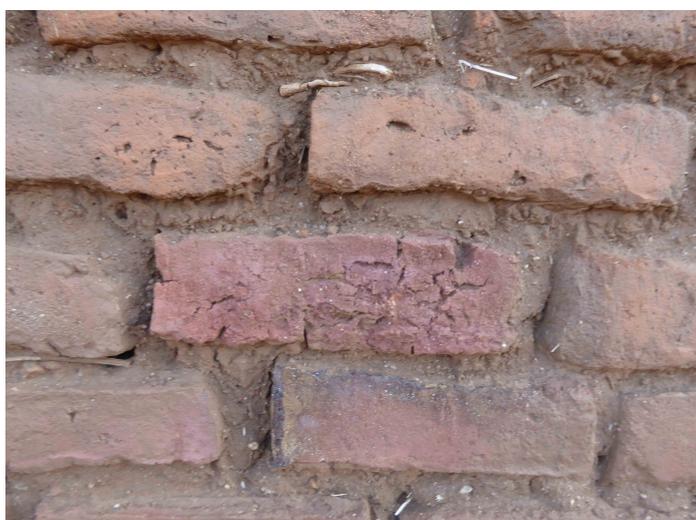
Figure 32. Typical local brick with mud mortar

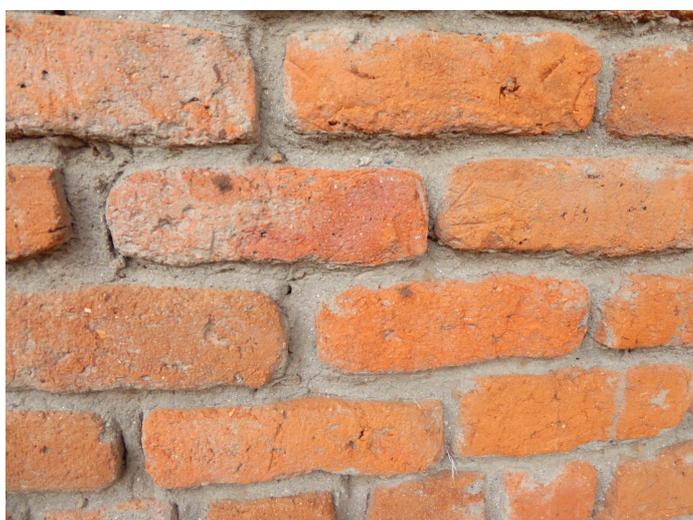
Figure 33. Typical local brick with cement mortar

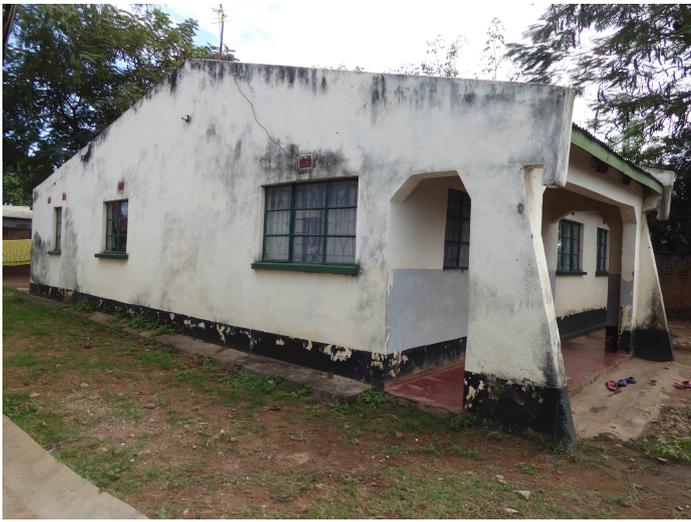
Figure 34. Example of buttresses well connected to the front walls of the house made in masonry brick and cement mortar.

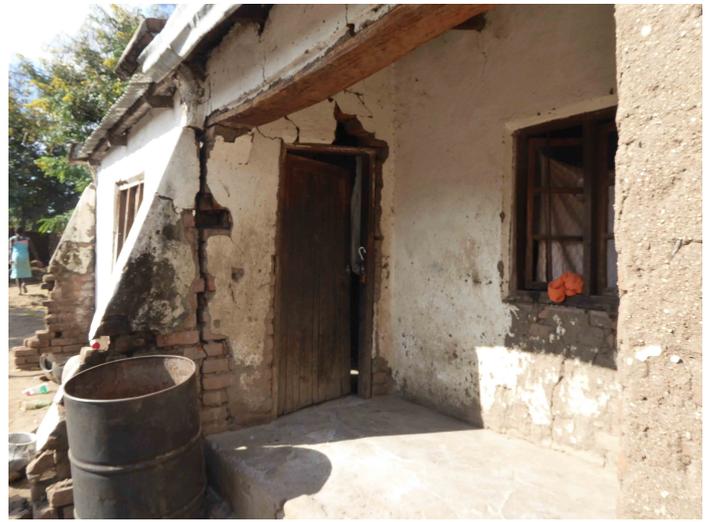
Figure 35. Example of buttresses completely disconnected from the front walls of the house made in masonry brick and mud mortar.

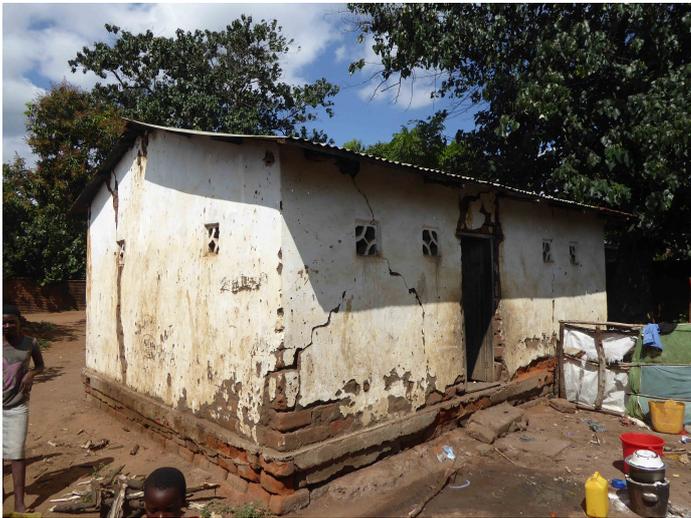
Figure 36. House deteriorated due to weathering, severe cracks and low maintenance. Some bricks are completely deteriorated or crushed.

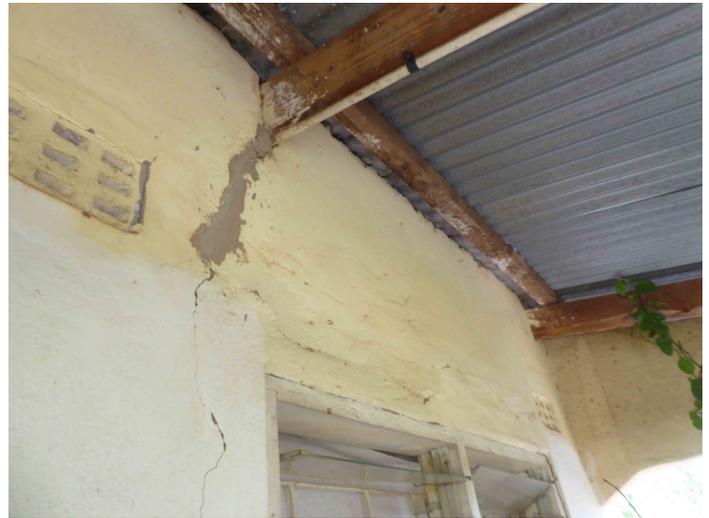
Figure 37. Vertical crack underneath the timber planks supporting the corrugated metallic sheets of the roof.

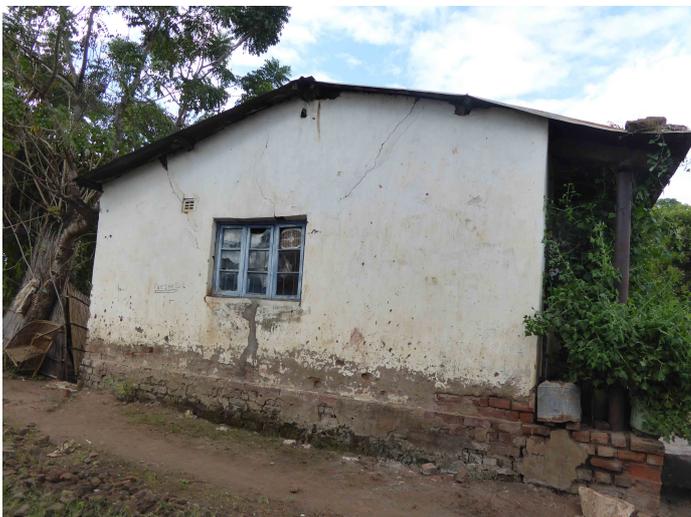
Figure 38. Typical cracks indicating

the overturning of the gable due to the purlins in the roof pushing against the wall.

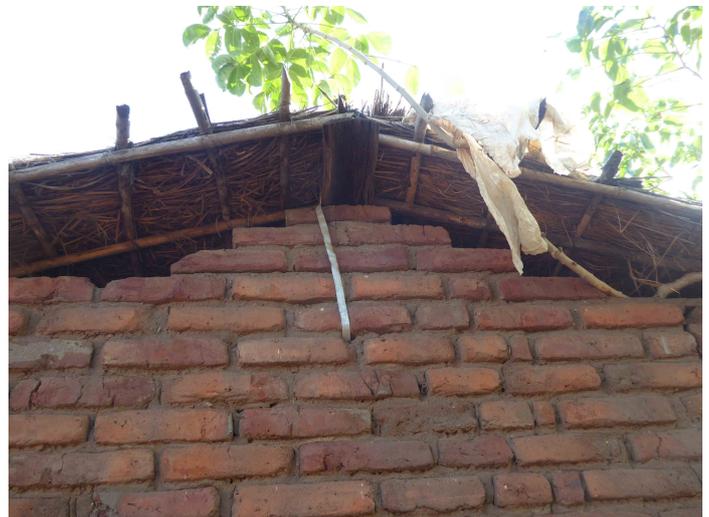
Figure 39. Gable walls completely

detached from the roof structure.

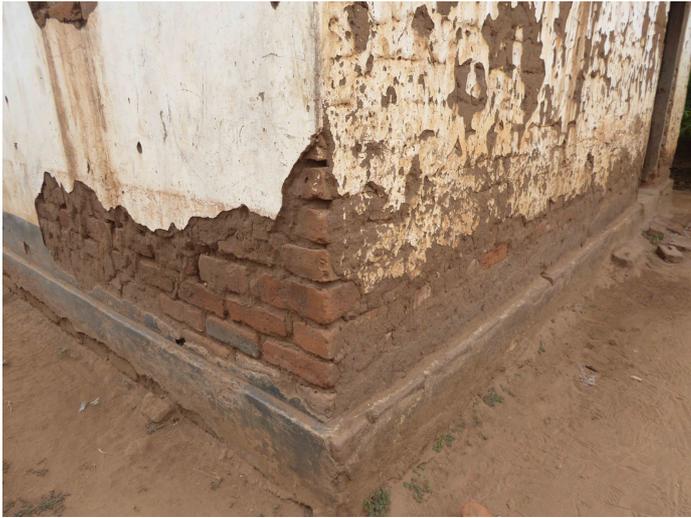
Figure 40. *Low maintenance of the house. Mortar is partially lost due to the loss of the plaster that has accelerated the process of degradation of the constructional materials.*

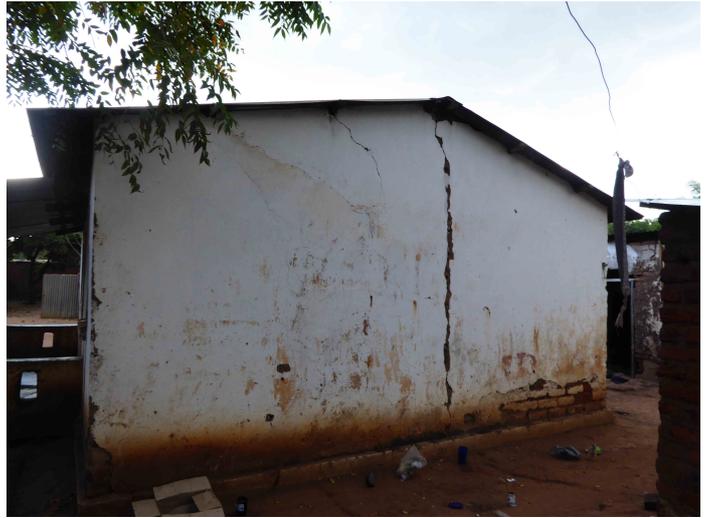
Figure 41. *Vertical crack running along the gable wall due to the weak connection between the external facade and internal facade.*

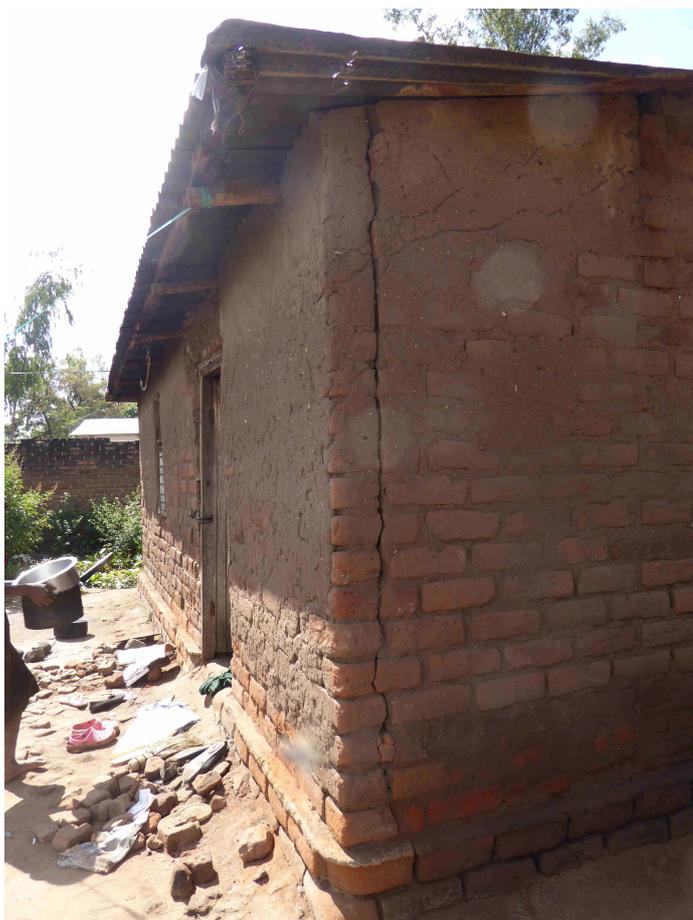
Figure 42. Karonga earthquake (2009). Out of plane failure mode due to lack of connections between slender single skin bearing walls made of clay bricks and mud mortar.

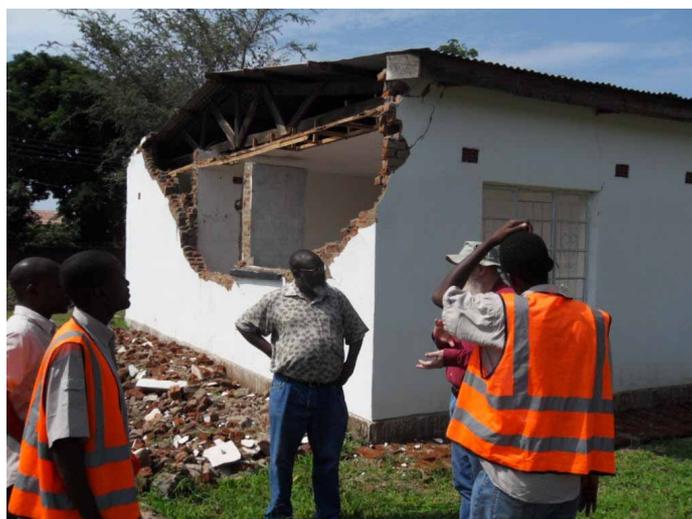
Figure 43. Karonga earthquake (2009). Collapse of the gable underlined by an arch crack pattern. The failure is caused by the improper connection between the gable and roof.

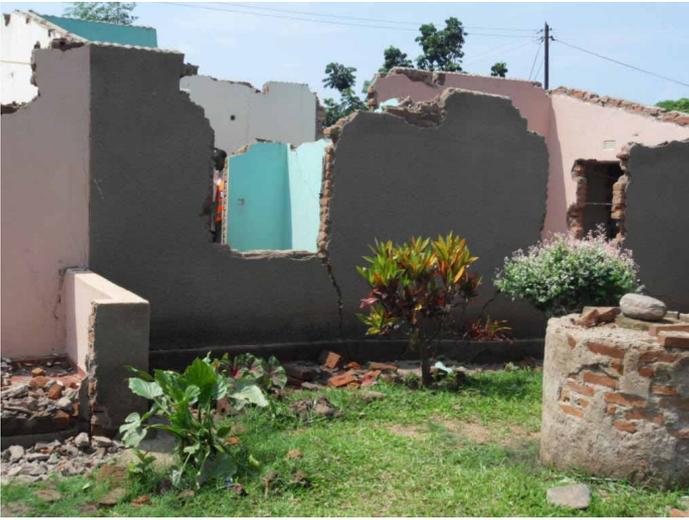
Figure 44. Karonga earthquake (2009). In plane failure modes of the spandrels on the top of the openings, and collapse of the roof. House has single skin walls made of clay brick of medium quality and cement mortar. The crack pattern is not visible, since

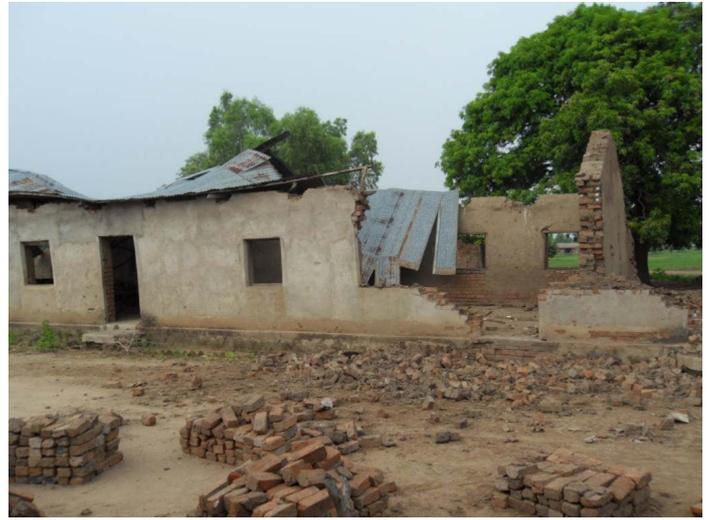
Figure 45. Karonga earthquake (2009). Corner failure mode. Collapse of the right corner of the house with double skin of clay brick of medium quality and mud mortar.

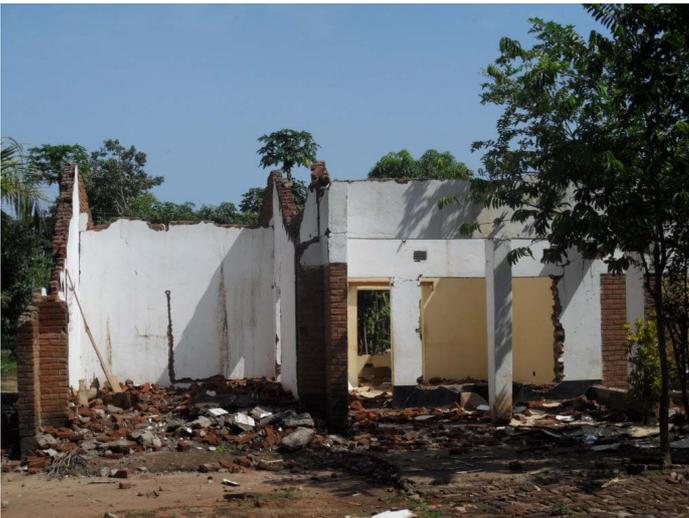
Figure 46. Karonga earthquake (2009). This type of failure involves the failure of three facades, well connected, which fail because the front facade completely collapsed in overturning and part of the side facades slid. The roof completely collapsed due

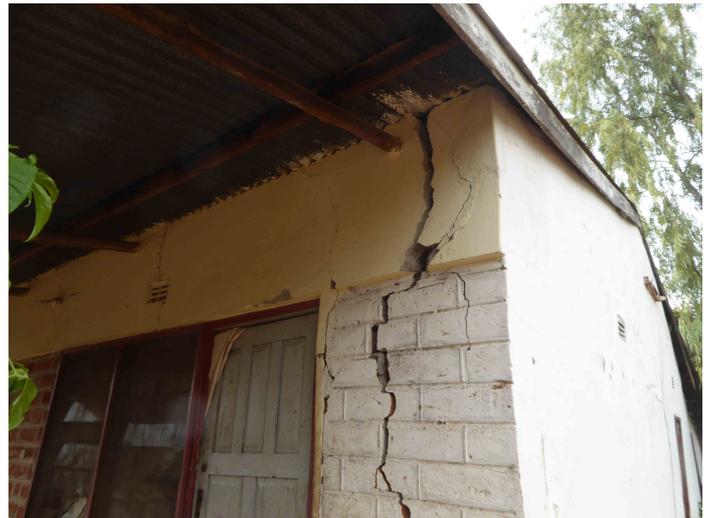
Figure 47. High seismic vulnerability of informal houses is given by a poor connection between walls

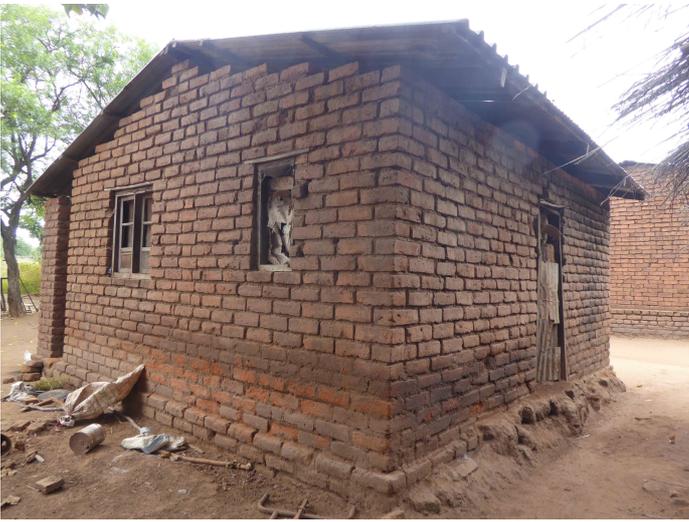
Figure 48. High seismic vulnerability of informal houses is given by a poor connection between walls and roof.

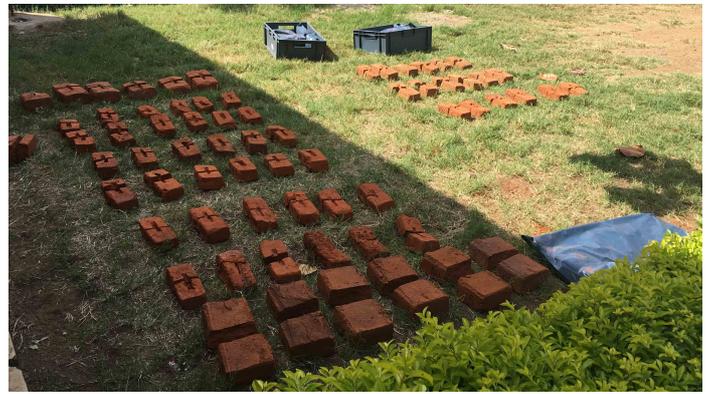
Figure 49. High seismic vulnerability of informal houses is given by poor quality of the mechanical properties of the bricks produced locally. Bricks have different size from the standards ones, and they differ considerably in terms of strength.

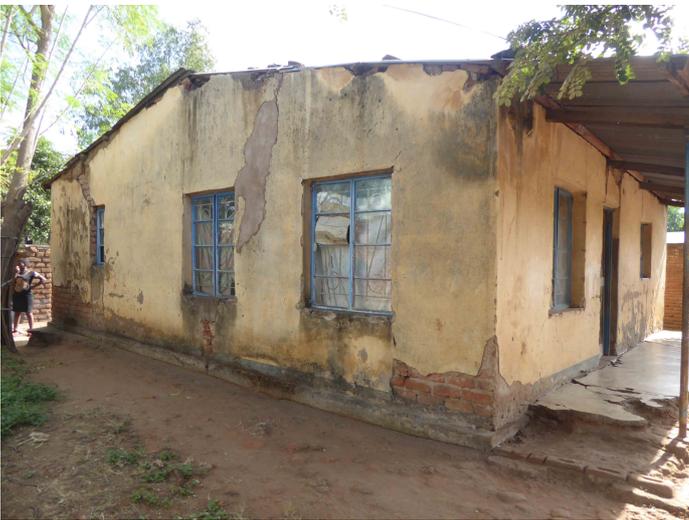
Figure 50. High seismic vulnerability of informal houses is given by low maintenance, and existing damage due to structural deficiencies.

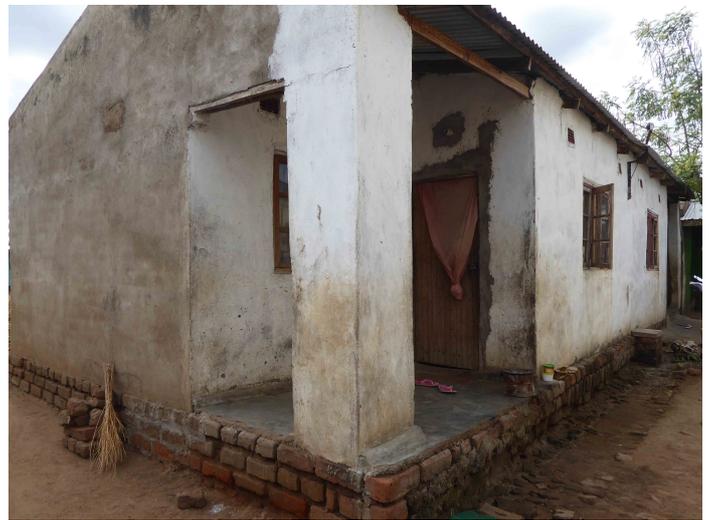
Figure 51. Presence of small re-corners do not affect substantially the seismic vulnerability of the informal houses.

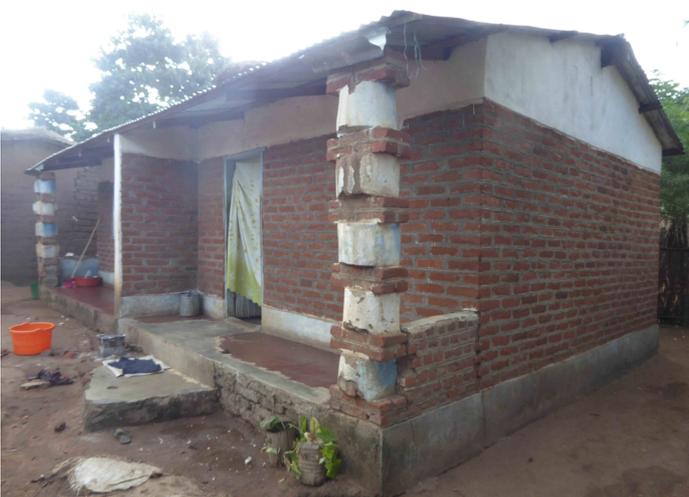
Figure 52. Columns of portico do

not impact on the seismic vulnerability of the informal houses, as they are built as a single degree of freedom detached from the main structures.

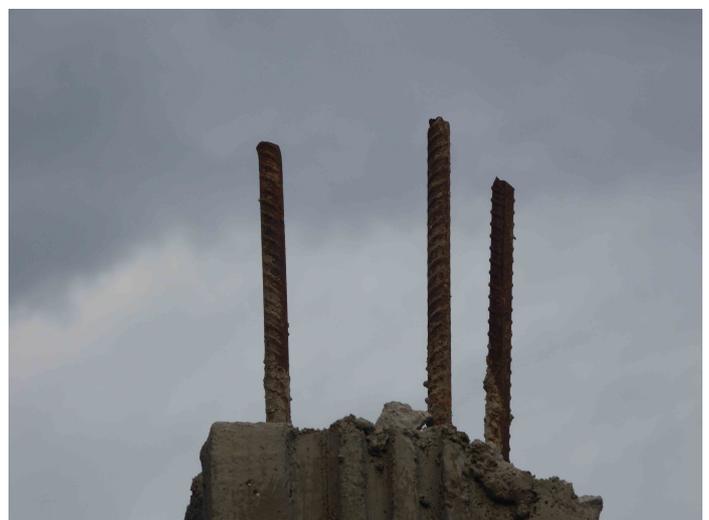
Figure 53. Columns of portico are

made of reinforced concrete to support canopy extended from the roof structure.

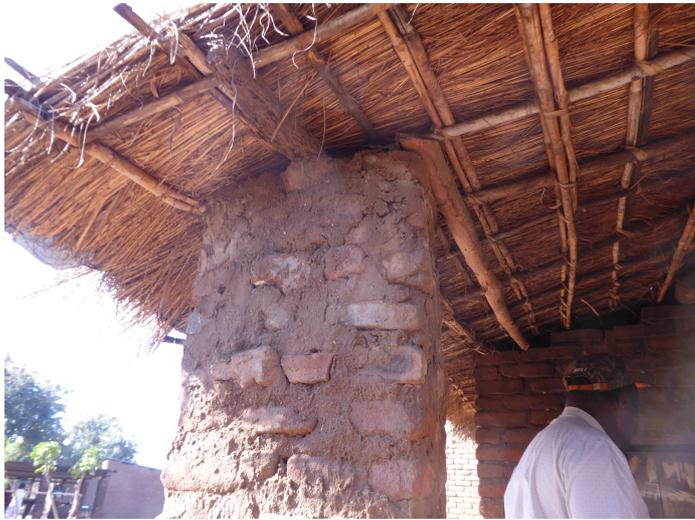
Figure 54. Columns of portico are made of bricks to support canopy extended from the roof structure

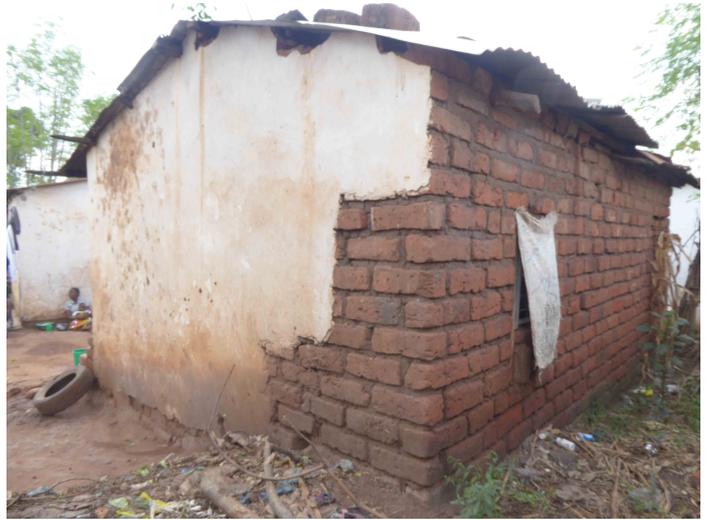
Figure 55. Seismic vulnerability - Class A: house with single skin walls made of local bricks and mud mortar. Roof is a flexible system made of timber purlins and rafters supporting corrugated metallic sheets, very damaged by weathering and deformed by la

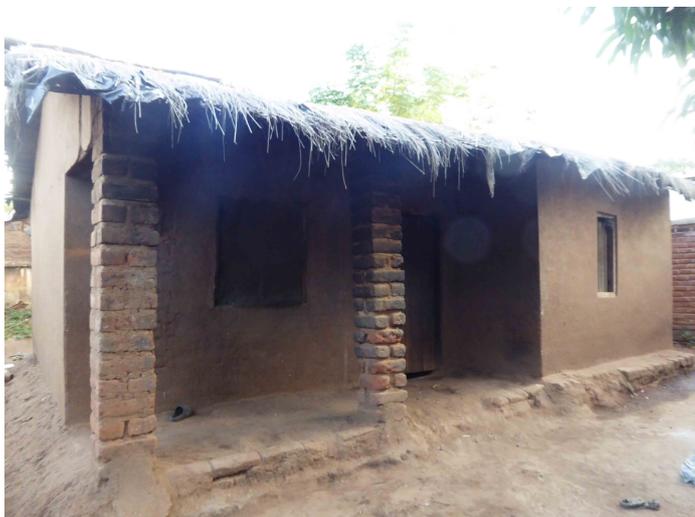
Figure 56. Seismic vulnerability - Class B: house with single skin walls made of local bricks and mud mortar. Roof is a flexible system made of timber purlins and rafters supporting thatch. The roof sits directly on the walls. No resting elements are in

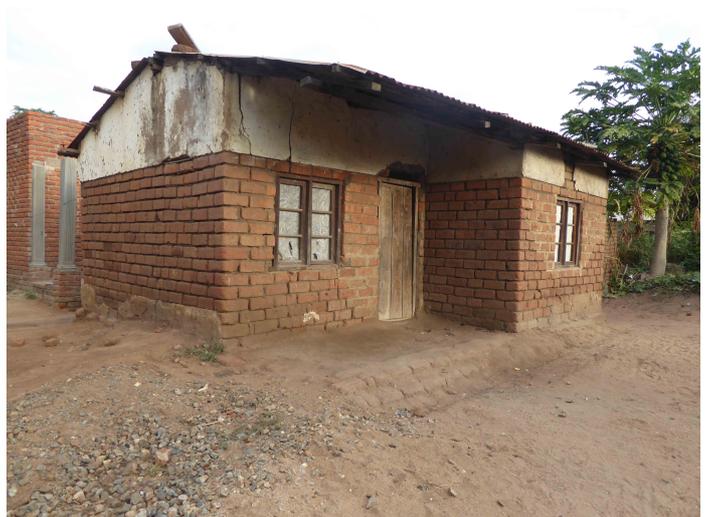
Figure 57. Seismic vulnerability - Class B: house with single skin walls made of local bricks and mud mortar. Roof is a flexible system made of timber purlins and rafters supporting corrugated metallic sheets. The roof sits directly on the walls, partiall

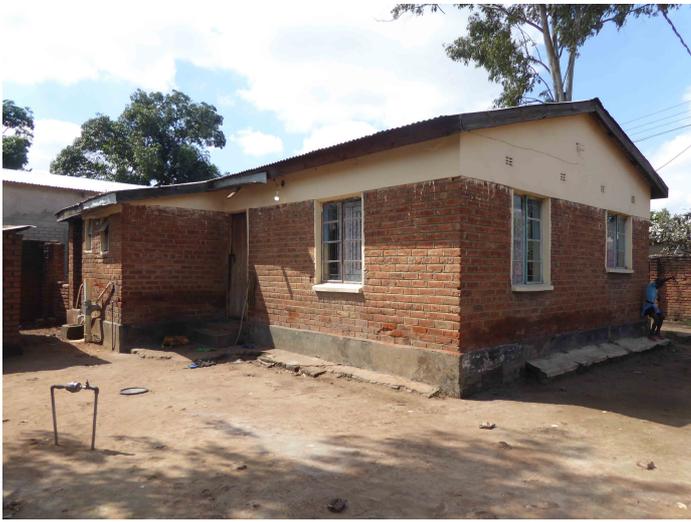
Figure 58. Seismic vulnerability - Class B: informal house with double skin walls made of local bricks and mud mortar. Roof is a flexible system made of timber purlins and rafters supporting corrugated metallic sheets. Rafters/purlins are nailed to wall p

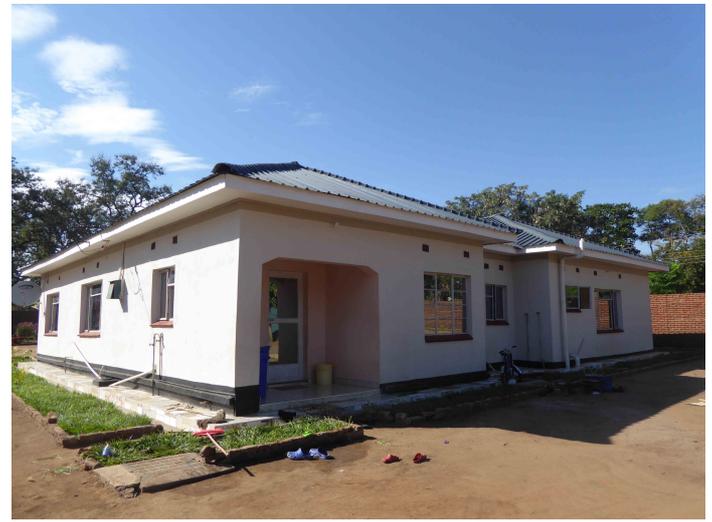
Figure 59. Seismic vulnerability - Class C: house with double skin walls made of local bricks and mud mortar. Roof is a flexible system made of timber purlins and rafters supporting corrugated metallic sheets. Rafters/purlins are nailed to wall plates fix
