World Housing Encyclopedia

HOUSING REPORT

Unreinforced brick masonry building with reinforced concrete roof slab

Report#	21
Last Updated	
Country	India
Author(s)	Ravi Sinha, Svetlana Brzev,
Reviewers	Svetlana N. Brzev,

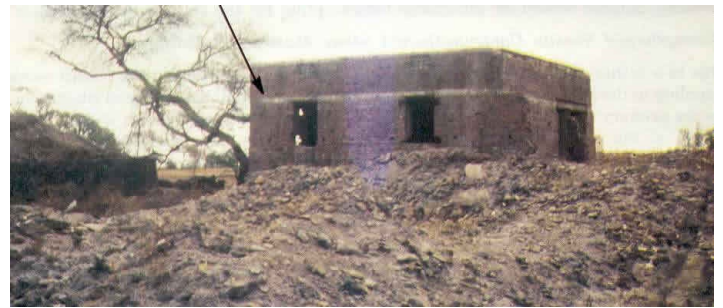
Key Seismic Resilient Features - RC Lintel Band and Good Quality Construction; note example of a building that sustained the effects of the 1993 Killari earthquake (M6.4) without damage although located very close to the epicentre

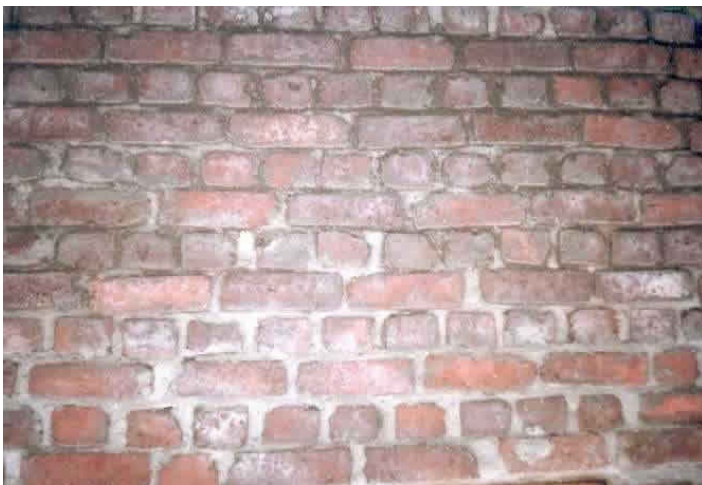
Construction Deficiency - Excessively Thick Mortar Bedding Joints

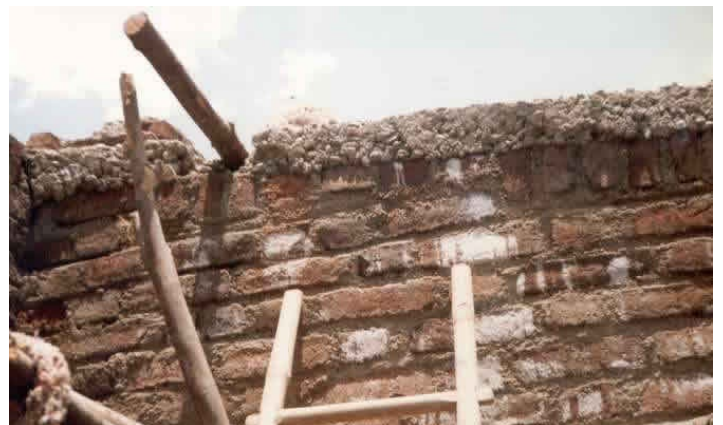
Construction Deficiency - Discontinuous RC Lintel Band (Bond Beam)

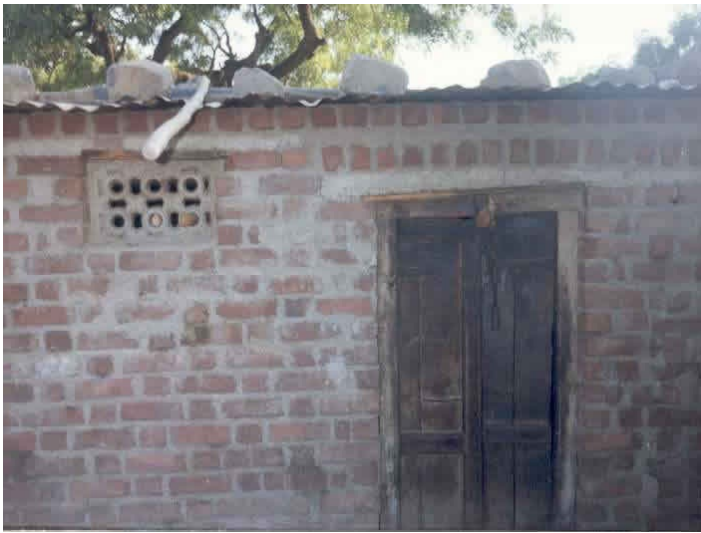
Construction Deficiency - Discontinuous RC Lintel Band

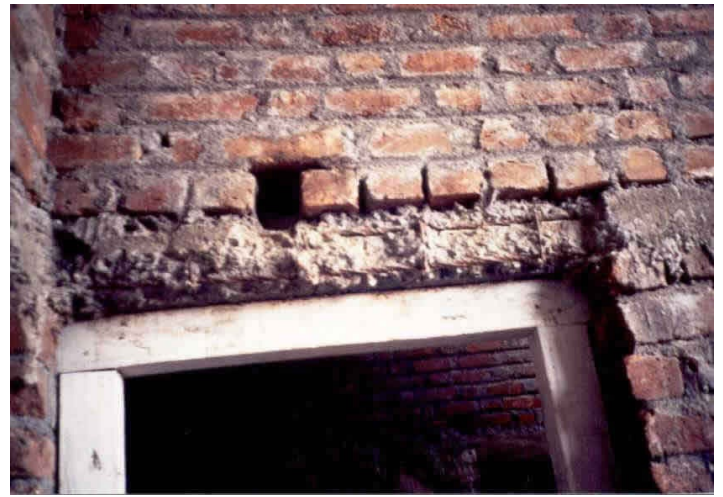
Construction Deficiency - Exposed Steel Reinforcement in RC Lintel Band Construction

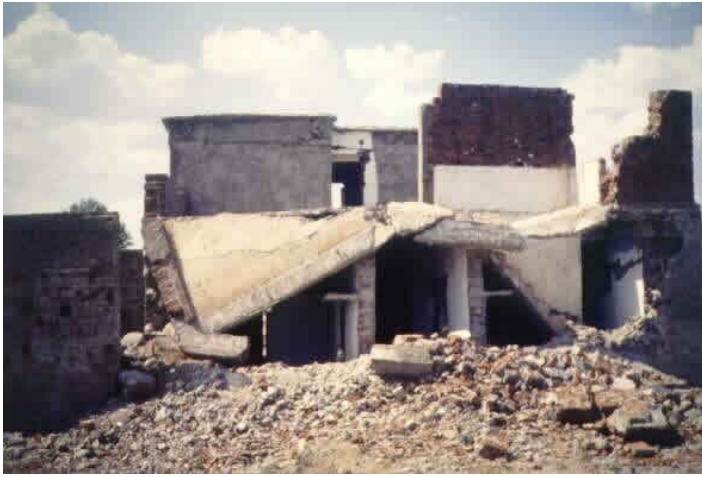
Typical Earthquake Damage - Roof Collapse Caused by the Wall Collapse (1993 Killari Earthquake)

Building construction of this type (without seismic provisions) suffered significant damage during Koyna (1967) and Killari (1993) earthquakes. Some damage was also observed during Jabalpur (1997) earthquake. The main damage patterns consisted of: shear cracks in walls, mainly starting from corners of openings; partial out of plane collapse of walls; partial caving-in of roofs due to collapse of supporting walls, and shifting of roof from wall due to torsional motion of roof slab. This construction has experienced moderate to very heavy damage in the 2001 Bhuj earthquake (M 7.6). In the epicenter region, several buildings of this type suffered total collapse of the walls resulting in the death and injury to a large number of people. The overall building performance was dependent on the type of roof system: buildings with lightweight roof suffered relatively less damage while buildings with RC roofs suffered much greater damage (Source: IIT Powai 2001). Importance and effectiveness of seismic provisions was confirmed both in the 1993 Killari earthquake and the 2001 Bhuj earthquake. A building with RC lintel band (located in the Killari village only few kilometers away from the epicenter) shown on Figure 9 sustained the earthquake effects with a minor damage while large majority of other buildings in the same village collapsed, causing over 1,400 deaths. Similarly, unreinforced masonry buildings with RC bands sustained the effects of the 2001 Bhuj earthquake with moderate damage while the neighbouring buildings of similar construction without seismic provisions collapsed (see Figure 23).

Wall: - Shear cracks in the walls, mainly starting from corners of openings. -Partial or complete out-of-plane wall collapse due to the lack of wall-roof anchorage and large wall slenderness ratio
Roof and floors: - Partial caving-in of roof due to collapse of supporting walls -Horizontal crack at the wall-roof connection - Shifting of roof from the wall due to torsional motion of roof slab.

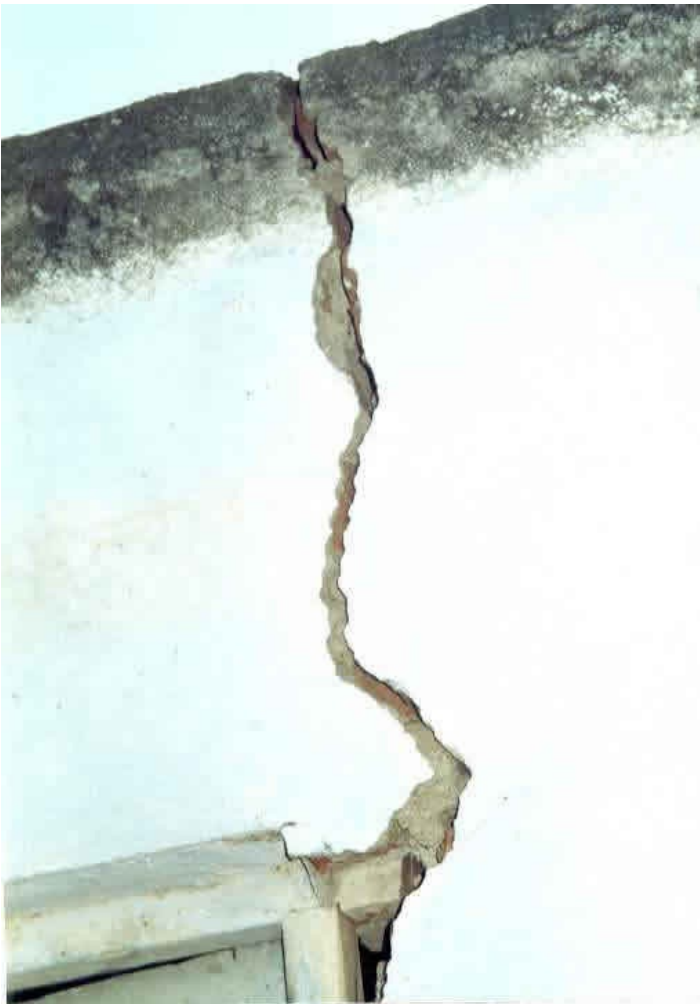
Typical Earthquake Damage - Wall Cracking above the Door Opening (1993 Killari Earthquake)

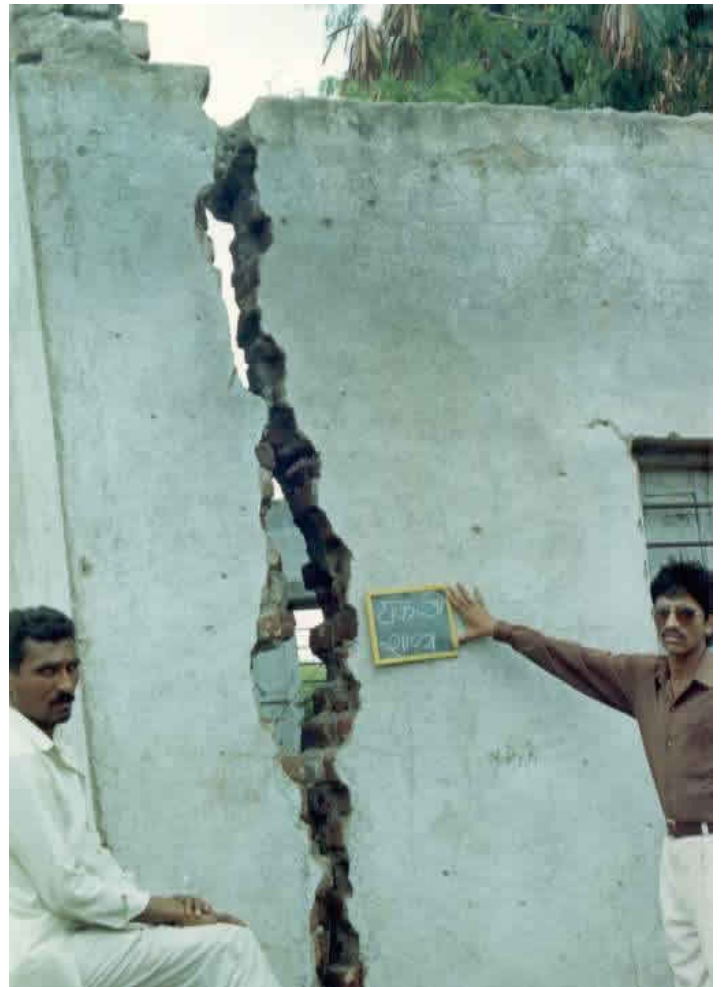
Typical Earthquake Damage - Wall Corner Failure (1993 Killari Earthquake)

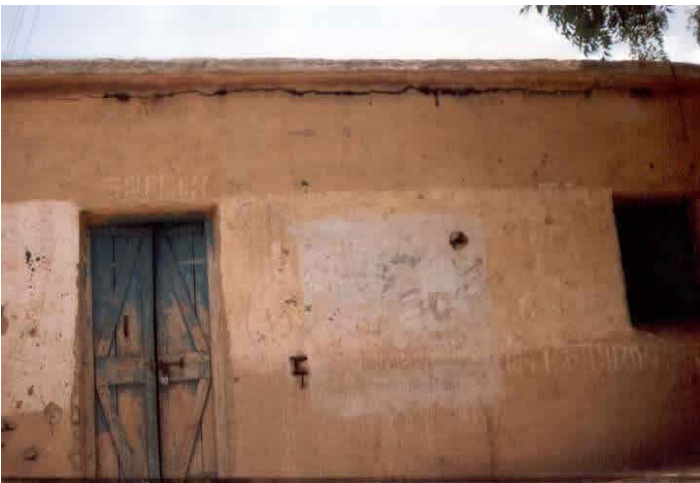
Typical Earthquake Damage - Sliding Failure of Roof-Wall Connection Due to the Absence of Wall Reinforcement (1993 Killari Earthquake)

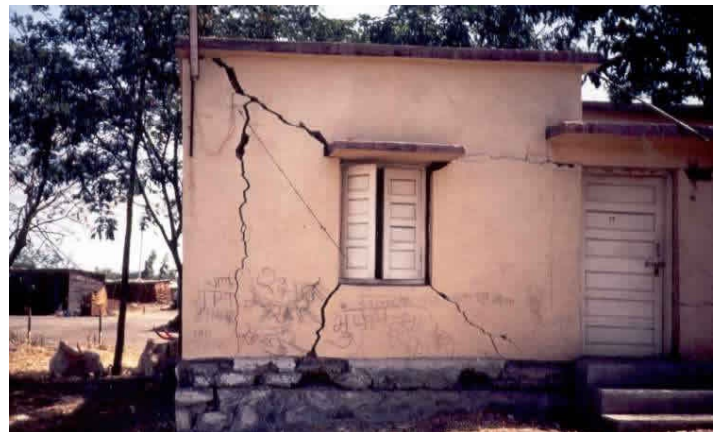
Typical Earthquake Damage: In-Plane Wall Cracking (1993 Killari Earthquake)

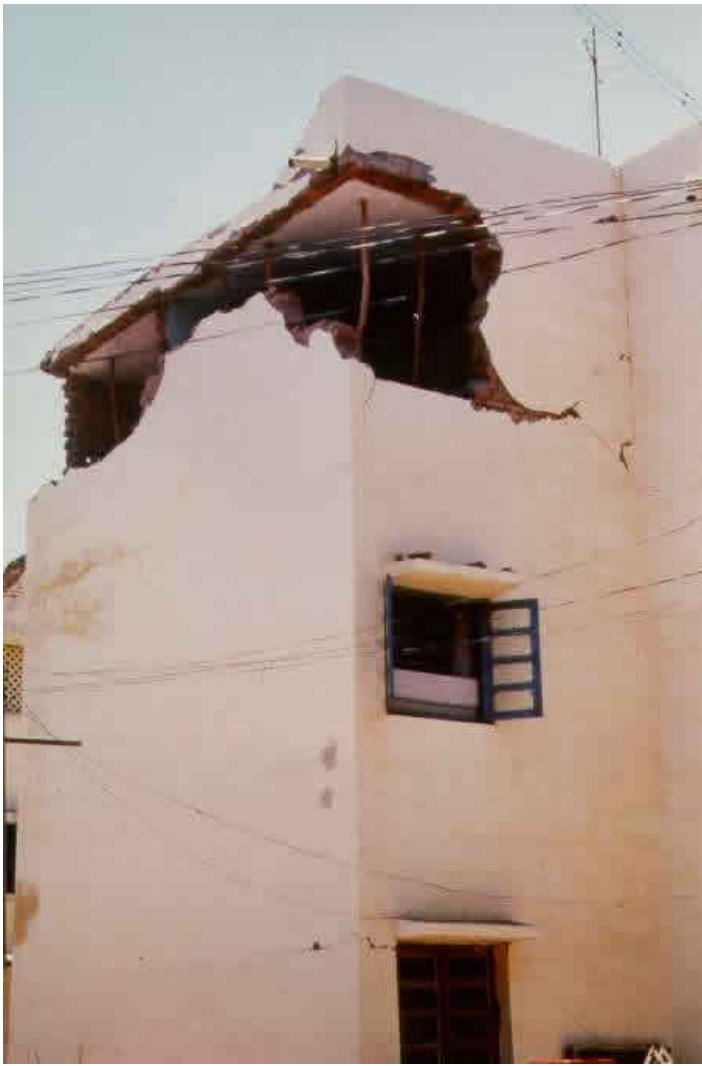
Partial Building Collapse in the 1997 Jabalpur Earthquake

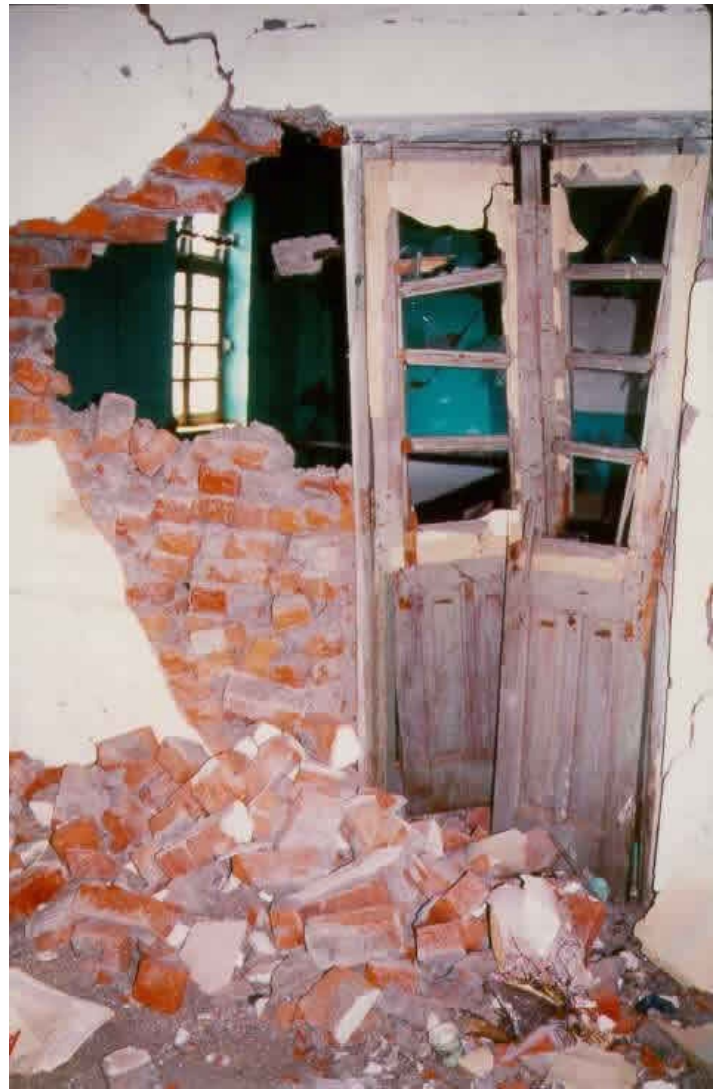
Failure of Brick Masonry Walls in the 1997 Jabalpur Earthquake

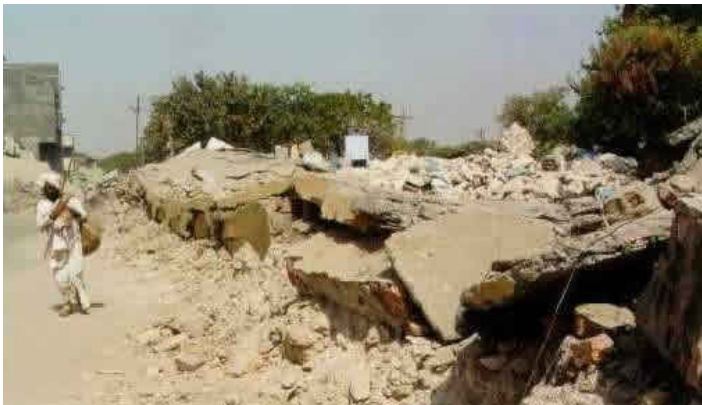
***Collapse of Brick Masonry Buildings in the 2001 Bhuj Earthquake
(Source: IIT Powai, 2001)***

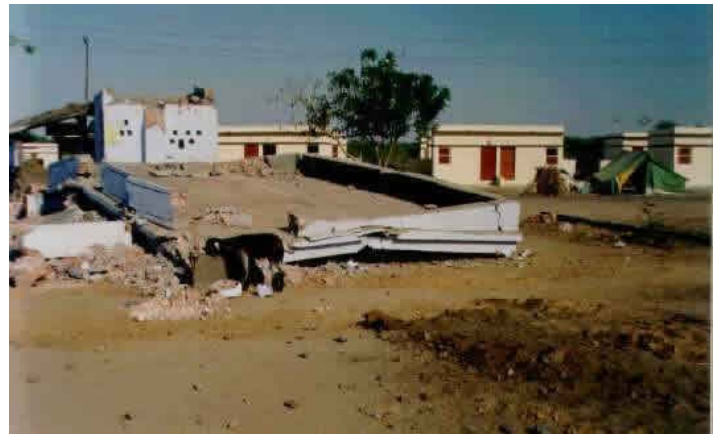
***View of a Collapsed traditional brick masonry building in cement mortar (foreground) and masonry building with lintel bands which sustained only a moderate damage in the 2001 Bhuj earthquake
(Source: IIT Powai, 2001)***

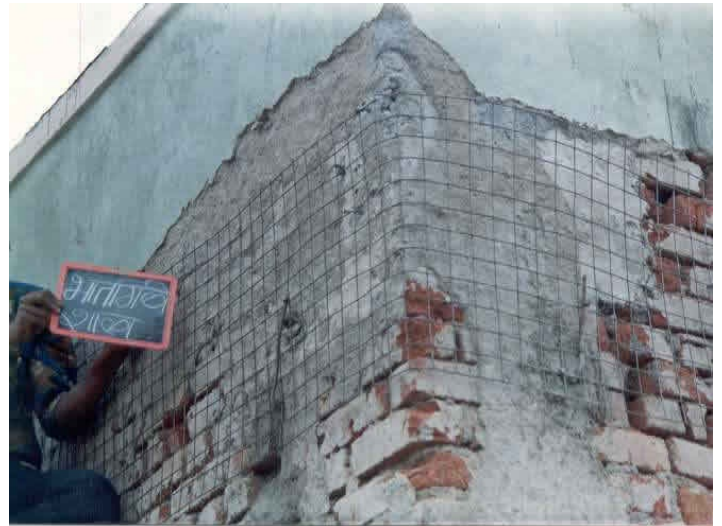
Seismic Strengthening Techniques - A Summary

Seismic Strengthening Techniques - Lintel Bandage

Structural Deficiency	Seismic Strengthening
Lack of integrity (box-type action)	Installation of seismic belt (bandage) at the lintel level; it consists of welded wire mesh installed above the lintel level and anchored to the wall. The mesh is covered with a thin cement plaster overlay (see Figure 25)
Cracks in the walls	In case of small cracks, pressure injection of epoxy grout; in case of large cracks, filling the gaps with cement grout and jacketing with reinforced cement overlay. (Source: IAEE 1986), see Figure 31.
Inadequate wall resistance (shear and tensile)	Reinforced concrete jacketing. Difficult to find skilled labor and materials for welded wire mesh in rural areas
Flexible floor/roof diaphragm (Corrugated metal sheets/timber)	Installation of RC roof band (bond beam). Provision of roof band is expected to enhance the overall integrity and improve torsional resistance of building
Cracking/ damage of wall corners (due to improper interlocking of cross walls)	Corner strengthening of wall corners - installation of welded wire mesh anchored to the walls with steel dowels and covered with a thin cement plaster overlay (GOM 1998), see Figure 26.

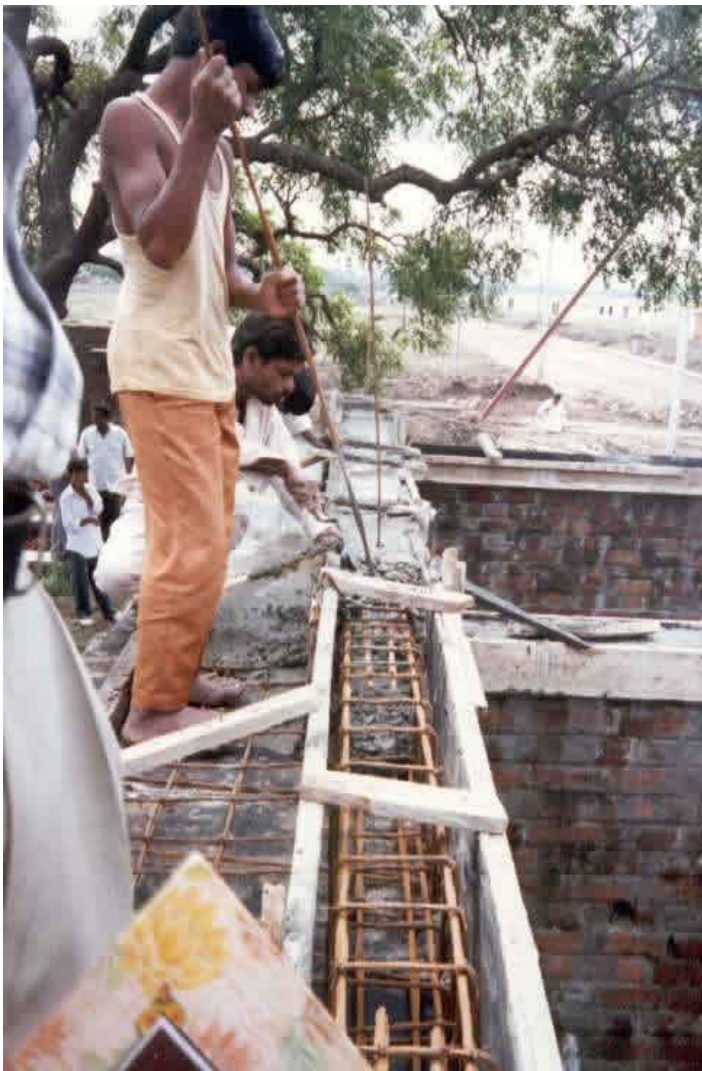
Construction of RC Lintel Band

Strengthening of New Construction: Roof: - Reinforced concrete roof band; provision of roof band results in an improved overall integrity and torsional resistance of the building. Wall: -RCC lintel band; very effective, how ever skilled labour and materials may not be available, see Figures 27, 28 and 29. -Improved quality of masonry (bricks and mortar) use of better quality bricks will drastically improve the wall seismic resistance; use or richer cement/sand mortar will improve wall shear resistance. -Provision of vertical reinforcement at wall corners and intersections, see Figure 30 (Source: IAEE 1986)

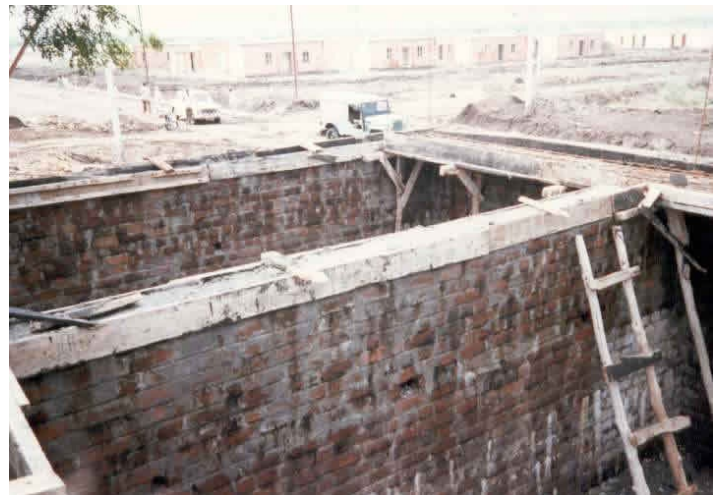
Construction of RC Lintel Band - Pouring of Concrete Completed

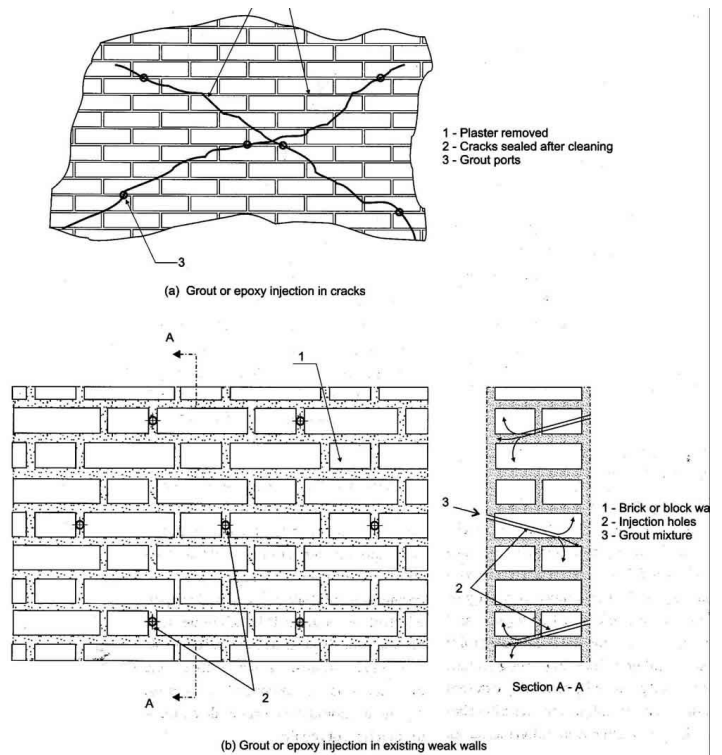
Repair of Wall Cracks by Epoxy Injection (Source: IAE 1986)
