World Housing Encyclopedia

HOUSING REPORT

Unreinforced brick masonry walls with pitched clay tile roof

Report#	22
Last Updated	
Country	India
Author(s)	Amit Kumar,
Reviewers	Ravi Sinha ,

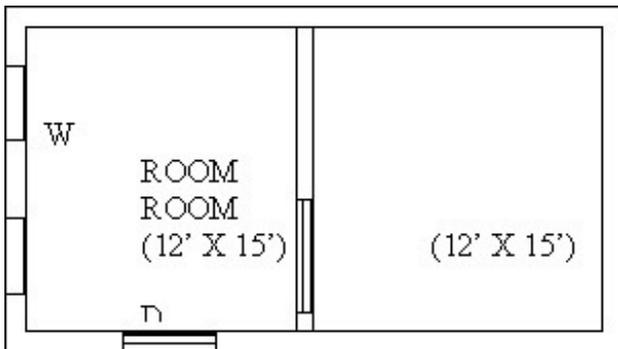
Plan of a Typical Building

When separated from adjacent buildings, the typical distance from a neighboring building is 3 meters. Typical Plan Dimension: The actual length and width of these building are widely varying depending on the requirements and economic condition of the owners. The size of the buildings may vary from 3 X 4 m to 5 X 15 m Typical Span: It depends upon the size of the building.

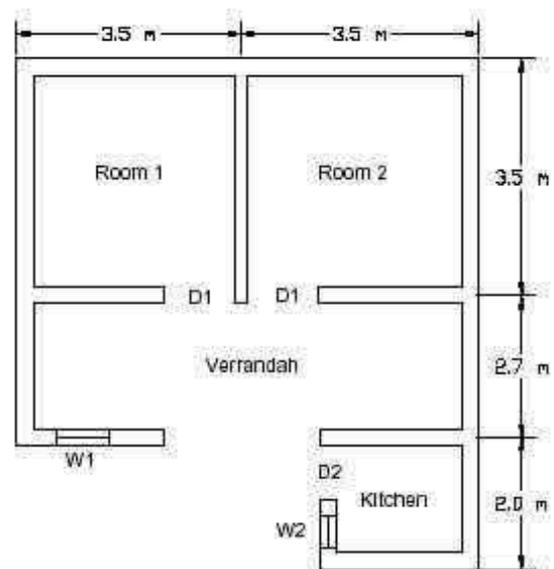
Thickness of Exterior wall = 0.3 m - 0.35 m

Thickness of Interior wall = 0.23 m

Typical Plan of a Single-story Residential Building, Kuchh and Rajkot Districts, Gujarat (Source: IIT Powai 2001)

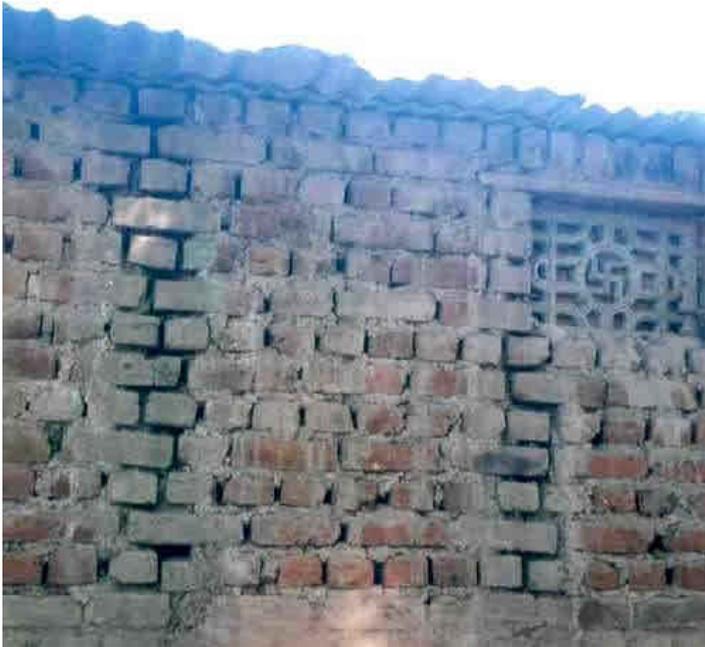
Critical Structural Details: Elevation of Brick Masonry Wall in Mud Mortar (Source: Svetlana Brzev)

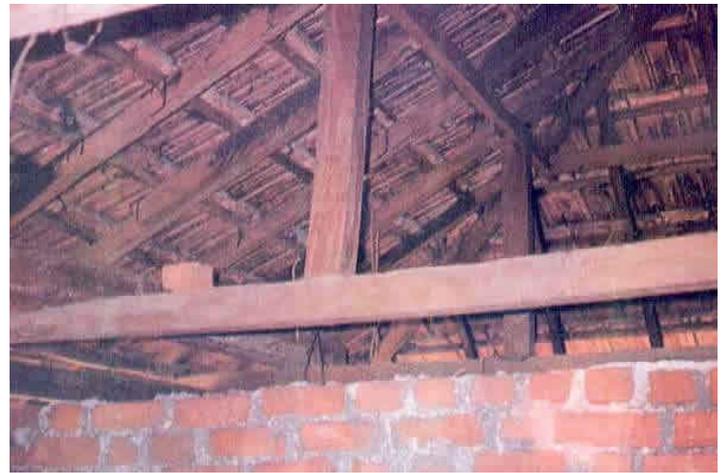
Critical Structural Details: Good Quality Roof Construction (Source: GOM 1998)

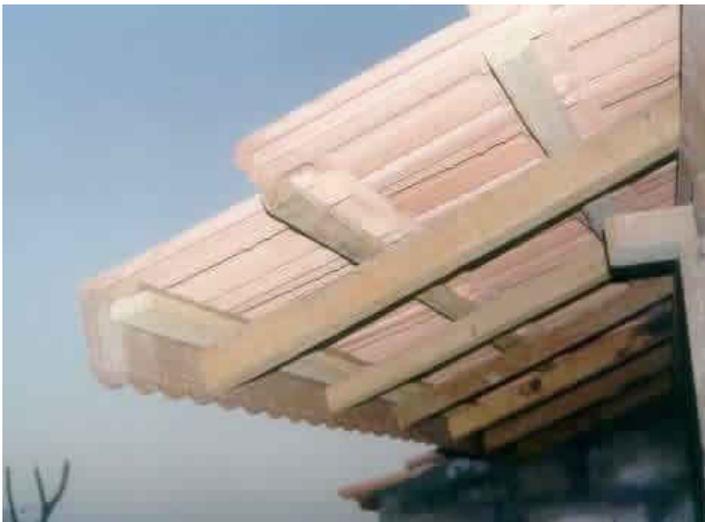
Critical Structural Details: Mangalore Tile Roof Construction (Source: Sudhir K. Jain, IIT Kanpur)

Generally the roofing elements are placed at the top of the wall without proper connection to the wall. The roofing elements such as purlins, rafters and ties rods are also not properly interconnected.

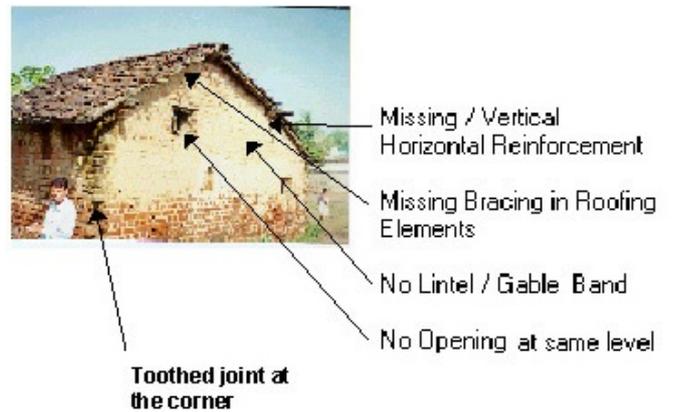
An Illustration of Key Seismic Deficiencies

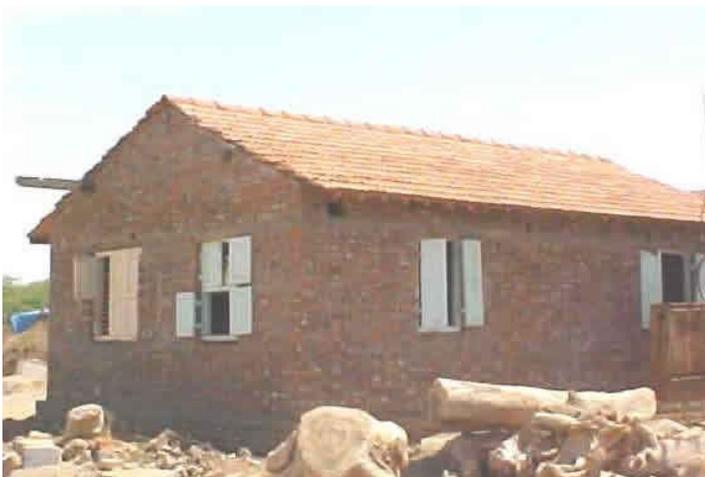
Key Seismic Resilient Features: RC Lintel Band and Good Quality Brick Masonry Construction (Source: Sudhir K. Jain, IIT Kanpur)

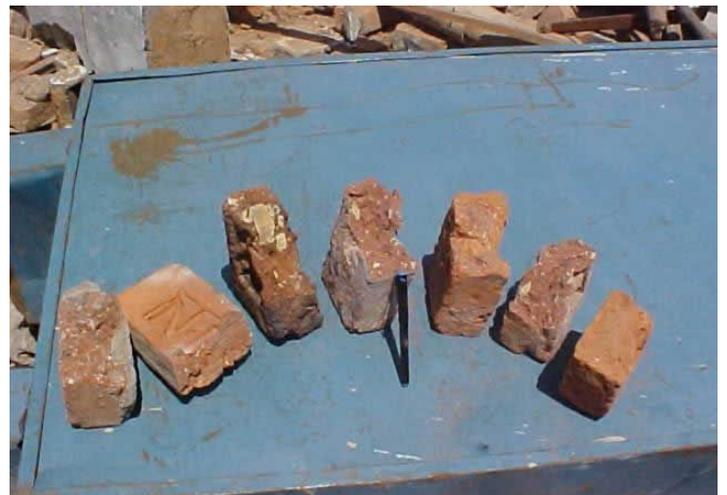
Construction Deficiency: Poor Quality Bricks (Source: Sudhir K. Jain, IIT Kanpur)

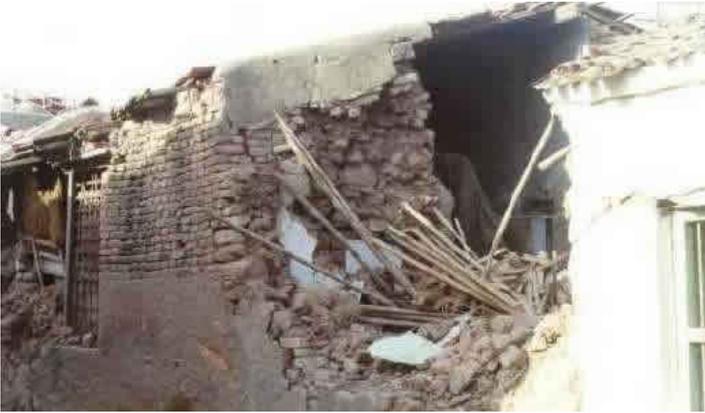
Typical Earthquake Damage - Wall Collapse Due to Poor Quality Brick Construction and Poor Inadequate Wall Connections in the 2001 Bhuj Earthquake (Source: IIT Powai 2001)

suffered total collapse of the walls resulting in the death and injury to large number of people. In masonry buildings with pitched roof, the roof tiles performed very poorly. In most cases, the roof tiles were damaged and in several instances, the tiles slid off the roof. Most of the dwellings have experienced failure of roofing tiles inside the house and rafters supporting the roof truss have also failed in some cases (Source: IIT Powai 2001).

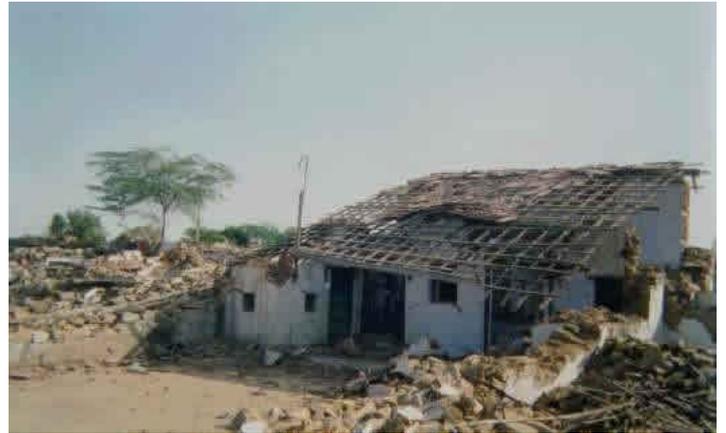
Failure of a Residential Building, Chobri Village near Bhachau, 2001 Bhuj Earthquake (Source: IIT Powai 2001)

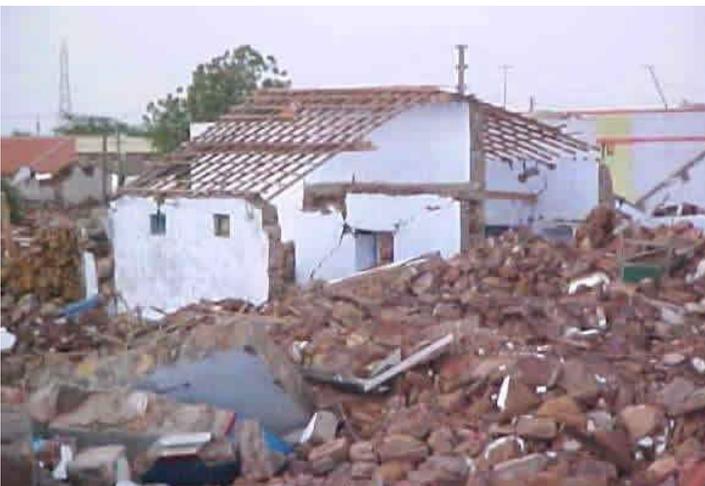
Typical Earthquake Damage:

Collapse of Roof and Walls of a Brick Lime Mortar House in the 2001 Bhuj Earthquake (Source: Sudhir K. Jain, IIT Kanpur)

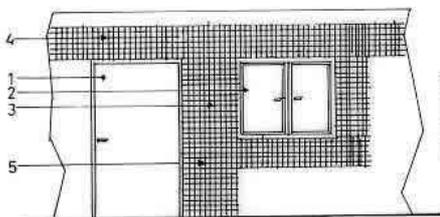
Figure 7
1. Door
2. Windows
3. Mesh of Ferro-cement
4. Seismic Belt
5. Overlap of mesh

Structural Deficiency	Seismic Strengthening
Lack of wall integrity	Installation of seismic belt
Inadequate roof connections	Bracing of roofing elements
(New Construction) Walls	- Use of rich cement/sand mortar - Provision of RC lintel band - Proper toothing joint at wall intersections
(New Construction) Roof	#NAME?

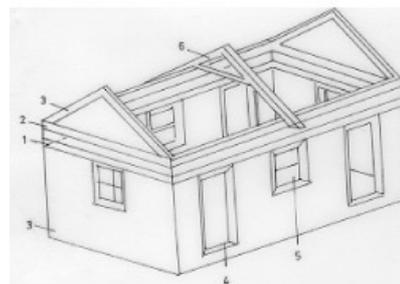
Figure 8 : Overall arrangement of seismic belts (Roofing removed)
1. Seismic belt above opening
2. Seismic belt below roof eaves level
3. Seismic belt on gable wall
4. Door
5. Window
6. Rafters

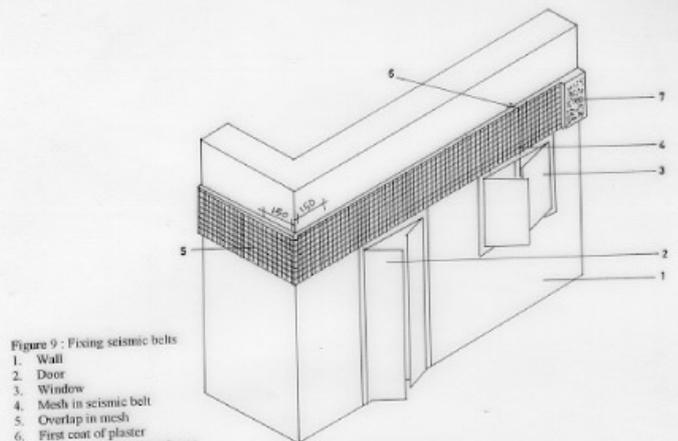
Figure 9 : Fixing seismic belts
1. Wall
2. Door
3. Window
4. Mesh in seismic belt
5. Overlap in mesh
6. First coat of plaster
7. External plaster, second coat
