World Housing Encyclopedia

HOUSING REPORT

Rural mud house with pitched roof

Report#	23
Last Updated	
Country	India
Author(s)	Amit Kumar,
Reviewers	Ravi Sinha,

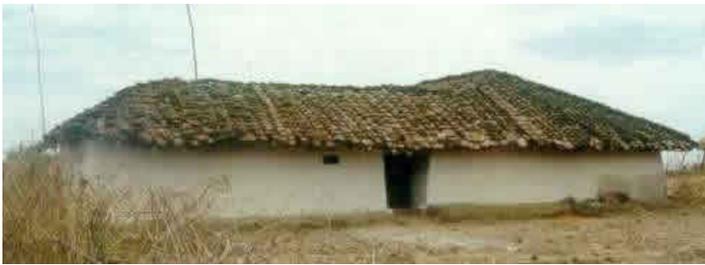
Typical Building

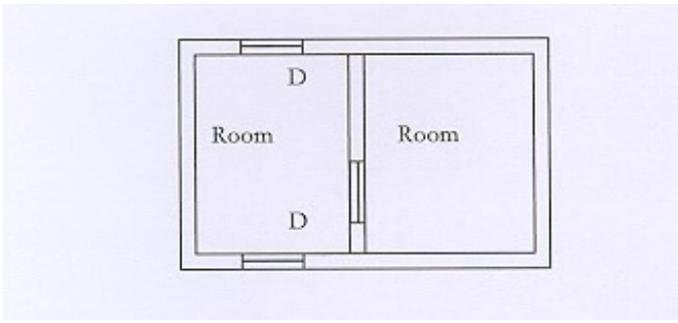
Plan of a Typical Building

Plan Shape	Rectangular, solid
Additional comments on plan shape	It is difficult to state the actual length and width of a typical building. The length and width varies according to the requirements. The ratio of such length and width can be 1#:1, 2:1 or 2 #:1. Typical Span: The building size and typical span depends on the number of occupants. Generally wooden posts are provided at the distance of 2 - 2.5 m centre-to-centre longitudinally and transversely.
Typical plan length (meters)	8
Typical plan width (meters)	4
Typical story height (meters)	3.5
Type of Structural System	Masonry: Earthen/Mud/Adobe/Rammed Earth Walls: Mud walls
Additional comments on structural system	Lateral Load Resisting System: The mud walls take the load of the roofing and wall elements. Sometimes the walls are provided with wooden posts at the corners and at intermediate locations. These are generally provided at spacing not exceeding 2 m center to center. However, the wooden posts and walls are not structurally integrated, and the loads are partially shared by walls and partially taken by frame, with each behaving independently of the other. Gravity Load-Bearing System: The roof loads are directly supported by the walls/frames whose loads are supported by the wall/frame foundations.

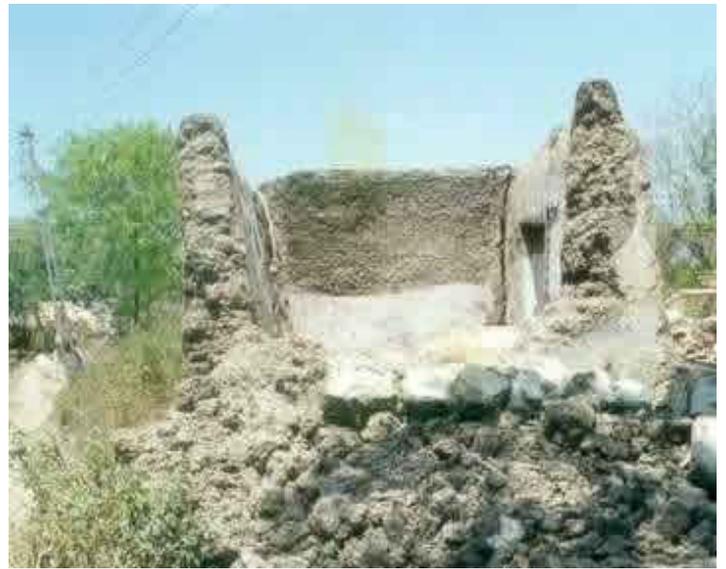
Critical Structural Details: Wall Section (Source: Sudhir K. Jain)

The building is constructed with the help of masons. Generally no technical and engineering input is used during the construction process. Foundation: Trench of about 2.5 feet is excavated along the walls. Stone blocks are rammed with mud into the trench to form consolidated foundation. Timber posts, if used, are erected during the ramming of stones. The load-bearing wall is erected above the ground level. The stone walls are sometimes constructed up to 2 feet above ground level, and the mud wall is extended above this level. Wall construction: The wall is made up of mixed mud with wheat husks and water (mud-polymer composite). Generally the wheat husk is mixed and kept for about a week to give it a homogenous texture. The mud mortar is placed and rammed to make it compacted. The wall is erected up to about 2.5 feet in each lift and allowed to dry for one or two days before the next lift. Roofing: Roof truss is either made up of bamboo, wood or built up steel section. The spacing between purlins and rafters are generally not regular. Generally old conventional typical house is covered with heavy clay tiles. The cladding material may not be firmly anchored to the trusses and wall. Openings : Generally mud wall buildings are provided with very few large openings. The construction of this type of housing takes place incrementally over time. Typically, the building is originally not designed for its final constructed size. The building byelaws in rural areas are not yet enforced. It requires proper enforcement to the rural and urban areas.

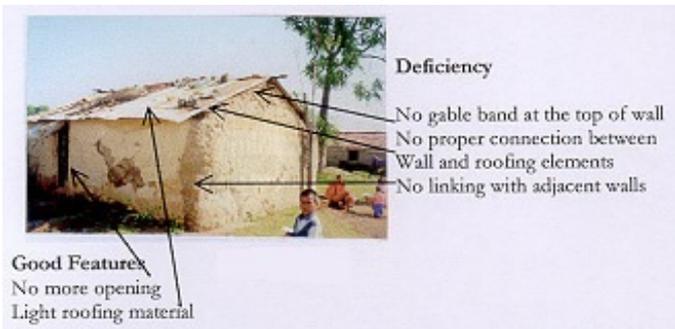
An Illustration of Key Seismic Features

Additional comments on structural and architectural features for seismic resistance	
Vertical irregularities typically found in this construction type	Other
Horizontal irregularities typically found in this construction type	Other
Seismic deficiency in walls	Very poor lateral resistance No lintel band is present Opening proportion is not proper The distance between corner and opening is not according to IS code specifications.
Earthquake-resilient features in walls	Provision of wooden columns at regular interval.
Seismic deficiency in frames	No proper connection between column and beam.
Earthquake-resilient features in frame	Partially, it works as a frame structure.
Seismic deficiency in roof and floors	Roof: The roofing elements are not interconnected. The roofing truss is not fully anchored to the wall Poor maintenance makes the roof truss more vulnerable to damage Roof does not provide rigid-diaphragm action.

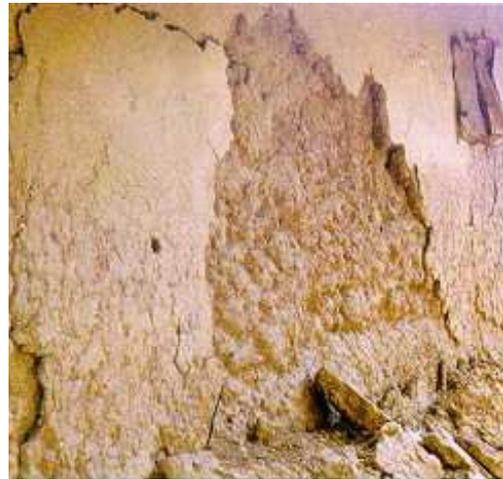
Typical Earthquake Damage

Damage patterns observed in past earthquakes for this construction type	Jabalpur earthquake of May 22, 1997 seriously affected the life and damaged properties in the epicentral area. It is estimated that about 33,000 buildings in the urban areas and 24,000 buildings in the rural areas were partially damaged or completely destroyed. A typical earthquake damage is shown on Figure 6 (Source: BMTPC Publication).
--	---

Partially or complete collapse of wall with failure. Damage observed at weaker sections i.e. joint of column and beam. Collapse of roofing

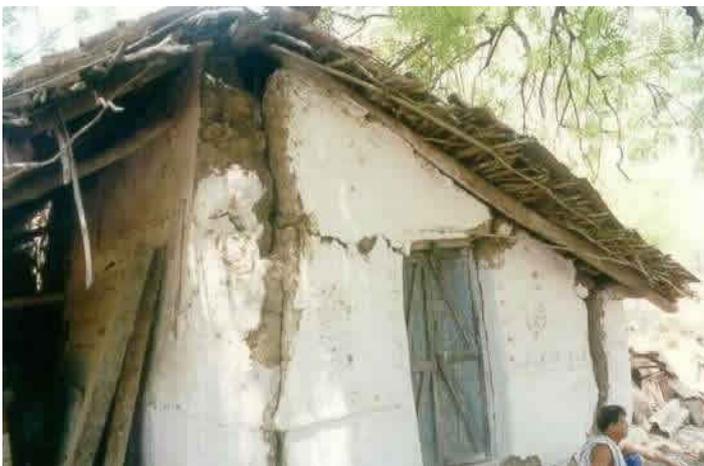
Typical Earthquake Damage - Cracking and Separation of Walls in the 1997 Jabalpur Earthquake (Source: Sudhir K. Jain, IIT Kanpur)

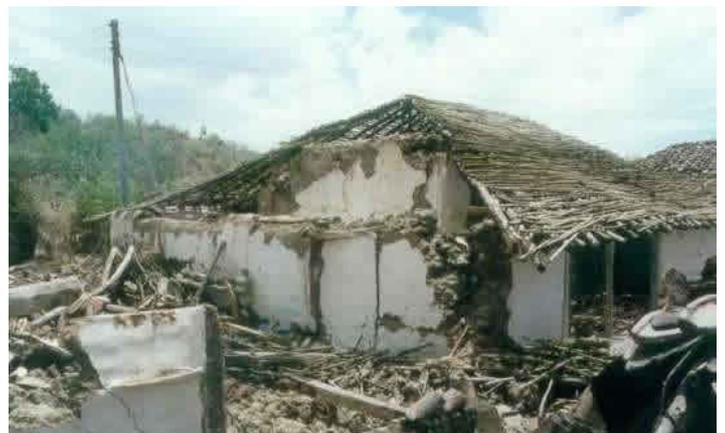
Typical Earthquake Damage - Collapse of roof in the 1997 Jabalpur Earthquake (Source: Sudhir K. Jain, IIT Kanpur)

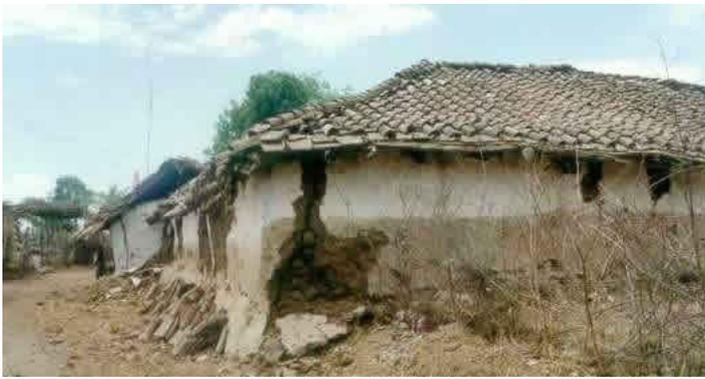
Typical Earthquake Damage - Cracking and Separation of Walls in the 1997 Jabalpur Earthquake (Source: Sudhir K. Jain, IIT Kanpur)

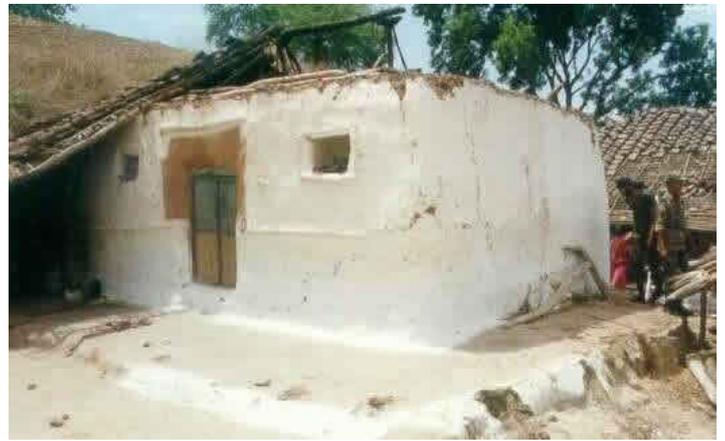
Typical Earthquake Damage - Cracking of Walls in the 1997 Jabalpur Earthquake (Source: Sudhir K. Jain, IIT Kanpur)

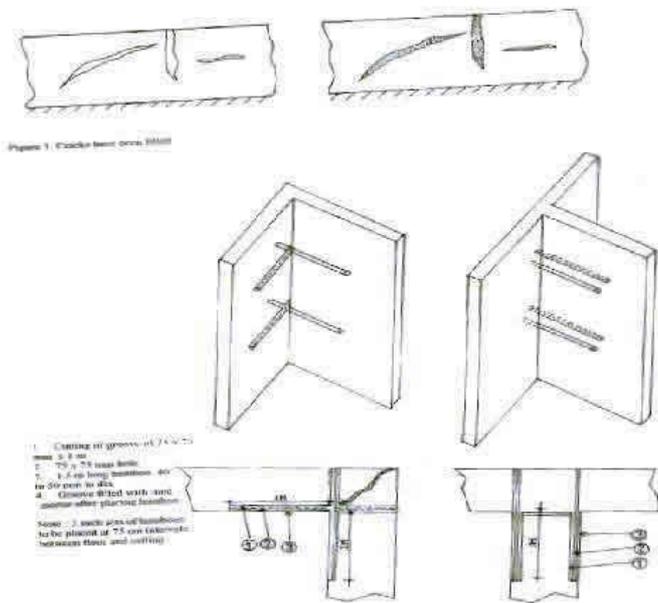
Strengthening measures suggested in IAEE Manual

Structural Deficiency	Seismic Strengthening
No connection between adjacent walls	Provision of wooden bracing at regular interval in walls
Poor connection between roofing elements	Strengthening of roofing elements through bracings Securely tying of rafters to roof truss after removal of all tiles and purlins at the roof level
Large Opening	Reducing the openings and provide additional strength to openings(Refer Figures 11 and 12)
Wall	Filling of cracks with good fibre-reinforced mortar; Stitching of corner cracks with bamboo ties at 75 cm c/c
New Construction	Wall Span:Provide additional support if span exceeds 5 m Planning: Place roof truss and rafters in a symmetric or regular arrangement Wall: Reduce height of wall to ensure height/thickness ratio less than 8; Provide bamboo seismic bands at lintel and roof level

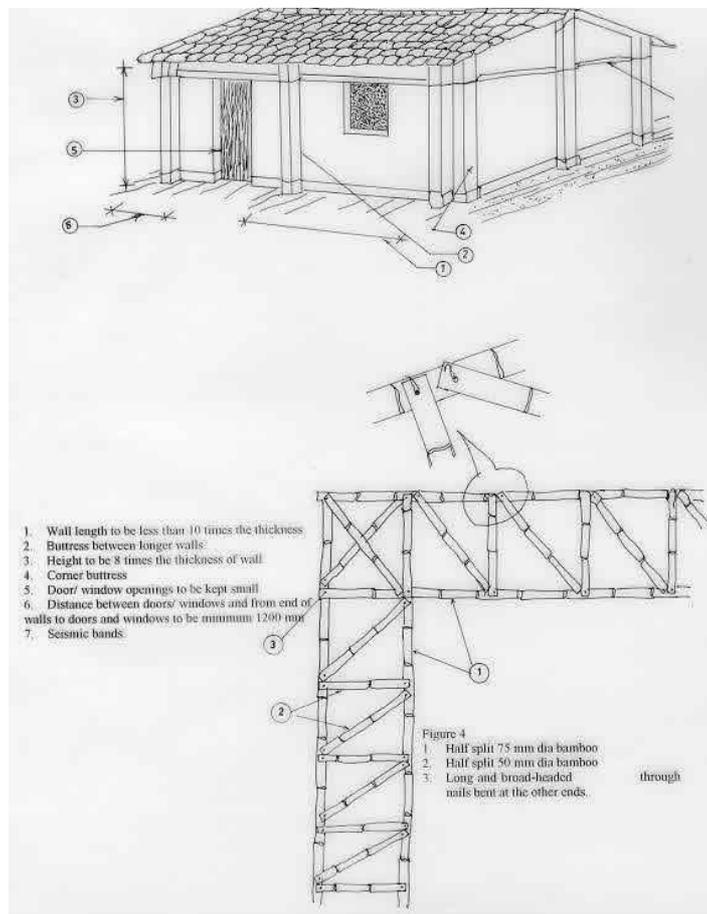
Strengthening measures suggested in IAEE Manual
