# World Housing Encyclopedia

## HOUSING REPORT

### **Semi-rigid steel frame with "Khorjinee" connections**

<b>Report#</b>	26
<b>Last Updated</b>	
<b>Country</b>	Islamic Republic of Iran
<b>Author(s)</b>	Behrokh Hosseini Hashemi, Mohsen Ghafory Ashtiany,
<b>Reviewers</b>	Farzad Naeim ,

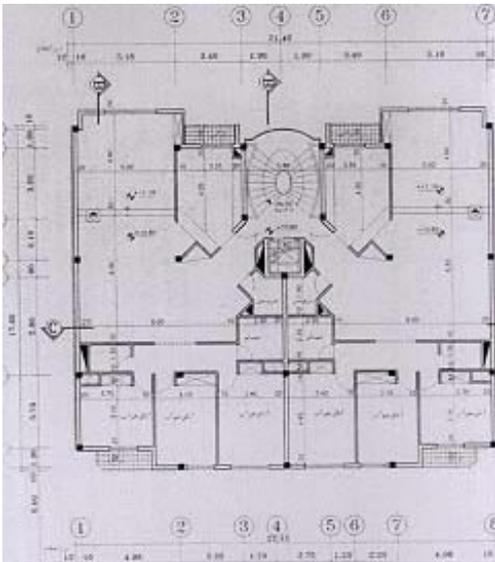
**Plan of a Typical Building**

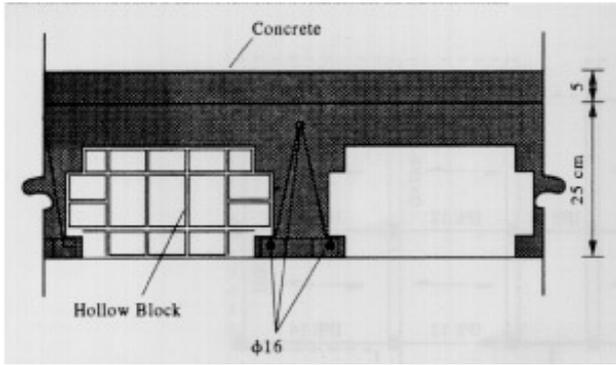
***A typical floor slab construction***

<b>Type of Floor System</b>	Other floor system
<b>Additional comments on floor system</b>	Concrete joists with infilled hollow blocks topped with concrete slab. The floor and roof are considered to be rigid diaphragm.
<b>Type of Roof System</b>	Roof system, other
<b>Additional comments on roof system</b>	Concrete joists with infilled hollow blocks topped with concrete slab. The floor and roof are considered to be rigid diaphragm.
<b>Additional comments section 2</b>	When separated from adjacent buildings, the typical distance from a neighboring building is several meters.

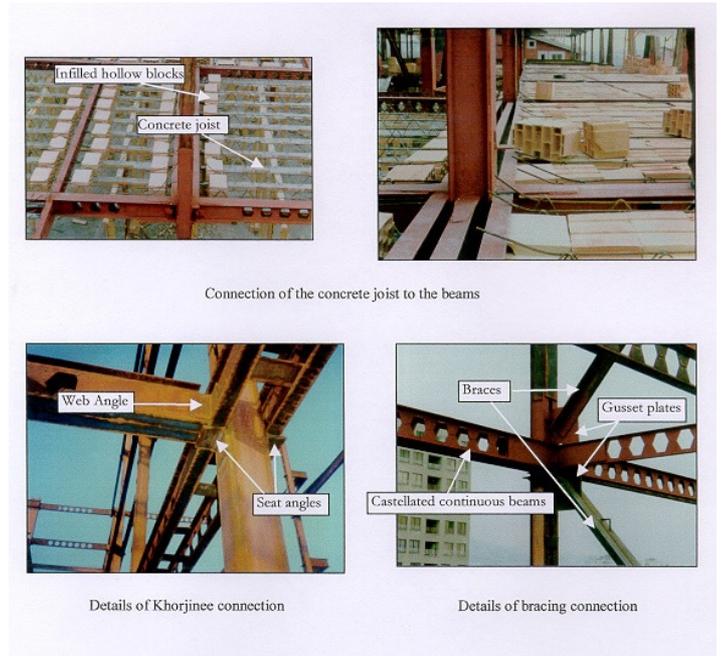
***Critical Structural Details***

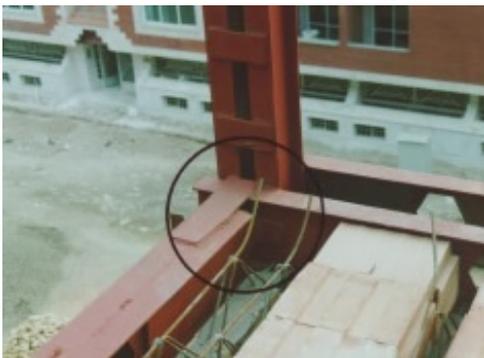
***A seismic deficiency: wrong connection detail***

The main problems are associated with the construction process. In most projects, designers do not provide any detail for the connections and this responsibility is left to experienced builders, who have no knowledge about the better performance of the connections in the case of earthquake happens.

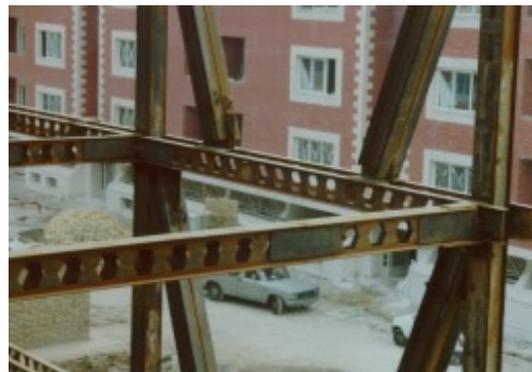
***Seismic deficiency-use of undefined bracing system***

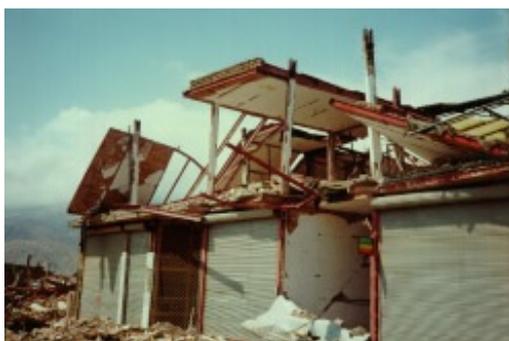
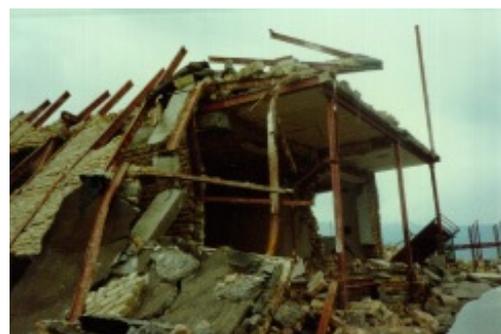
***Building damage in the 1990 Manjil earthquake-collapse caused by the connection failure***

<b>Damage patterns observed in past earthquakes for this construction type</b>	
<b>Additional comments on earthquake damage patterns</b>	Walls: Out of plane collapse, Classical X shear cracking. Frames: Buckling of the storey. Roof/Floor: Total/partial collapse. Connections: Excessive rotations, shear failure of the welds, unsitting.

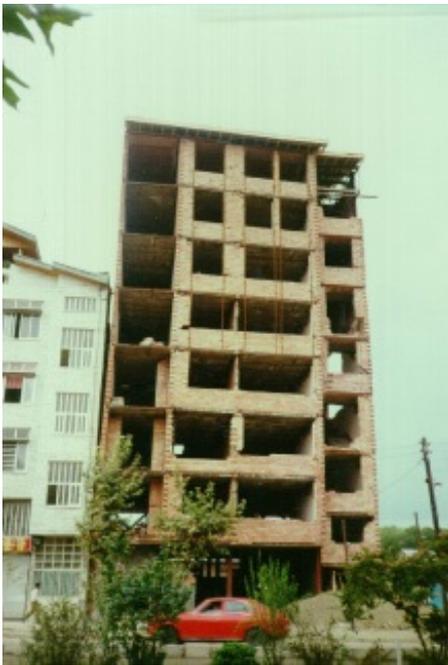
***Minor damage due to pounding between two adjacent buildings in the 1990 Manjil earthquake***

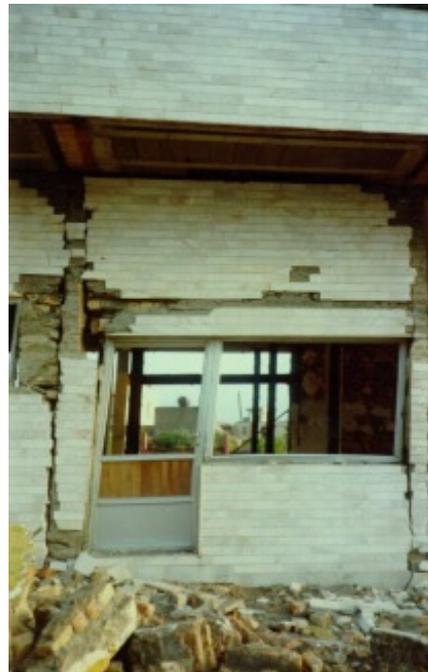
***Failure due to soft story behavior in the 1990 Manjil earthquake***

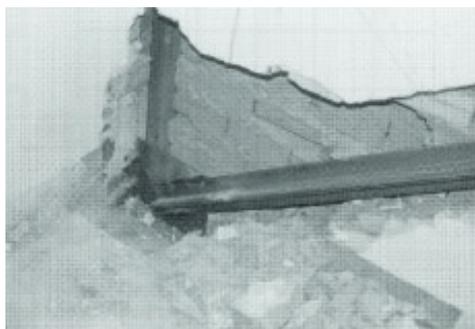
***Illustration of Seismic Strengthening Techniques-New Braces Added to the Main Frame***

<b>Structural Deficiency</b>	<b>Seismic Strengthening</b>
Steel frame	Add diagonal steel bracings as required (high cost/high effectiveness/simple construction)
Connections	Strengthening connections by adequate and proper welding (medium cost/medium effectiveness/simple construction)
Foundations	At the location of the new bracing, strengthening of foundation is essential (high cost/medium effectiveness/complex construction)
New Construction	Steel frame: Design steel frame for gravity load and steel bracing for lateral resistant system (medium cost/medium effectiveness) Connections: Provide proper details for connections (low cost/high effectiveness) Foundations: Proper design (low cost/high effectiveness)
<b>Additional comments on seismic strengthening</b>

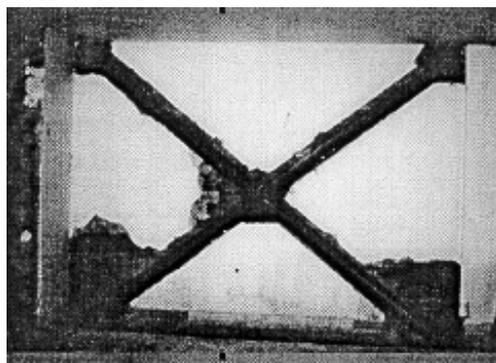
***Strengthening of the existing braces***

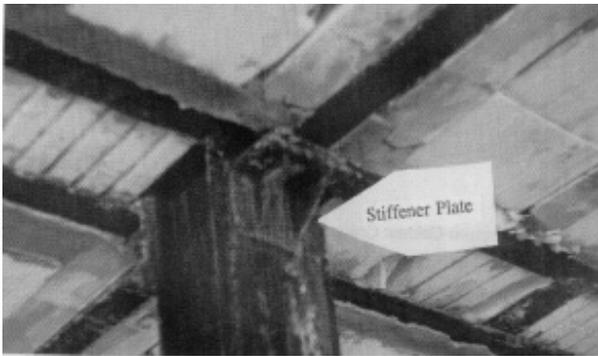
***Stiffener plates used for strengthening the connections***

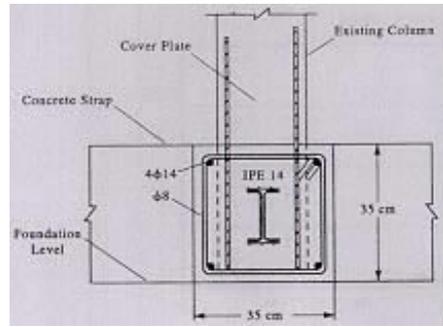
***Detail used to join footing together through steel tie beam***
