World Housing Encyclopedia

HOUSING REPORT

Confined Masonry Building with Concrete blocks, tie-columns and beams

Report#	27
Last Updated	
Country	Iran
Author(s)	Behrokh Hosseini Hashemi, Faramarz Alemi, Mohsen Ghafory Ashtiany,
Reviewers	Farzad Naeim,

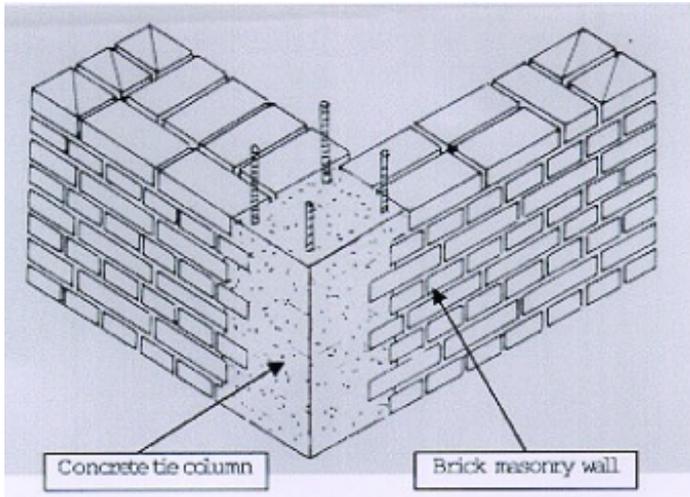
Critical Structural Details: Concrete tie column

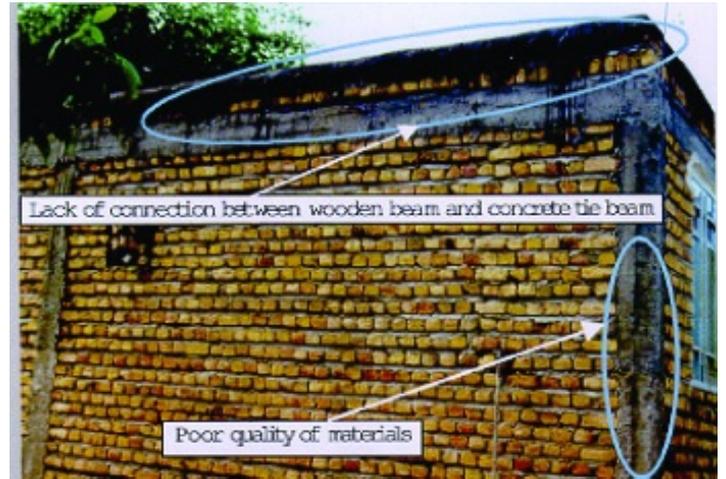
An Illustration of Key Seismic Deficiencies: lack of Connection Between Wooden Beam and Concrete Tie Beam and Poor Quality of Materials

features in frame	
Seismic deficiency in roof and floors	Lack of proper connection between roof and masonry shear walls They are not perfectly rigid diaphragm.
Earthquake resilient features in roof and floors	
Seismic deficiency in foundation	
Earthquake-resilient features in foundation

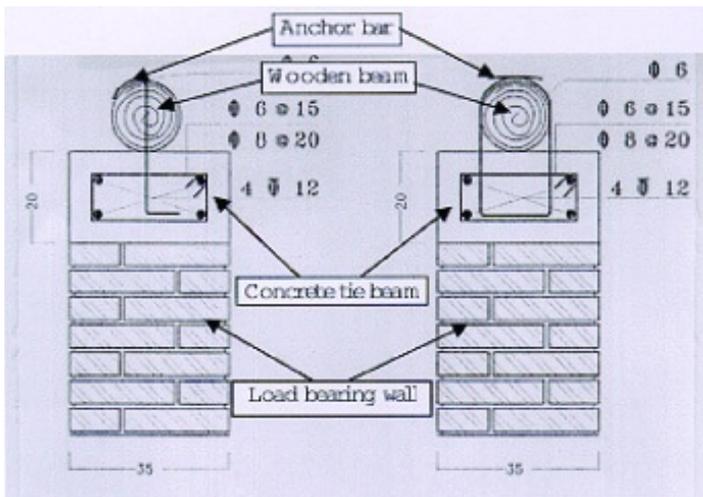
Wall cross-section showing a concrete tie beam and roof-to-wall connection

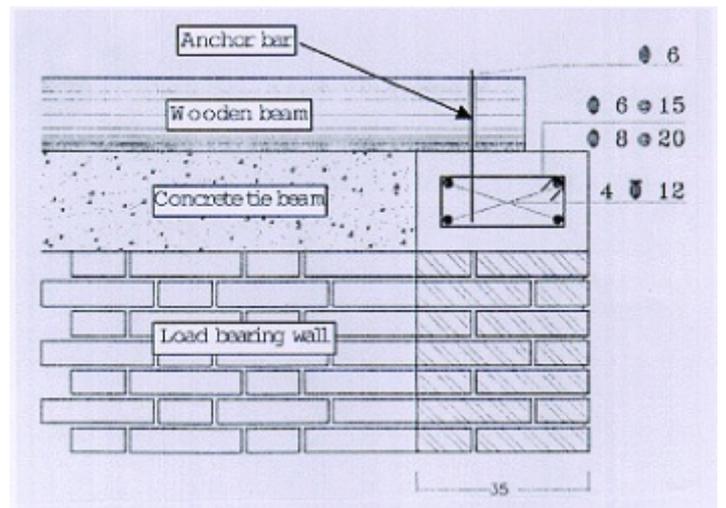
Wall side view showing a concrete tie beam and roof-to-wall connection

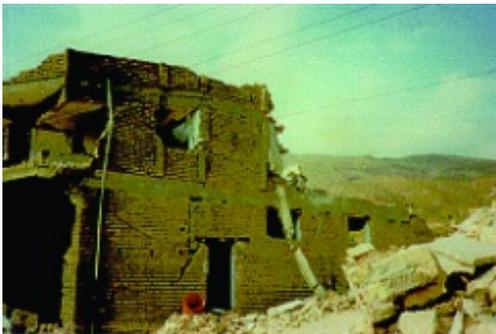
Damage caused by the absence of concrete posts (1990 Manjil earthquake)

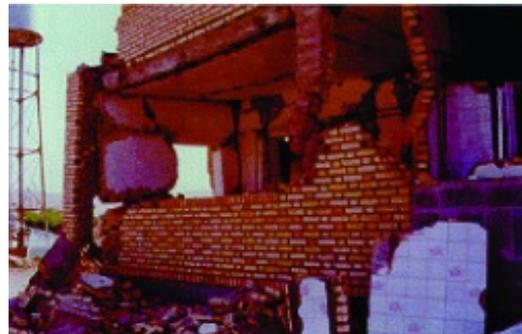
Damage due to large opening, absence of masonry shear wall and short column behavior in concrete post (1990 Manjil earthquake)

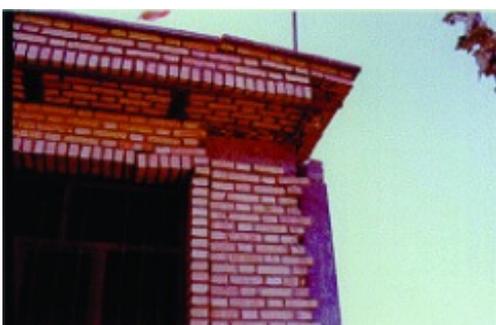
***Damage in the wall panel (1990
Manjil earthquake)***

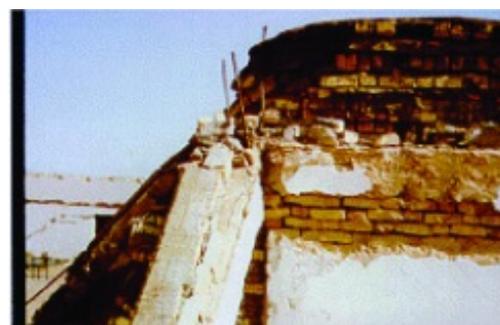
***Collapse due to heavy roof (1990
Manjil earthquake)***

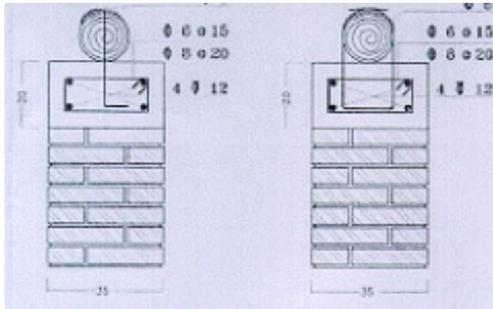
Illustration of Seismic Strengthening Techniques

Structural Deficiency	Seismic Strengthening
Shear wall	Add new shear wall
Tie beams	Increasing the size of the existing tie beams and adding new tie beams for added new walls
Roof	Proper connections of the wood beams to the tie beams (existing and new construction).
New Construction	Roof: Proper connections of the wood beams to the tie beams.

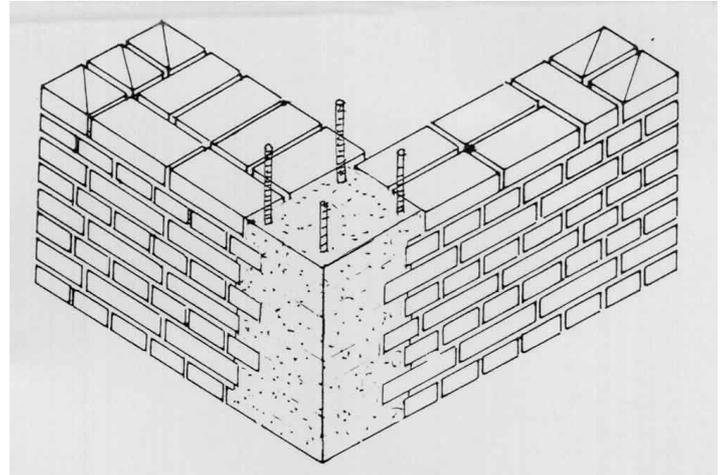
Seismic Strengthening: Addition of a new concrete post
