World Housing Encyclopedia

HOUSING REPORT

Single-family reinforced concrete frame with masonry infill walls house

Report#	30
Last Updated	
Country	Italy
Author(s)	Maurizio Leggeri, Giuseppe Lacava, Eugenio Viola,
Reviewers	Craig D. Comartin,

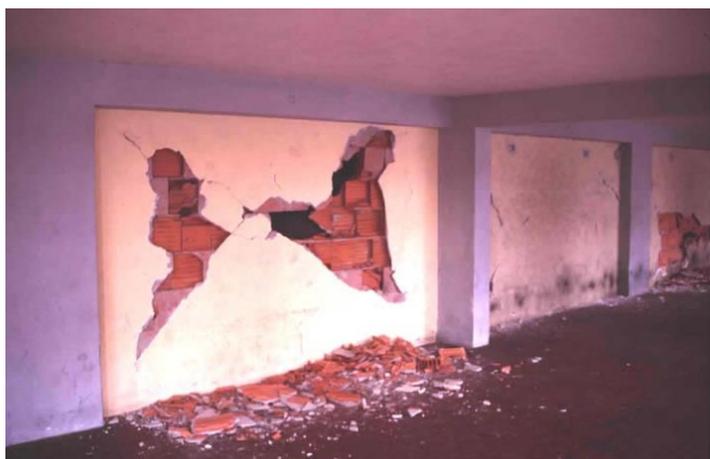
Typical Earthquake Damage - Cracking of Hollow Clay Tile Partitions

Additional comments on structural and architectural features for seismic resistance	
Vertical irregularities typically found in this construction type	Other
Horizontal irregularities typically found in this construction type	Other
Seismic deficiency in walls	Unreinforced hollow clay tile infill walls Earthquake Damage Patterns: Diagonal ("X"-cracking) and failure see Figure 11 and 12.
Earthquake-resilient features in walls

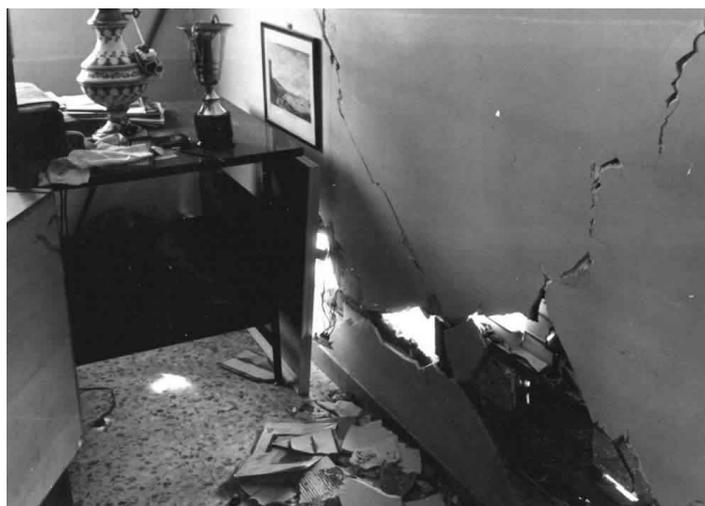
Typical Earthquake Damage-Cracking of Masonry Partitions
