World Housing Encyclopedia

HOUSING REPORT

Two-story unreinforced brick masonry building with wooden floors

Report#	41
Last Updated	
Country	Kyrgyzstan
Author(s)	Svetlana Uranova, Ulugbek T. Begaliev ,
Reviewers	Svetlana N. Brzev,

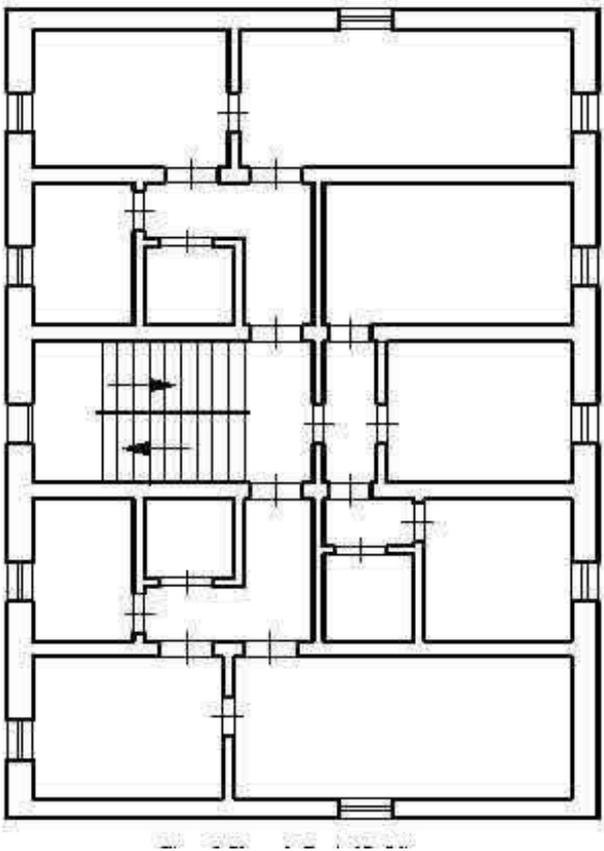
Plan of a Typical Building

Plan Shape	Rectangular, solid
Additional comments on plan shape	Typical shape of a building plan for this housing type is rectangular.
Typical plan length (meters)	30
Typical plan width (meters)	12
Typical story height (meters)	3.5
Type of Structural System	Masonry: Unreinforced Masonry Walls: Brick masonry in mud/lime mortar
Additional comments on structural system	Gravity load-bearing system: Elements of gravity load-resisting system are the same as lateral load-resisting system. Wooden floor beams also carry gravity loads. The beams are supported by the wall; however, without any special anchorage. Typical beam cross-sectional dimensions are: 70-150 mm width and 150-250 mm depth. Wooden floors typically do not have concrete topping. Details of floor structures and wall-floor connections are illustrated in Figure 4. Lateral load-resisting system: The lateral load-resisting system in buildings of this type consists of unreinforced brick masonry walls. Brick masonry walls are usually constructed in mud mortar. Typical wall thickness ranges from 380 mm to 510 mm. Walls are usually perforated with rather large door and window openings. Window and door lintel beams are made of timber board or steel bars embedded in mortar. Typical lintel details are shown in Figure 5. Wooden floors do not act as diaphragms.

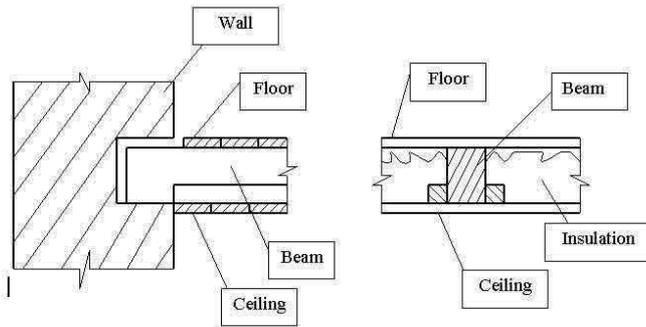
Critical Structural Details - wall and floor connection details

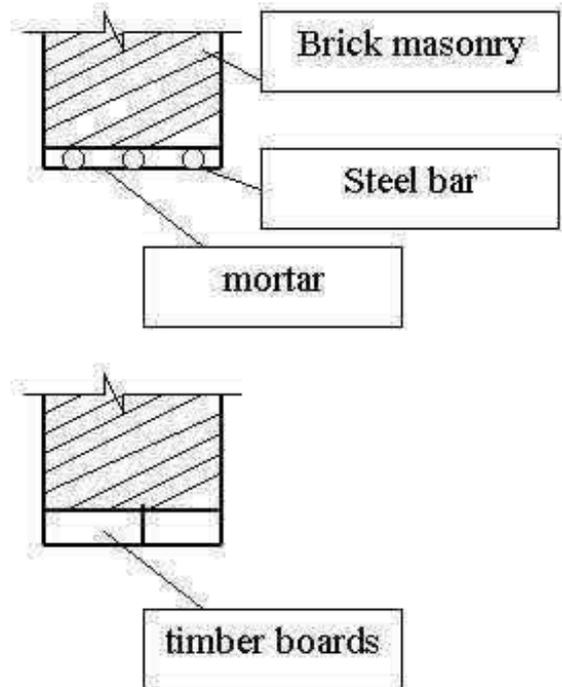
Cross-section through door lintels

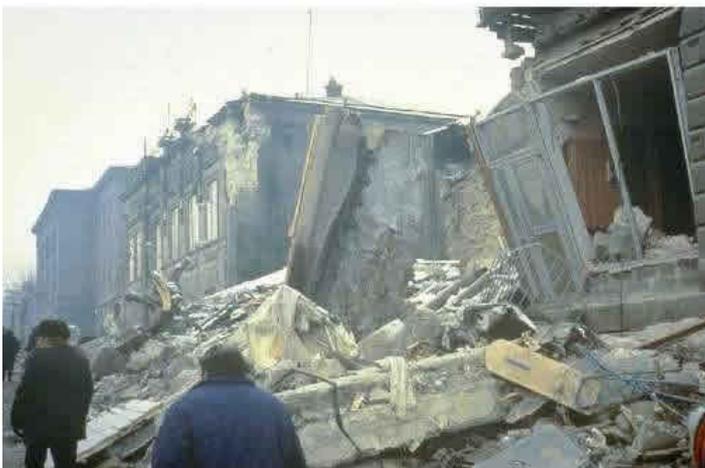
A Photograph Illustrating Typical Earthquake Damage (1988 Armenia earthquake, source: EERI Annotated slide collection)

The epicenter of the Suusamir earthquake was in the hilly area (mountains). Maximum earthquake intensity (based on the 12-point intensity scale) was 9. Buildings of this type affected by the earthquake were away from the epicenter, located in the region with intensity 6-7 on the same 12-point intensity scale. In the Kairakum earthquake, intensity reported in the cities (where this type of construction is found) was 6-7. Most buildings of this type suffered various extent of damage to masonry walls. Buildings of this type were also damaged in the 1988 Spitak, Armenia earthquake (see Figure 6).

Overall damage patterns observed in past earthquakes for this type of construction included damage to the walls or complete collapse of buildings; the extent of damage depends on the direction of seismic waves, earthquake intensity, and pier dimensions. Wall failure was due to in-plane or out-of-plane shear, more often as a result of out-of-plane shear.
