World Housing Encyclopedia

HOUSING REPORT

Houses with mud walls and thatch roofs

Report#	42
Last Updated	
Country	Kyrgyzstan
Author(s)	Svetlana Uranova, Ulugbek T. Begaliev ,
Reviewers	Svetlana N. Brzev,

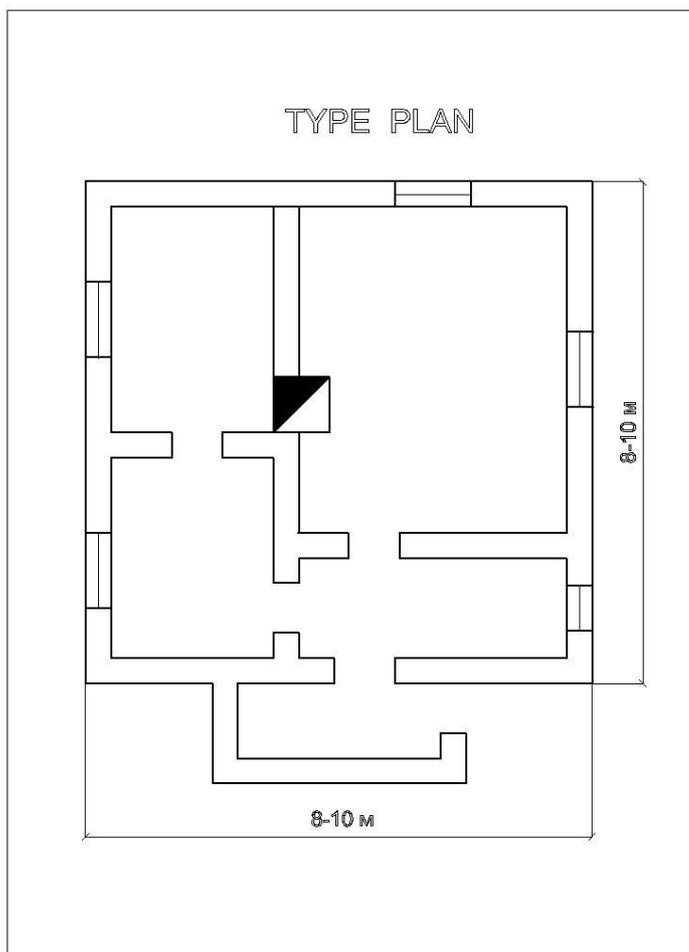
Plan of a Typical Building

Plan Shape	Rectangular, solid
Additional comments on plan shape	Typical shape of a building plan for this housing type is rectangular.
Typical plan length (meters)	10
Typical plan width (meters)	10
Typical story height (meters)	3
Type of Structural System	Masonry: Earthen/Mud/Adobe/Rammed Earth Walls: Mud walls
Additional comments on structural system	Lateral load-resisting system: Lateral load-resisting system for buildings of this type consist of clay walls and wood roof and floor structures. Gravity load-bearing system: The gravity load-bearing structure consists of the same elements as lateral load-resisting structure..
Gravity load-bearing & lateral load-resisting systems	There are several subtypes related to this structural system: adobe block walls, cast-in-place mud walls, and cast-in-place mud walls with timber elements (sinch).
Typical wall densities in direction 1	5-10%
Typical wall densities in direction 2	5-10%

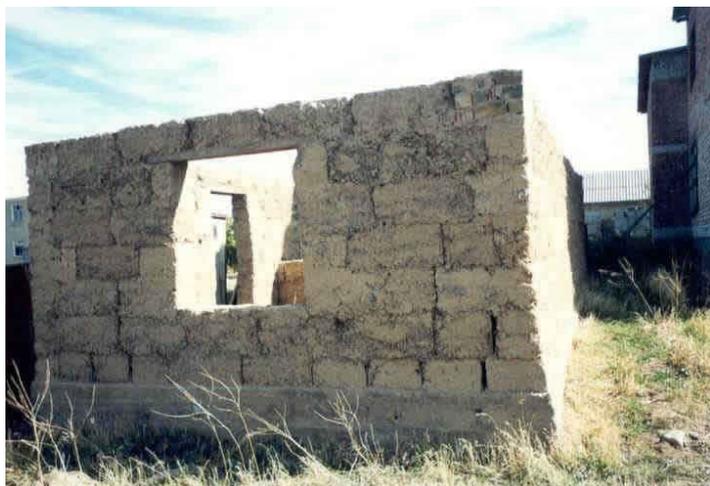
An Illustration of Key Seismic Features and/or Deficiencies

Additional comments on structural and architectural features for seismic resistance	
Vertical irregularities typically found in this construction type	Other
Horizontal irregularities typically found in this construction type	Other
Seismic deficiency in walls	Wall material (clay) is characterized with low compressive and shear strength.
Earthquake-resilient features in walls	
Seismic deficiency in frames	
Earthquake-resilient features in frame	
Seismic deficiency in roof and floors	Wood beams are not joined together in the horizontal diaphragm.
Earthquake resilient features in roof and floors	
Seismic deficiency in foundation

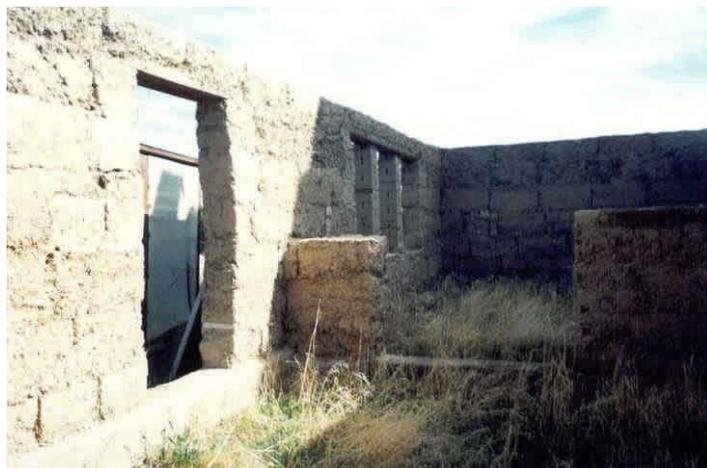
Illustration of Key Seismic Features

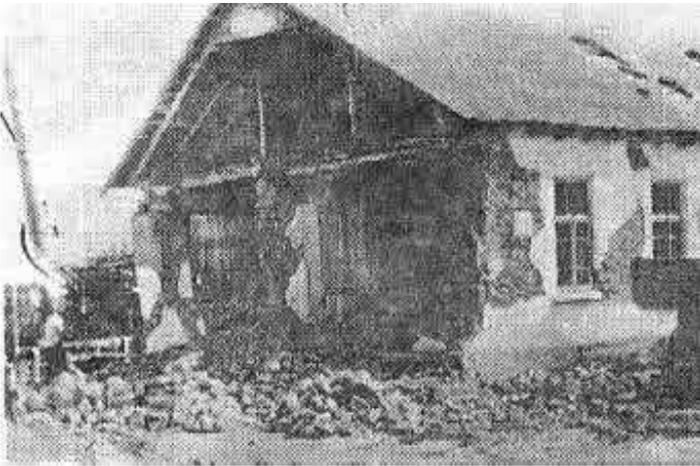
A Photograph Illustrating Typical Earthquake Damage

Overall damage patterns observed in past earthquakes for this type of construction included damaged or collapsed walls due to in-plane and out-of-plane seismic effects and collapse of buildings.
