World Housing Encyclopedia

HOUSING REPORT

Unreinforced concrete and masonry bearing wall construction (designed for gravity loads only)

| Country | PALESTINIAN TERRITORIES |

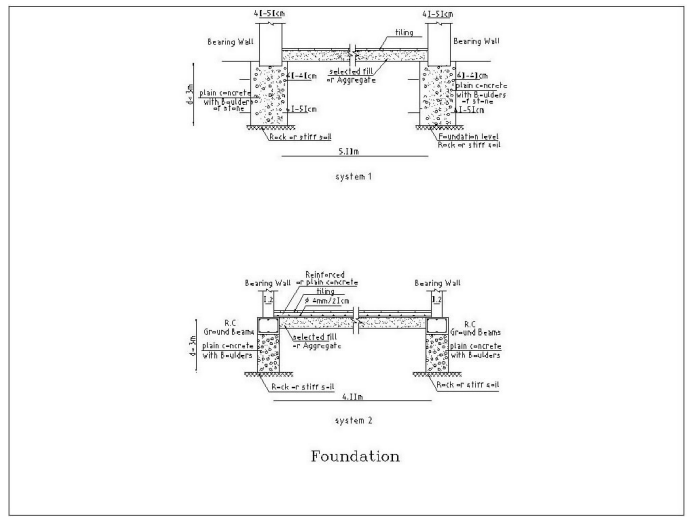
Critical Structural Details (e.g. wall section, foundations, roof-wall connections, etc.)

Critical Structural Details

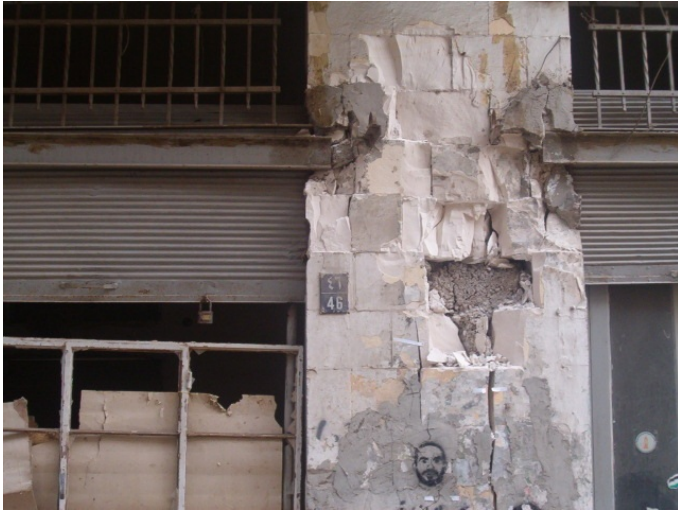
Earthquake damage

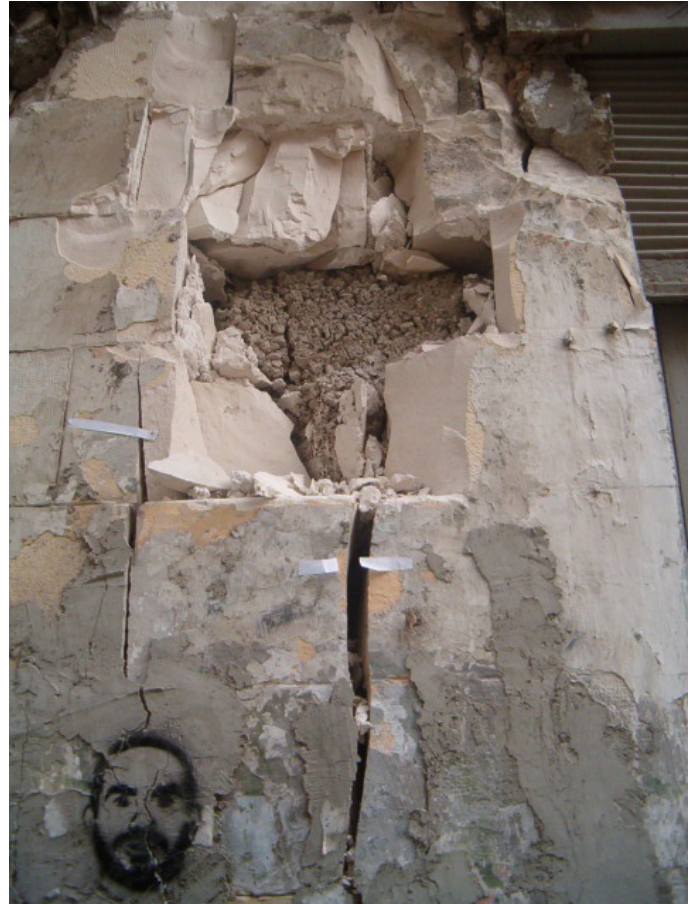
Earthquake damage

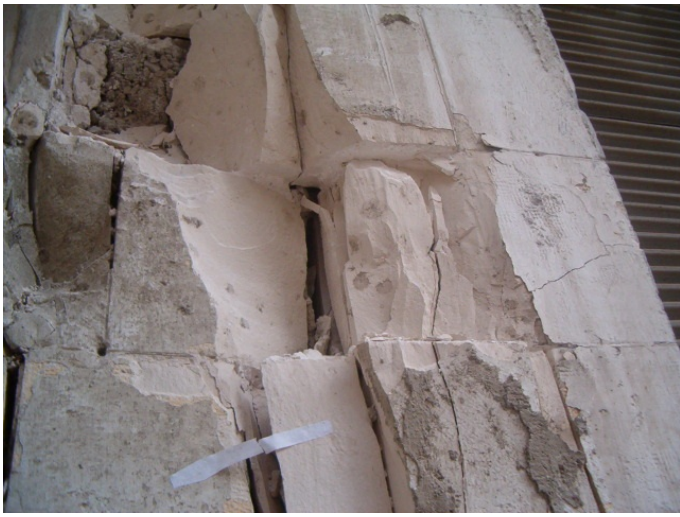
Earthquake damage

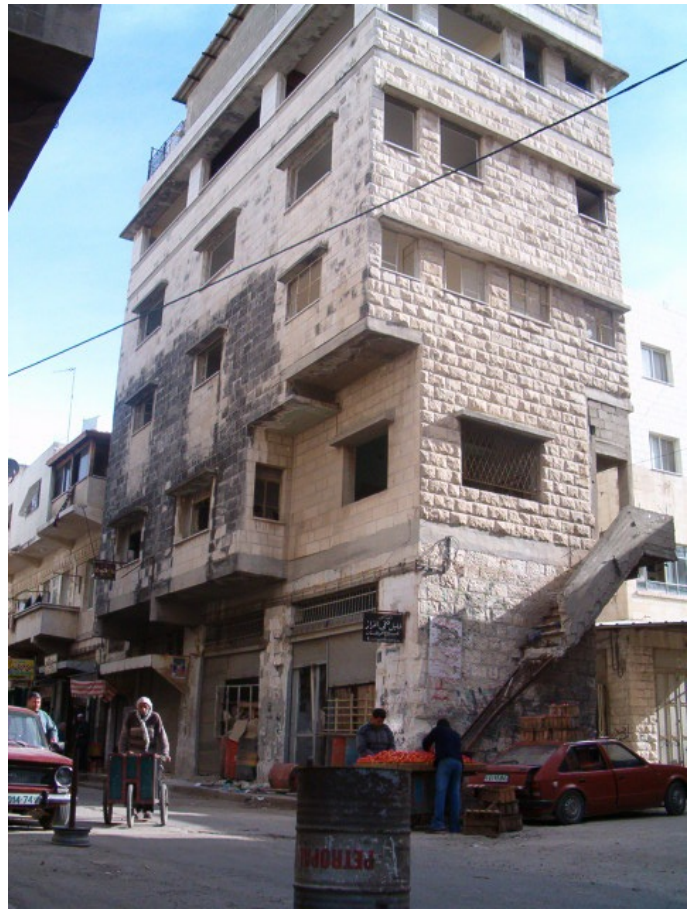
Earthquake damage

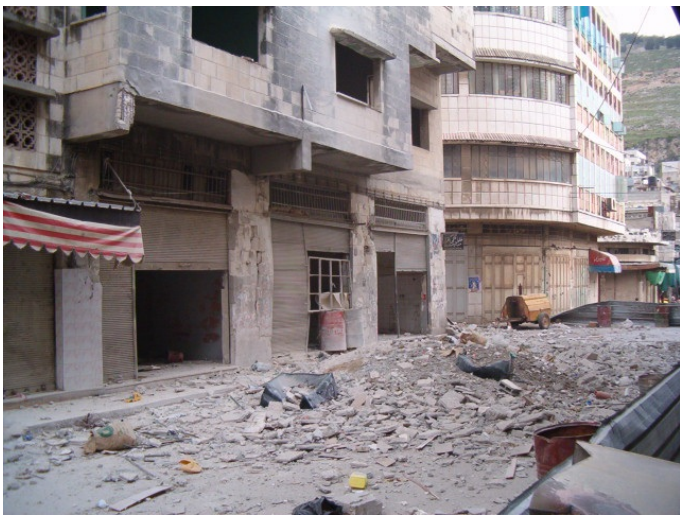
Earthquake damage
