World Housing Encyclopedia

HOUSING REPORT Adobe house

Report#	52
Last Updated	
Country	Peru
Author(s)	Cesar Loaiza, Marcial Blondet, Gianfranco Ottazzi,
Reviewers	Sergio Alcocer,

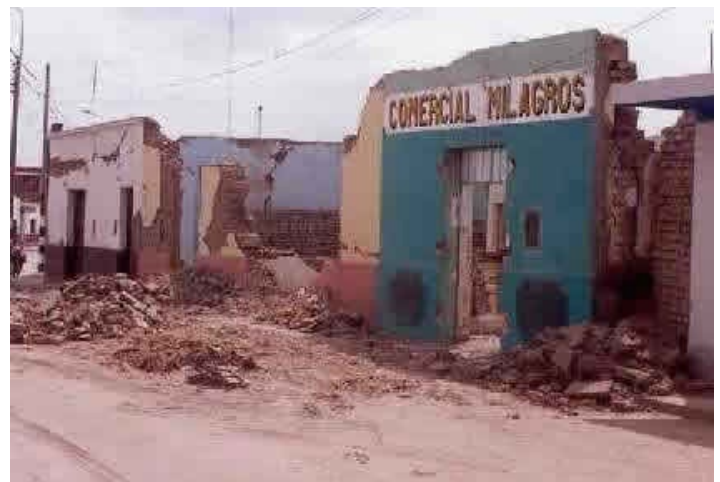
Key Seismic Deficiencies - Adobe Wall Failure Due to Out-of-Plane

Seismic Forces

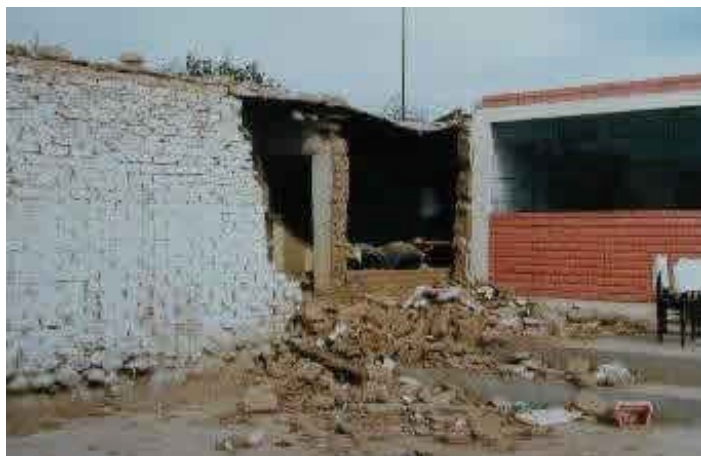
Key Seismic Deficiencies - Wall Damage Due to Inadequate In-Plane Seismic Resistance

Wall shear cracking

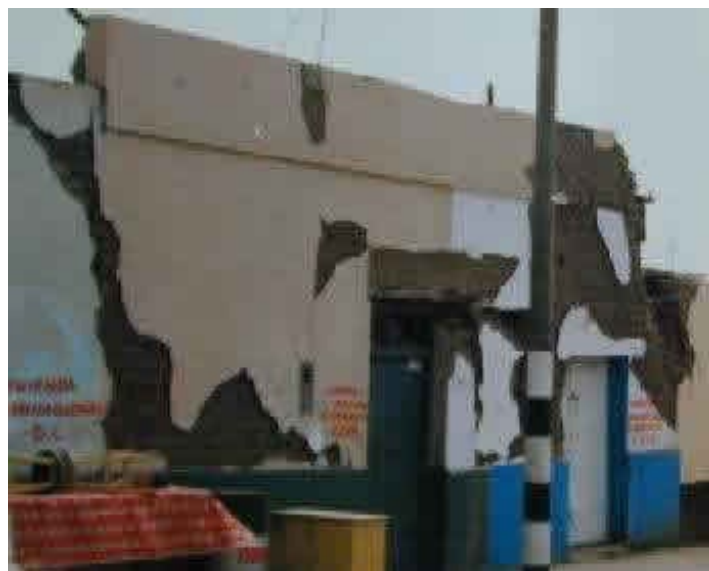
A Photograph Illustrating Typical Earthquake Damage (November 1996 Nasca Earthquake)

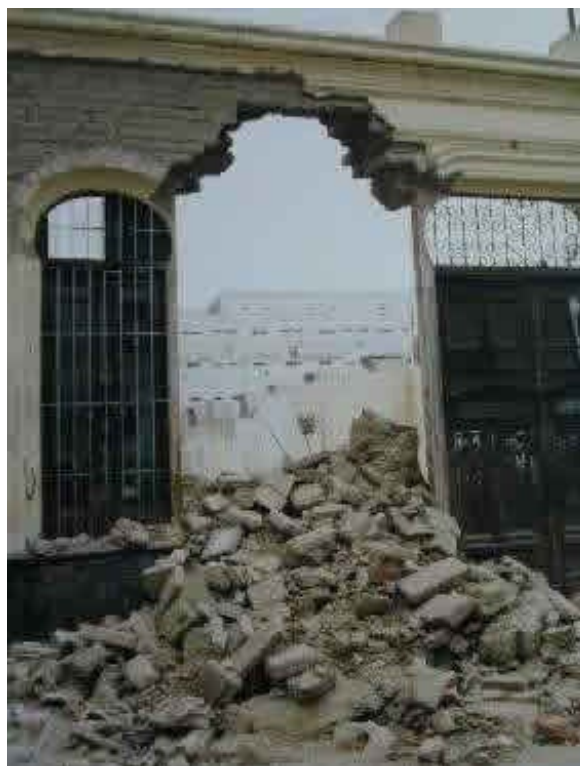
A Photograph Illustrating Typical Earthquake Damage (November 1996 Nasca Earthquake)

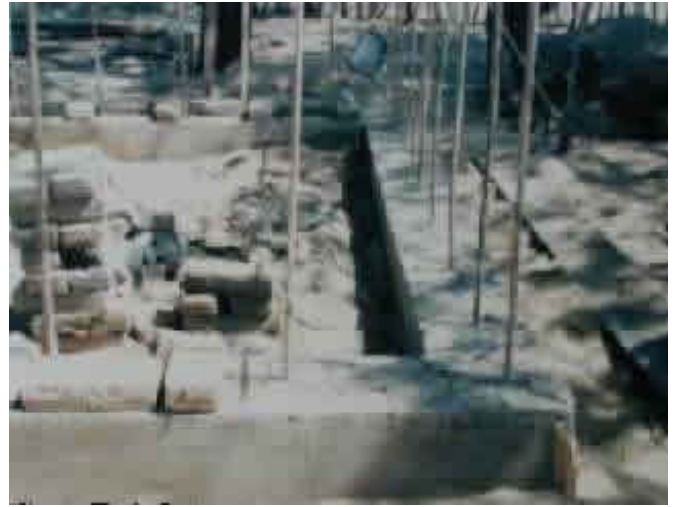
Seismic Strengthening - Construction of Wooden Beams atop the Adobe Walls

Structural Deficiency	Seismic Strengthening
Adobe walls- Lack of confinement	Adobe walls are confined with reinforced concrete tie columns and beams. Concrete columns are cast against the serrated endings of adobe walls. This is a very good seismic strengthening system, however it could be expensive for owners.
Lack of integrity- adobe walls	A wood beam is cast atop the walls, keeping them united during an earthquake. It is an

inexpensive system. (see Figure 10)
Adobe walls-poor in-plane and out-of-plane resistance	A steel mesh fixed with metal plates is installed to strengthen the adobe walls. The mesh is applied on both wall surfaces and at the wall corners. This is a very effective and inexpensive strengthening system, developed at the Catholic University of Lima.
(New Construction): Improved integrity of adobe walls	A wooden beam is cast atop the walls, keeping them united during an earthquake. Rectangular wood beams are used as lintels. (see Figure 10)
(New Construction):Reinforcing of walls with bamboo cane reinforcement	Bamboo cane is used in adobe walls to provide ductility and improve tensile resistance. This is a very effective and inexpensive strengthening system. Cane does not increase significantly the lateral resistance, however lateral drifts are reduced.
