World Housing Encyclopedia

HOUSING REPORT

Concrete frame and shear wall building

Report#	6
Last Updated	
Country	Chile
Author(s)	Ofelia Moroni, Cristian Gomez,
Reviewers	Sergio Alcocer,

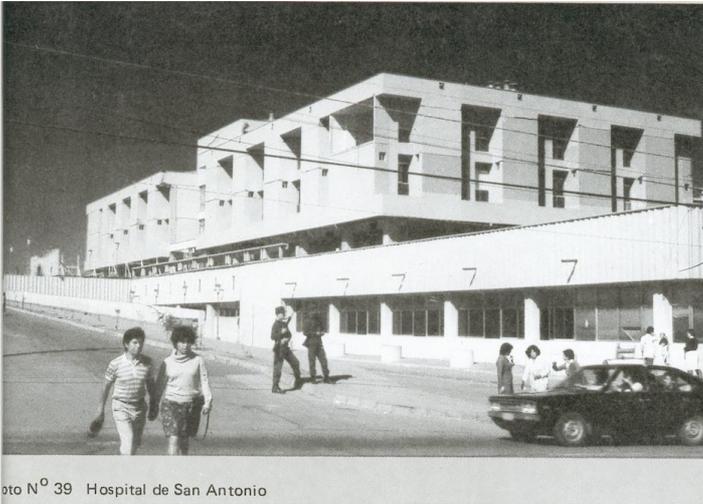
San Antonio Hospital, March 3, 1985 Lolleo earthquake

Damage patterns observed in past earthquakes for this construction type	<p>In the southern part of Chile, buildings of this type did not exist at the time of the 1960 earthquake, and the only reported example of damage is the hospital in Valdivia. In the 1985 earthquake, structural damage was not reported in buildings of this type with the exception of the San Antonio Hospital, located very close to epicenter. Out of plane tilting occurred in some non-structural masonry walls at the third floor level (Figure 9) and some columns, not properly confined, in the first floor were damaged at the top. (Figures 9,10 and 11). In fact there were two building blocks-one of them was 3-story high and one basement with no damage, whereas the other one was 4 story high with a flower stand on the top floor that was damaged. The other photo (Figure 12) represent a 4-story buildings at Valparaiso that had experienced some damage in interior panel and contents.</p>

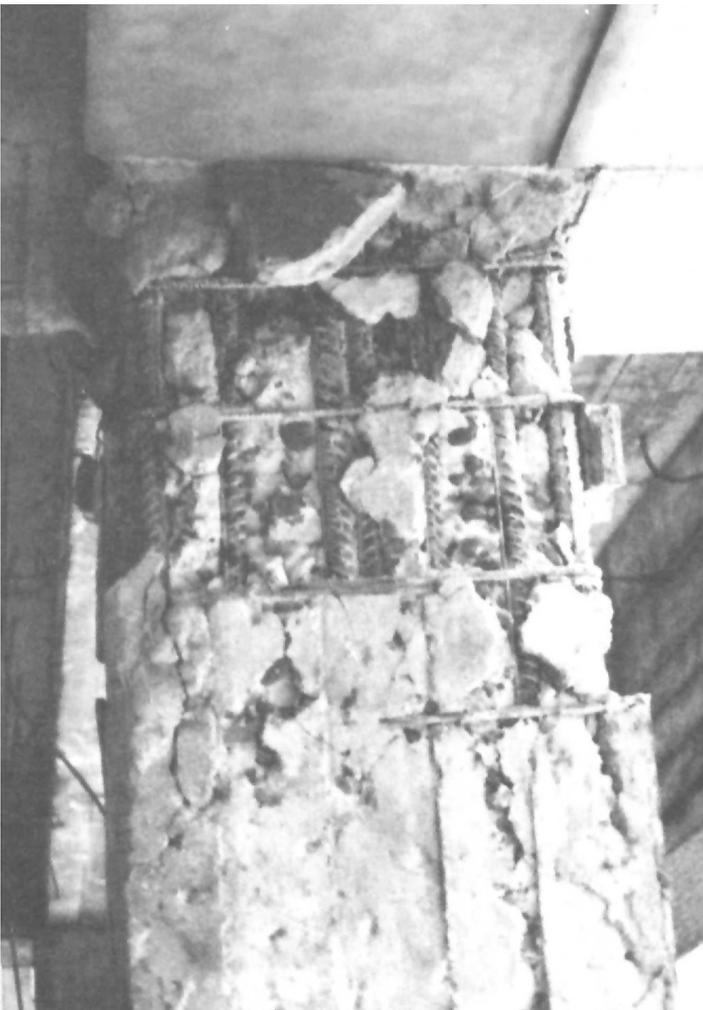
San Antonio Hospital, close-up damaged in the 1985 Lolleo

Additional comments on seismic strengthening provisions	
Has seismic strengthening described in the above table been performed?	The hospital at San Antonio was repaired; however, the details are not available.
Was the work done as a mitigation effort on an undamaged building or as a repair following earthquake damages?	This is not a common activity in Chile. The only situation when buildings are repaired is after an earthquake, when some constructive deficiencies appeared. It is normal to observe some small cracks in the concrete.
Was the construction inspected in the same manner as new construction?	
Who performed the construction: a contractor or owner/user? Was an architect or engineer involved?	A contractor performed the construction, of course an architect and engineer were involved.
What has been the performance of retrofitted buildings of this type in subsequent earthquakes?	Since 2001, no subsequent earthquake has occurred in the central zone of Chile.
