World Housing Encyclopedia

HOUSING REPORT

Street front building with arcade at the first floor (contemporary construction)

Report#	62
Last Updated	
Country	Taiwan
Author(s)	Yao, George C., M.S. Sheu,
Reviewers	Craig D. Comartin,

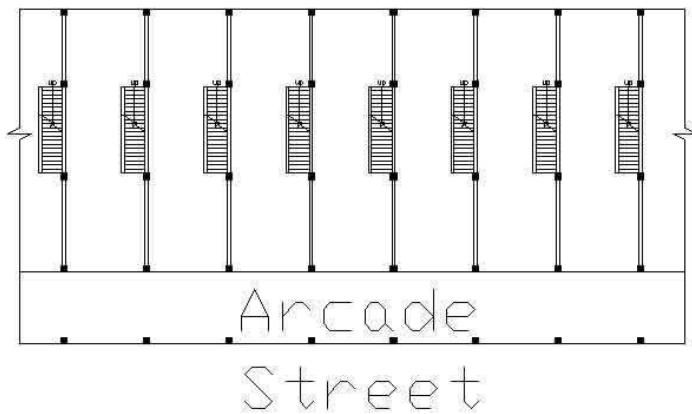
**Typical Ground Floor Plan- Past
Practice (Source: EERI 2001)**

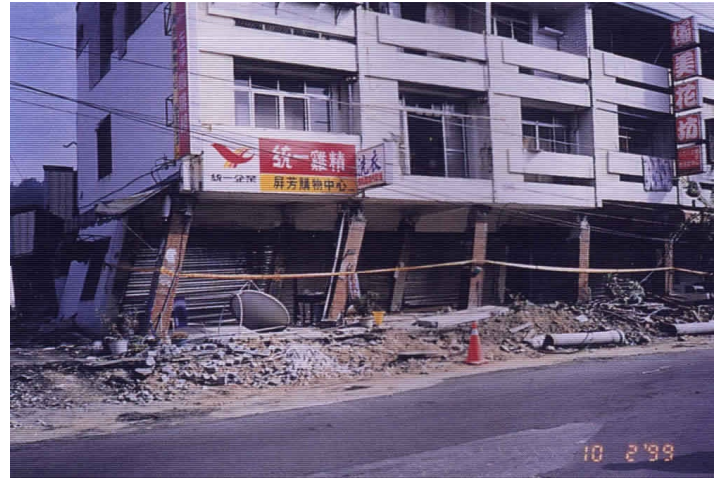
A Photograph Illustrating Typical Earthquake Damage

Although many buildings of this construction type sustained significant damage in the 1999 Chi Chi earthquake, most of them performed satisfactorily. Earthquake damages are illustrated in Figures 11-16. The main causes for damage observed after the earthquake are (EERI, 2001): 1) Poor configuration attributable to the open front combined with inadequate column lateral reinforcement (ties). The large displacement demands from the soft-story and torsional effects often damaged the plastic hinge regions of the columns at the open front. All damaged columns were observed to have nonductile confinement reinforcement details consisting of widely spaced horizontal hoops, more than 300 mm apart, and 90 degree hooks. Usually, the lack of confinement reinforcement in the plastic hinge regions resulted in brittle failure. In some cases, hinge rotation caused buildings to permanently lean out of plumb. In other cases, buildings with no signs of earthquake damage

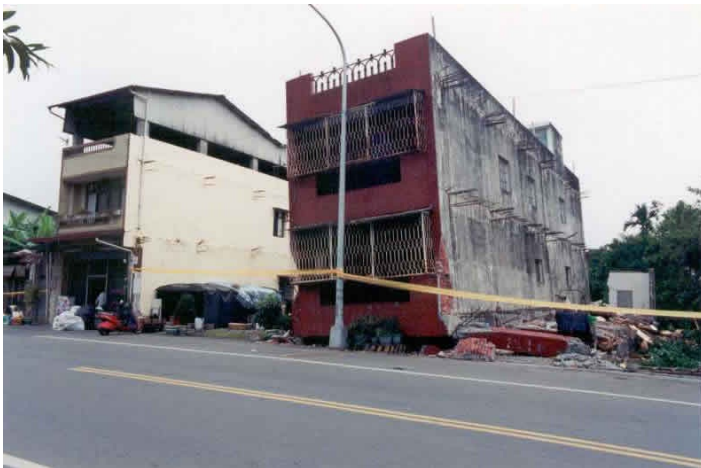
Earthquake damage - Collapsed Three-story building in the 1999 Chi Chi earthquake (Source: EERI 2001)

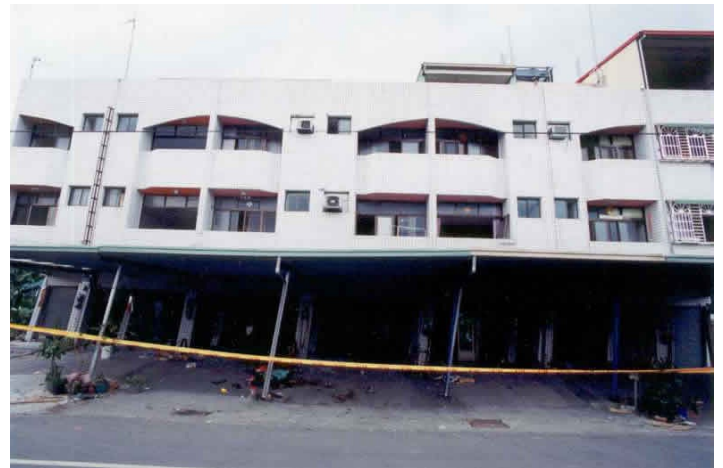
Earthquake Damage - Partial Collapse of a Three-story building in the 1999 Chi Chi Earthquake (Source: EERI 2001)

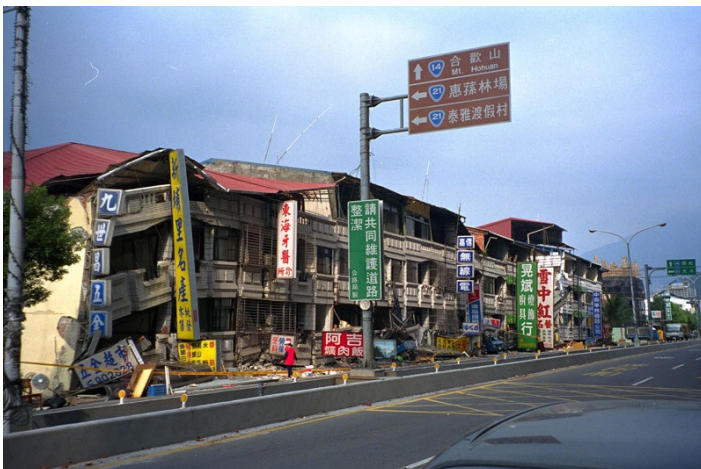
Earthquake Damage - Pancake Collapse of an Entire City Block in the 1999 Chi Chi earthquake (Source: EERI 2001)

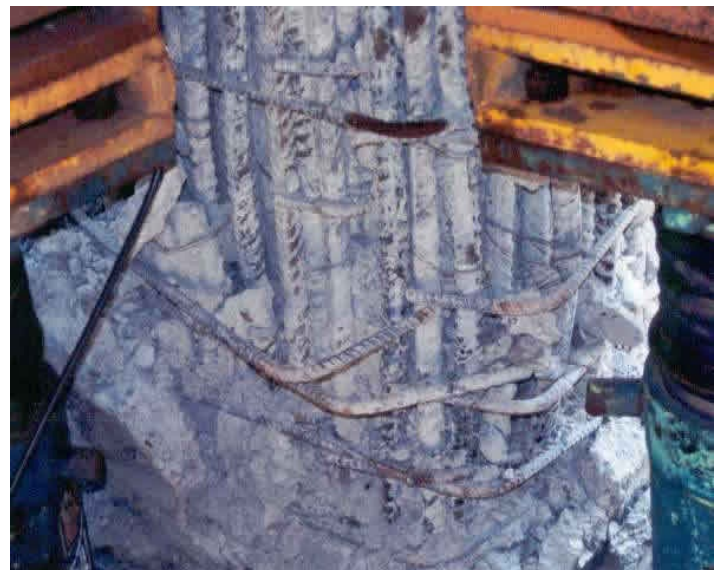
Earthquake Damage - Opening of 90 degree column hooks in the 1999 Chi Chi earthquake (Source: EERI 2001)

Seismic Deficiency: Column ties -90 degree hook were used instead of 135 degree hooks (Source: EERI 2001)

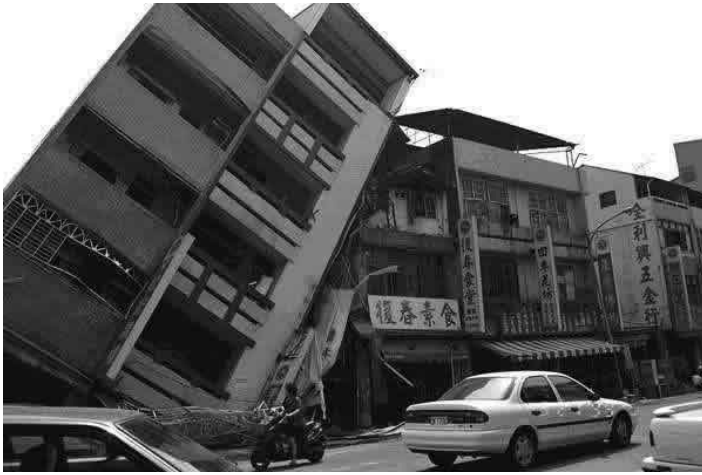
Collapse of a Concrete Frame Building in the 1999 Chi Chi Earthquake (Source: EERI 2001)
