# World Housing Encyclopedia

## HOUSING REPORT

### Stone masonry apartment building

<b>Report#</b>	75
<b>Last Updated</b>	
<b>Country</b>	Algeria
<b>Author(s)</b>	Mohammed Farsi, Farah Lazzali, Yamina Ait-Mziane,
<b>Reviewers</b>	Marjana Lutman ,

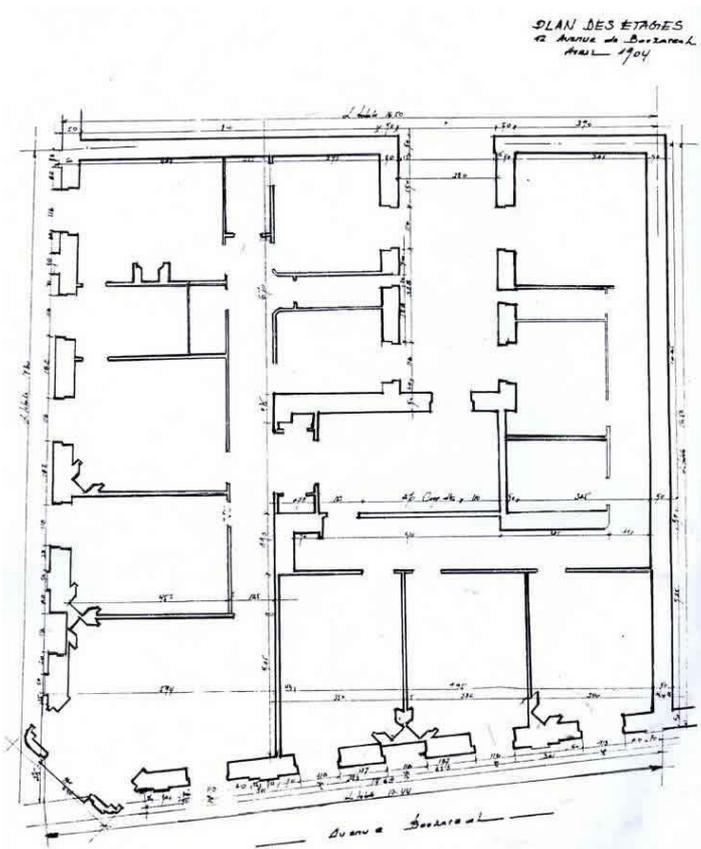
**Typical Building Plan**

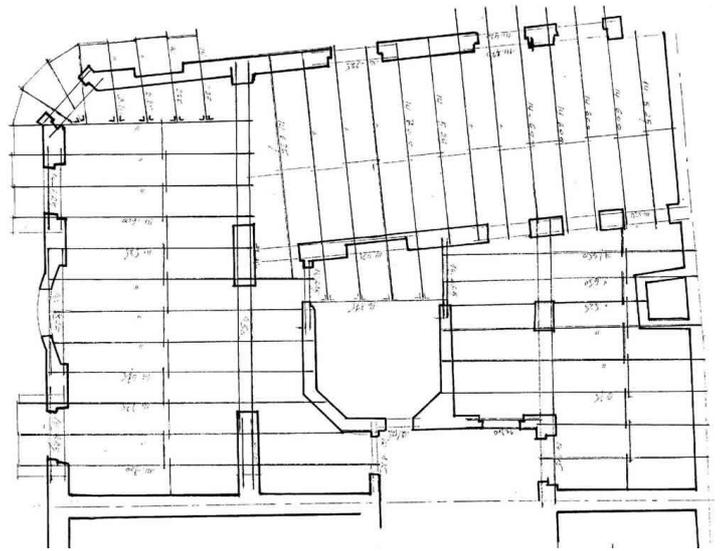
**Typical Roof Plan**

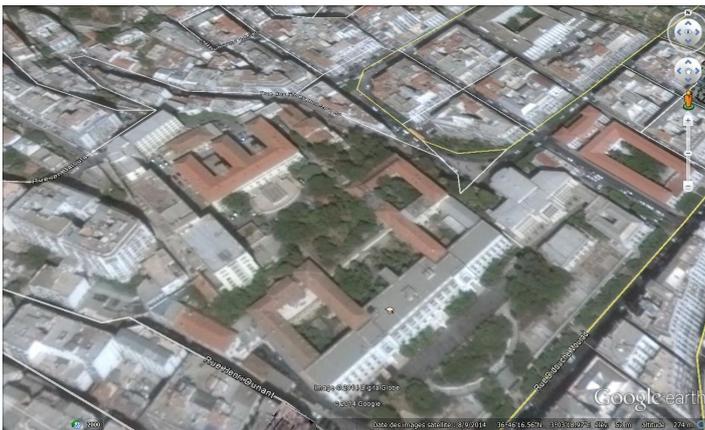
**Plan shape of Stone masonry apartment buildings**

<b>Plan Shape</b>	Square, solidSquare, with an opening in planRectangular, solidRectangular, with an opening in planL-shapeTriangular, with an opening in planE-shapeU- or C-shapeIrregular plan shape
<b>Additional comments on plan shape</b>	The building plan for this housing type can be of different forms: rectangular, L-shaped, U-shaped, etc. (see photos 1 and 2)
<b>Typical plan length (meters)</b>	25
<b>Typical plan width (meters)</b>	15
<b>Typical story height (meters)</b>	3.5
<b>Type of Structural System</b>	Masonry: Stone Masonry Walls: Rubble stone (field stone) in mud/lime mortar or without mortar (usually with timber roof)Masonry: Stone Masonry Walls: Massive stone masonry (in lime/cement mortar)
<b>Additional comments on structural system</b>	Lateral load-resisting system: The lateral load-resisting system consists of the stone masonry walls built in longitudinal and cross directions. Wall thickness varies from 400 to 600 mm. Low-strength mortar (either cement/sand or mud mortar) has been used. According to the Algerian Seismic Code (RPA99), this construction is permitted only if confined with reinforced concrete ties in vertical and horizontal direction, and with RC slabs used as floor and roof structures. The maximum building height allowed by the Code depends on the seismic zone (17 m, 14 m and 11 m, for seismic zones I, II and III, respectively).Gravity load-bearing system: Stone masonry walls are the principal elements of the gravity load-bearing structure.

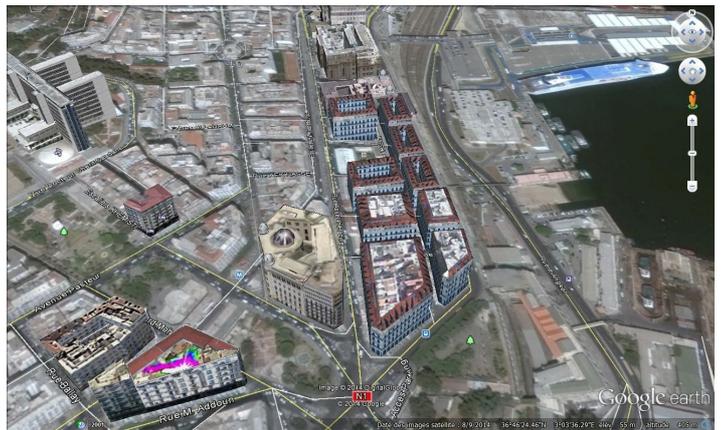
**Plan shape of Stone masonry apartment buildings**

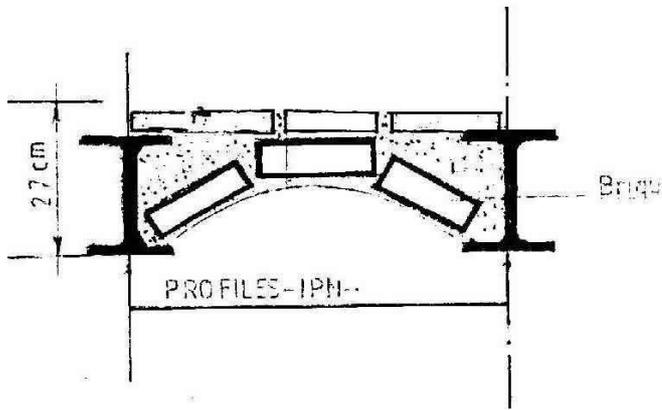
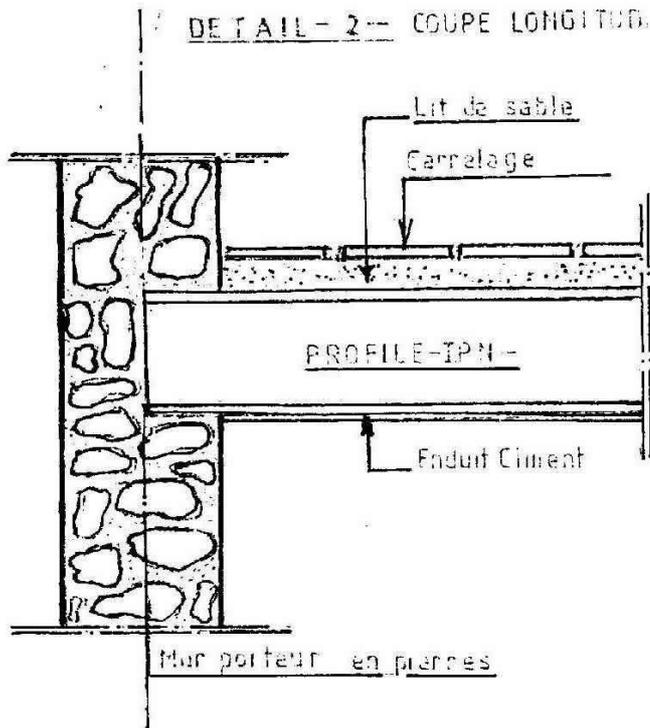
***Critical Structural Details: Wall-Roof Connection and Vaulted Brick Floor Structure***

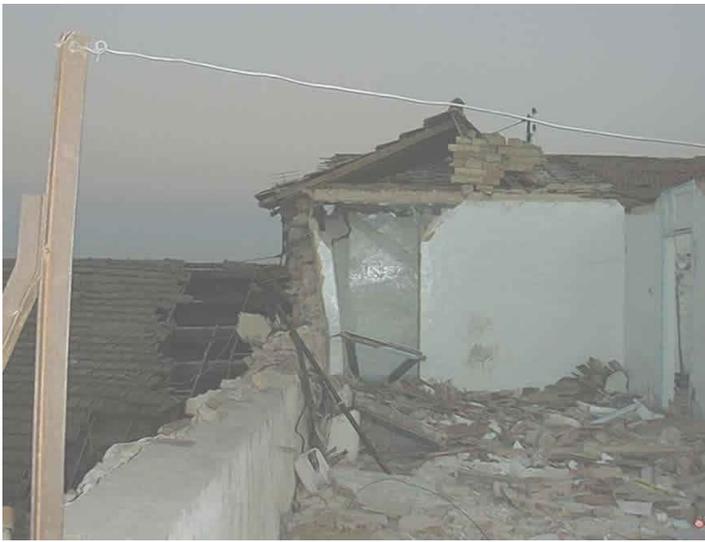
**Typical Earthquake Damage:  
Partial Roof Collapse (1999 Ain-  
Temouchent Earthquake)**

<b>Damage patterns observed in past earthquakes for this construction type</b>	Damage patterns vary from diagonal "X"-cracks to total wall collapse, and partial to total collapse of the roofs/slabs. The following damage patterns were also observed:- Horizontal cracks between walls and floors, - Vertical cracks at walls intersections, - Out of plane collapse of external walls, - Diagonal cracks in wall piers, - Partial or complete disintegration of walls, - Partial or complete collapse of the building
<b>Additional comments on earthquake damage patterns</b>	Earthquake Total Number of Apartment Buildings (all types) Damage level (MSK scale) 1 2 3 4 5 1980 El-Asnam 4844439 1304 1351 863 8871989 Tipaza 4511 1480 1102 223 426 12801994 Mascara 1874 470 302 351 212 5391999 Ain-Tmouchent 3398 1062 606 684 528 518

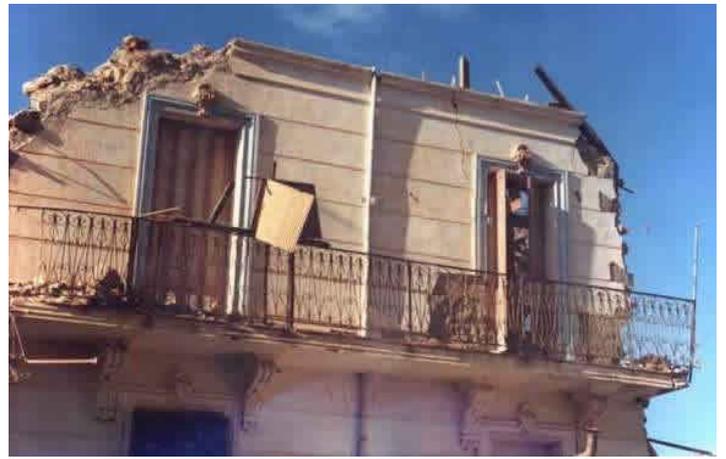
**Typical Earthquake Damage:  
Collapsed Roof of a Masonry  
Building (1989 Tipaza Earthquake)**

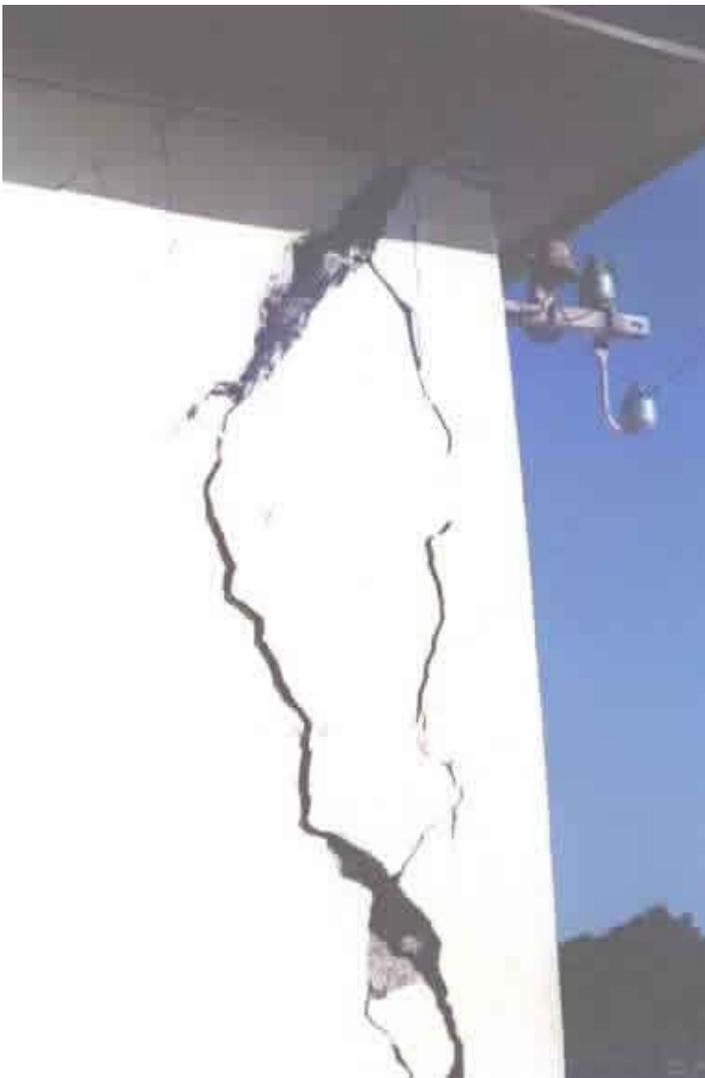
**Typical Earthquake Damage:  
Cracking in the Wall Corners**

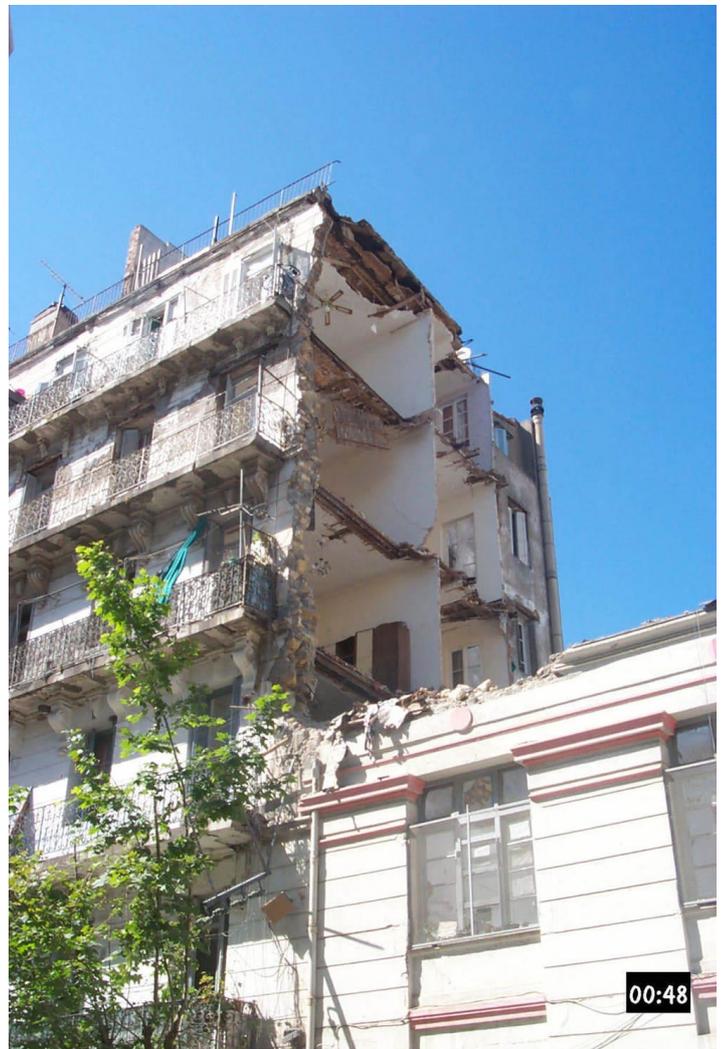
**Damage to a stone masonry  
building in Algiers in the May 21,  
2003 earthquake**

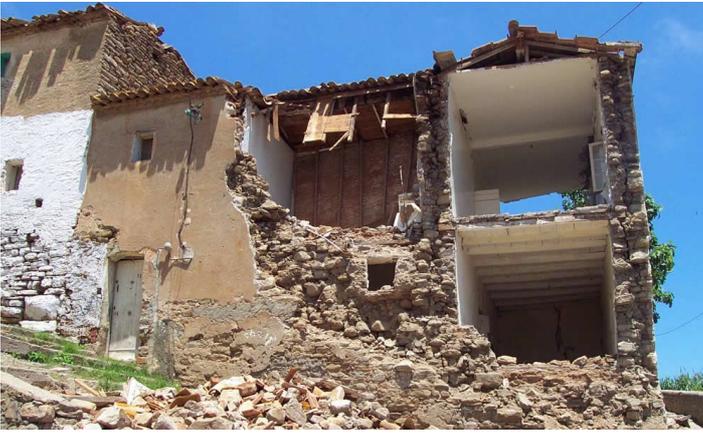
***Totally collapsed stone masonry building in Dellys (Boumerdes) in the May 21, 2003 earthquake***

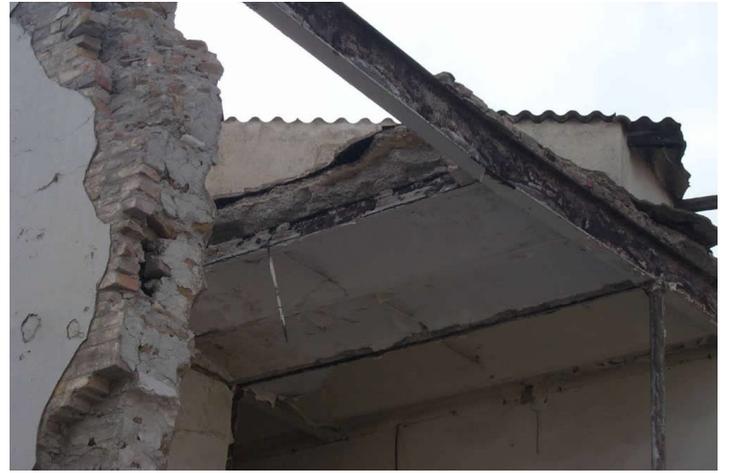
***Collapse of the vaulted brick and steel floor system in the May 21, 2003 earthquake (El Harrach district, Algiers)***

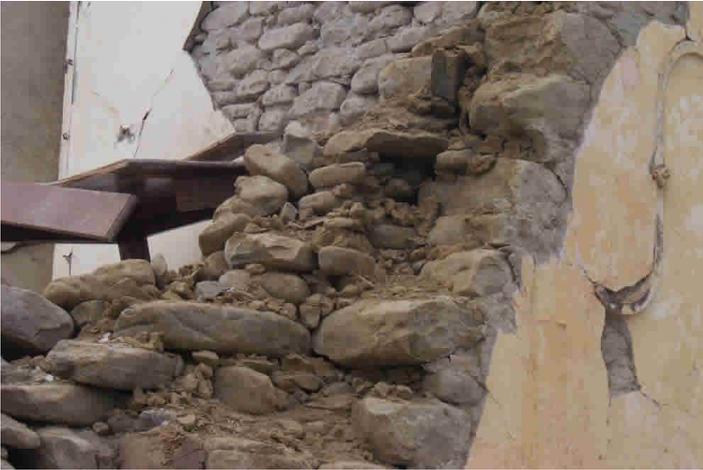
***Collapse of a rubble stone masonry wall made of river stones and mud mortar in the May 21, 2003 earthquake (Sidi Daoud, Boumerdes)***

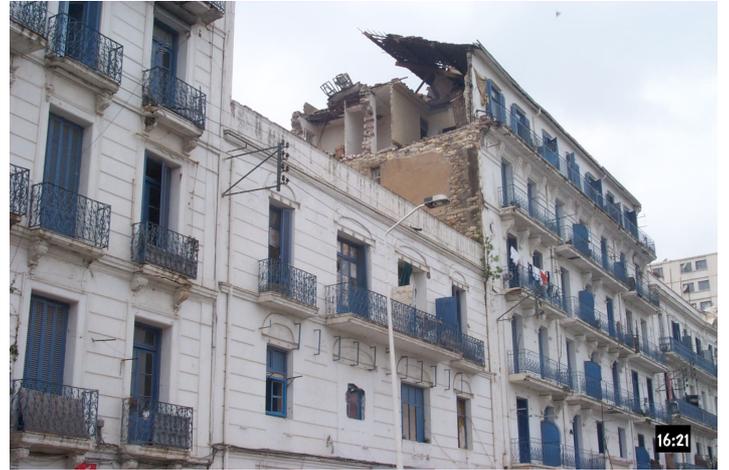
***Damaged wooden framed roof of stone masonry apartment buildings by the May 21st, 2003 Boumerdes earthquake.***

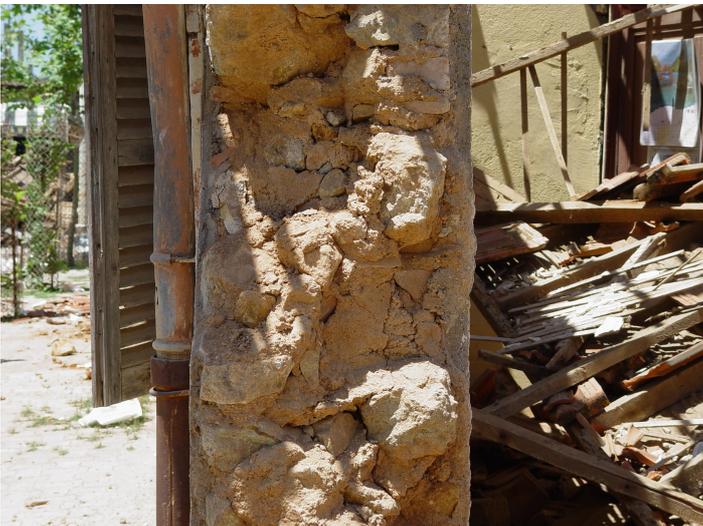
***Rubble stone (field stone) masonry with earth mortar constituting the apartment building walls in many***

*cases.*

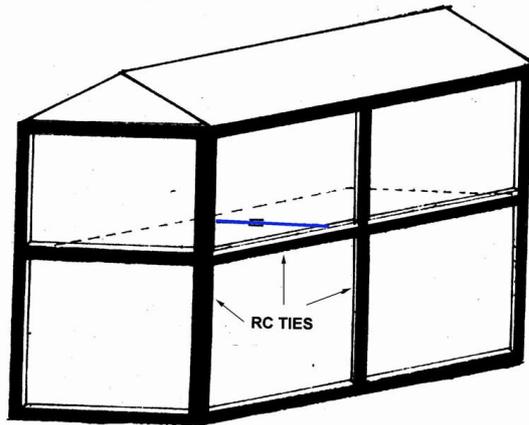
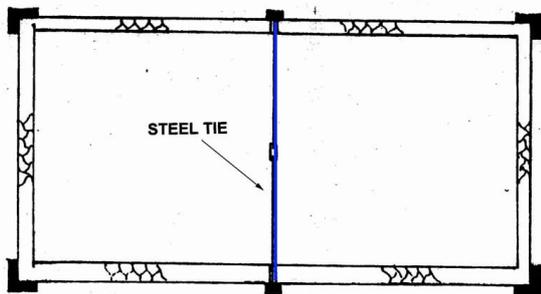
ELEVATION

PLAN

***Seismic Strengthening Techniques: Provision of Horizontal and Vertical RC Ties at the Exterior and Horizontal Steel Ties at the Interior***

<b>Structural Deficiency</b>	<b>Seismic Strengthening</b>
Cracks in the stone masonry walls	- Cracks less than 0.3 mm width; by injection using fluid cement mortar- Large cracks: injection and adding stitching dog or steel bars; rebuilt using bricks or stones to bridge the crack zone in case of vertical crack; using metallic plate in case
Lack of integrity	Addition of horizontal and vertical RC ties at exterior and steel ties in the interior, see Figure 7A

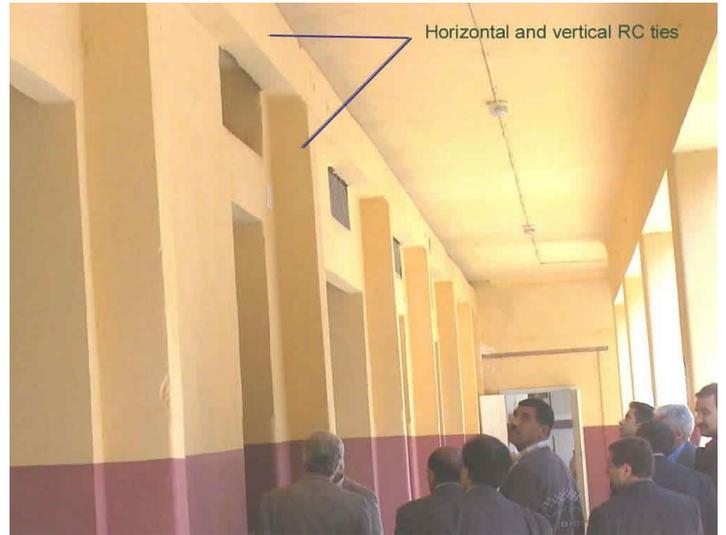
***Seismic Strengthening Techniques: An Example of a Strengthened Building with Vertical and Horizontal RC Ties at the First Floor Level***

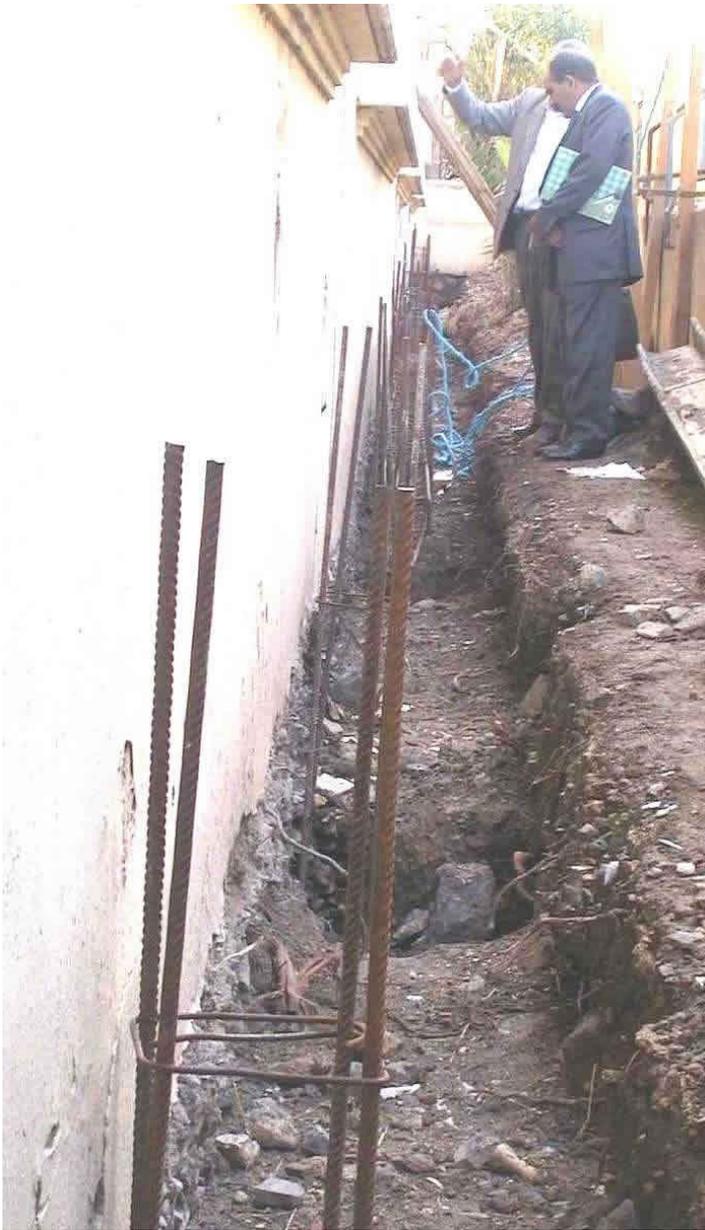
***Seismic Strengthening  
Techniques: Construction of RC Ties***

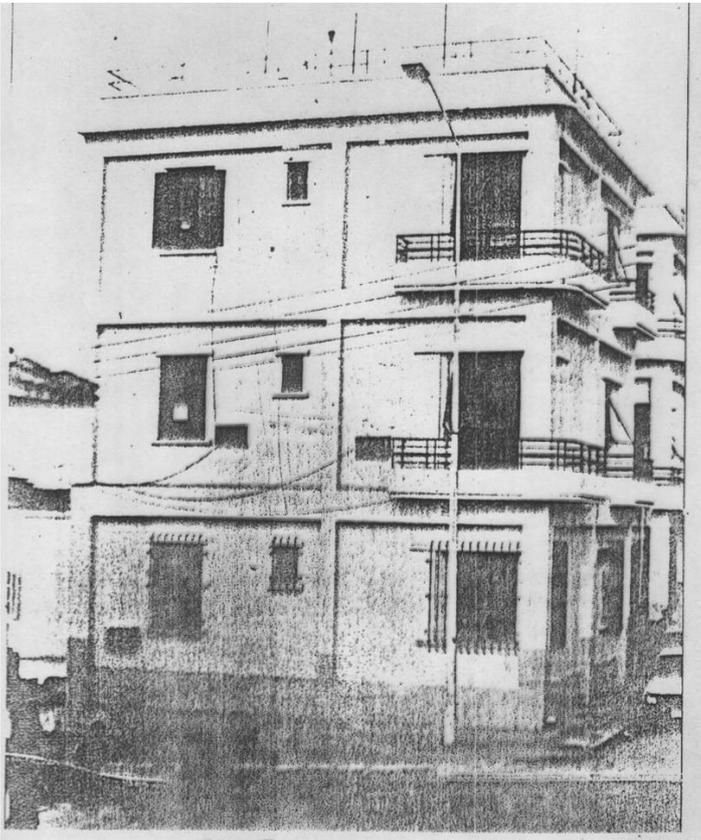
***Retrofitted building following 1980 El Asnam earthquake. Addition of horizontal and vertical RC ties at exterior and steel ties in the interior.***
