World Housing Encyclopedia

HOUSING REPORT

RC Structural Wall Building : Moment frame with in-situ shear walls

Report#	78
Last Updated	
Country	Romania
Author(s)	Maria D. Bostenaru, Ilie Sandu,
Reviewers	Vanja Alendar,

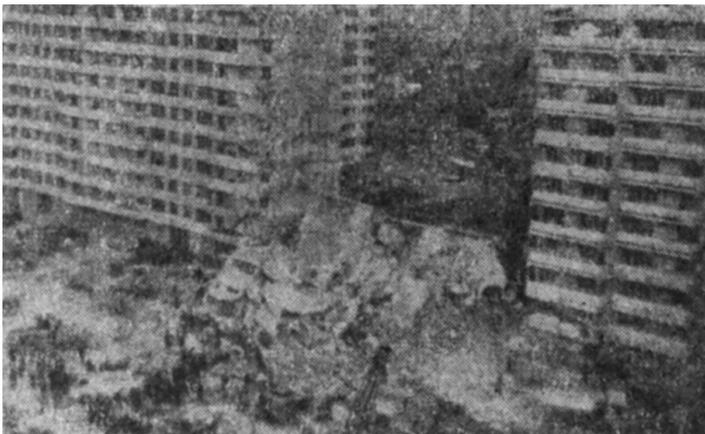
Collapse of OD16 Building in the 1977 Vrancea Earthquake

This region is well known as a seismically prone area, with the epicenter of damaging earthquakes close to Vrancea. Earthquakes with the Richter magnitude of over 7.0 occur once in 30 years. Bucharest, the capital, is located around 150km south of the epicenter and lies in the main direction of the propagation of seismic waves. The Bucharest area is located on the banks of the Dmbovita and Colentina river, on non-homogeneous alluvial soil deposits. During the earthquake of 4 March 1977 (Richter magnitude 7.2), over 30 buildings collapsed in Bucharest, killing 1,424 people. It should be noted that the buildings of "OD" type suffered damages of various extent in the 1977 earthquake, and one building unit ("trason") totally collapsed (that was the only shear wall building that collapsed in the earthquake). Buildings with their longitudinal direction aligned parallel with the direction of seismic waves (mainly in Berceni and Drumul Taberii areas of Bucharest) were most affected. The damage patterns were the strongest on the OD16 site. The earthquake action in 1977 was mainly in NNE-SSV direction. Out of 167 building units ("trasons") of the "OD" type existing in Bucharest at the time of the 1977 earthquake, only 7 were lightly damaged; the remaining building units suffered a partial collapse (7 units) or were damaged (19 significantly damaged, 72 moderately damaged, 61 lightly damaged) Balan (1982), Argent (1998). According to the reports, damages to this construction type were due to inadequate wall density in the longitudinal direction, inadequate amount and detailing of wall reinforcement, lack of lateral confinement in the walls and in the boundary elements ("bulbs") causing brittle concrete failure and buckling of reinforcement. In addition, quality of concrete construction was found to be rather poor. No damages to the buildings of this type were observed in the 1986 and 1990 earthquakes. In the 1977 earthquake (M 7.2), no significant damages were observed on other buildings of similar construction.

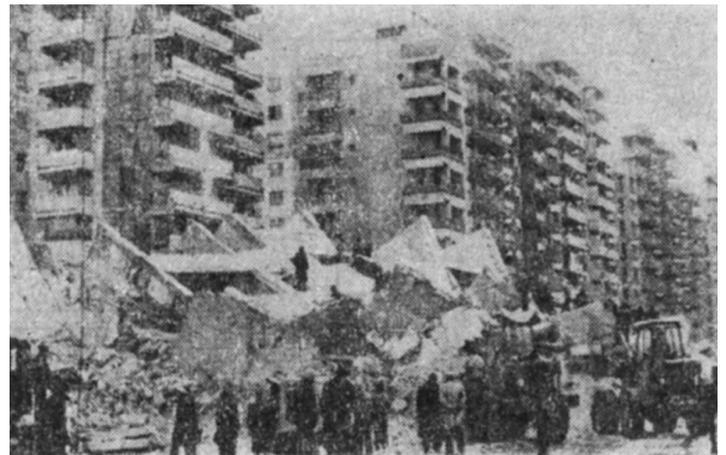
Building Collapse in the 1977 Vrancea Earthquake (OD16 Building)
