World Housing Encyclopedia

HOUSING REPORT

Buildings with hybrid masonry walls

Report#	8
Last Updated	
Country	Chile
Author(s)	Ofelia Moroni, Cristian Gomez, Maximiliano Astroza,
Reviewers	Sergio Alcocer,

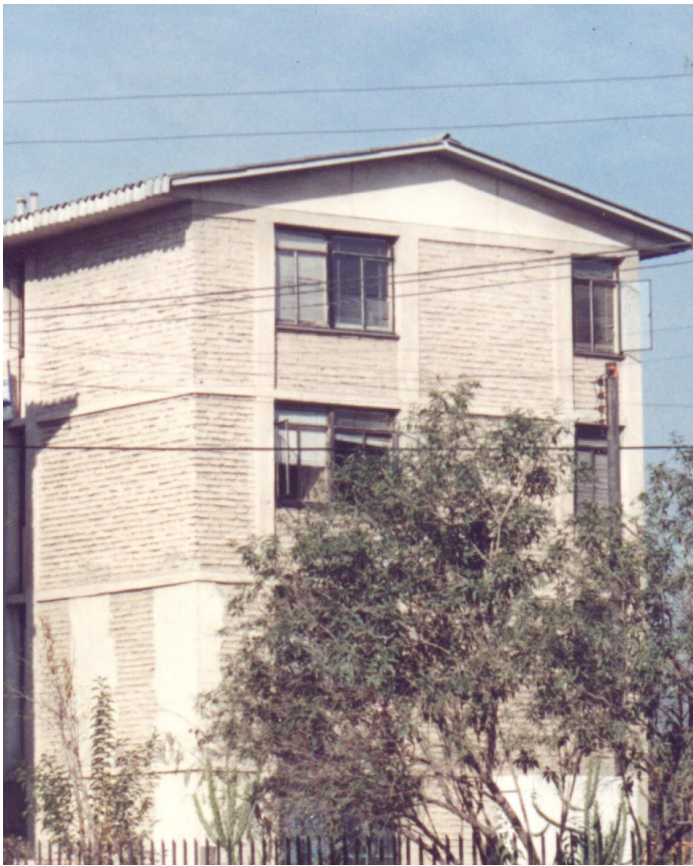
Key load-bearing elements

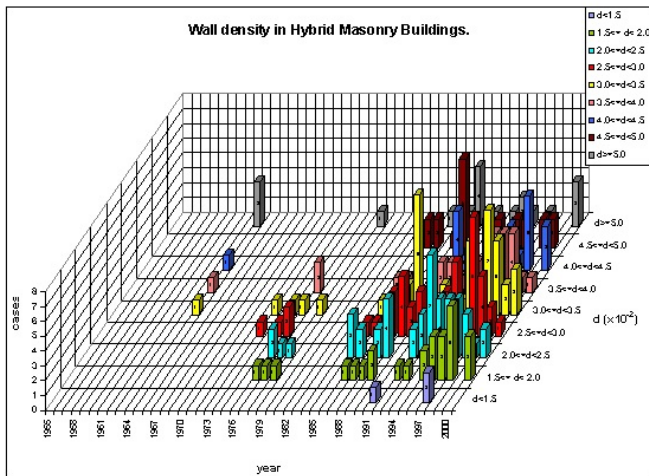
Wall density for hybrid masonry buildings

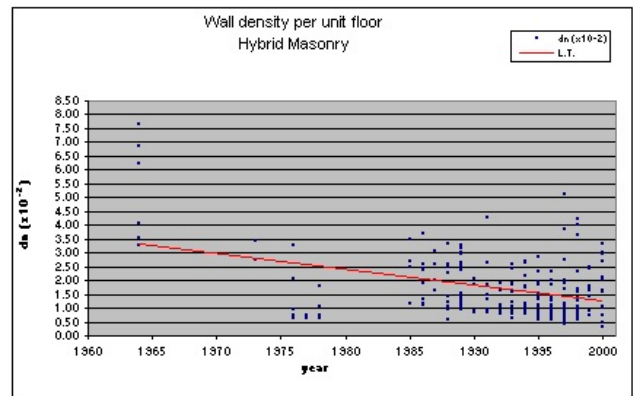
Wall density per unit floor: hybrid masonry

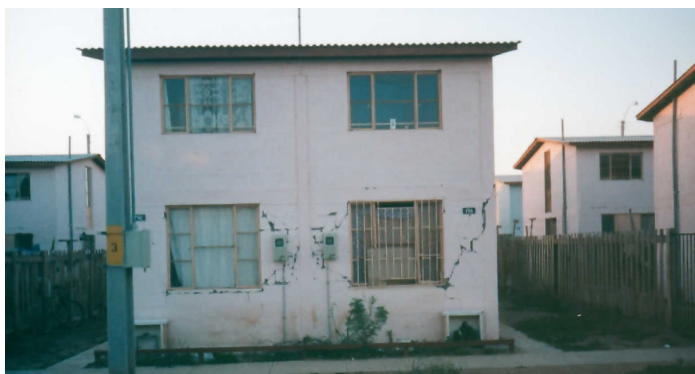
Photograph illustrating typical earthquake damage (1997 Punitaqui earthquake)

earthquakes for this type of construction included perimeter walls with shear cracks, out of plumb and separations at the corners, crushing at the wall bottom due to compression failure and interior walls, usually confined, with only small cracks.

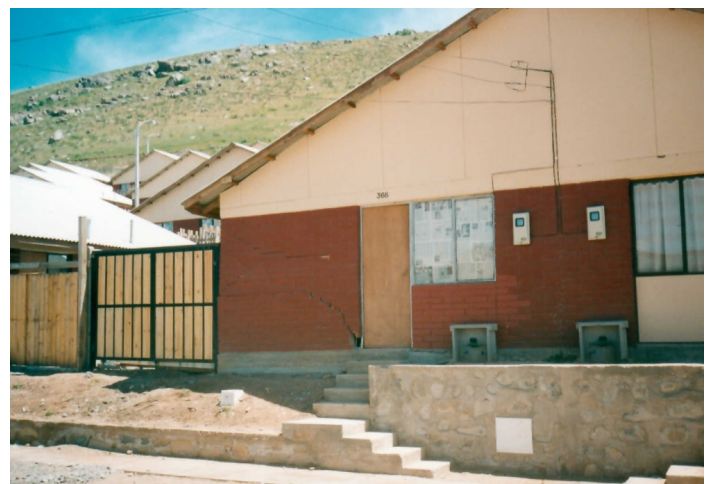
Earthquake damage (1997 Punitaqui earthquake)

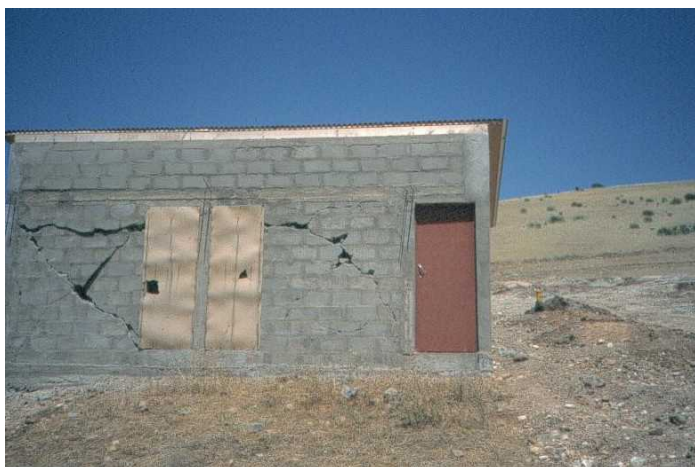
Earthquake damage (1997 Punitaqui earthquake)

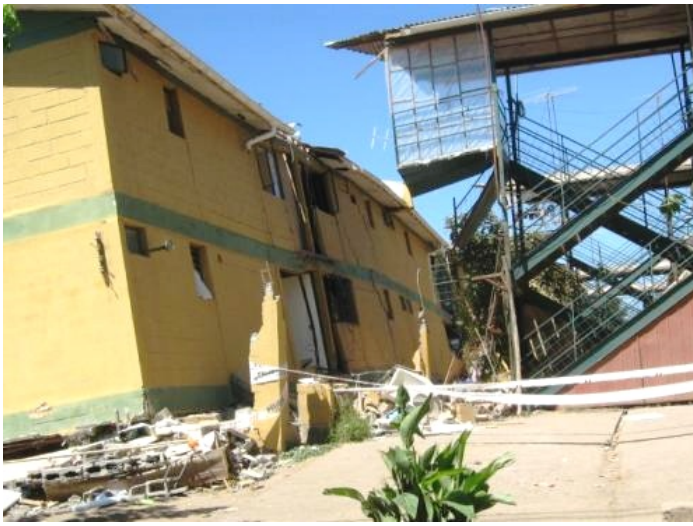
Collapsed three-story partially confined building in Santa Cruz, 2010

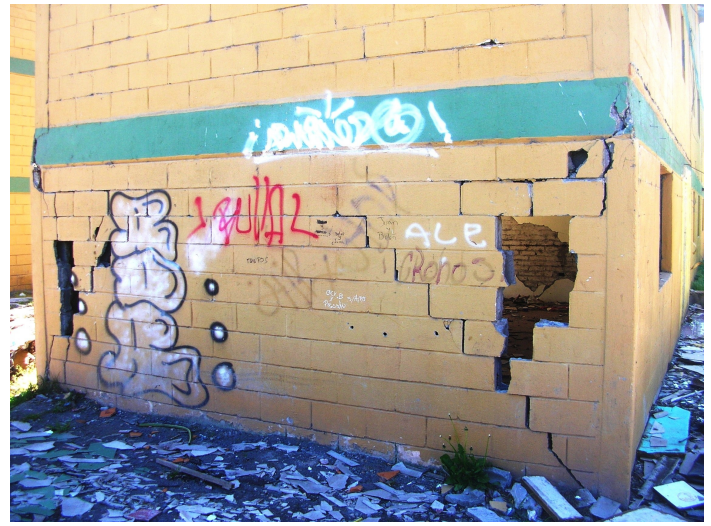
Stair-stepped cracking and masonry disintegration

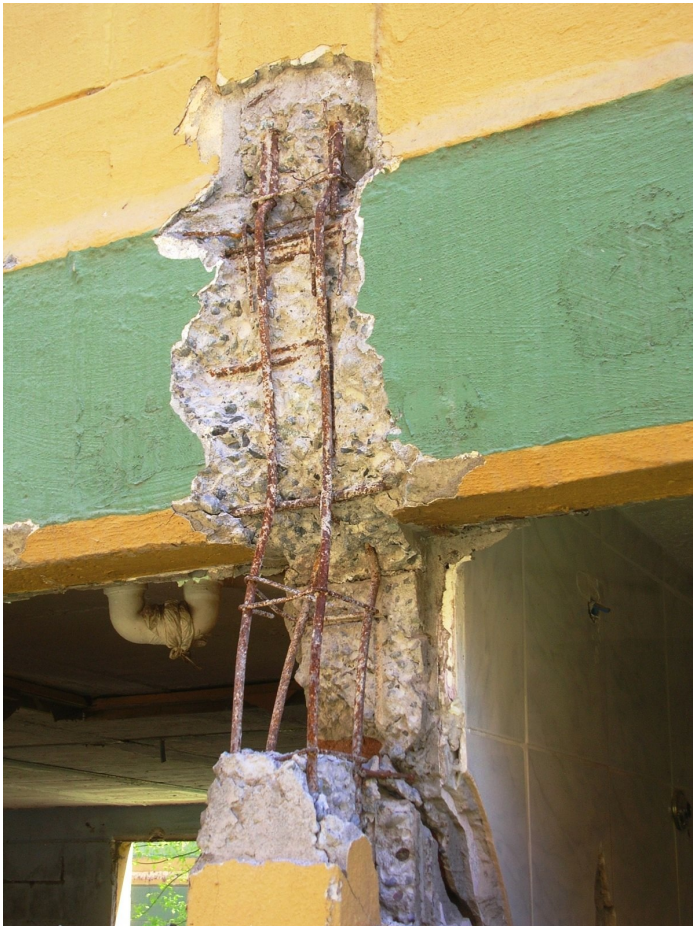
Improper detailing of tie-beam-to-tie-column joint

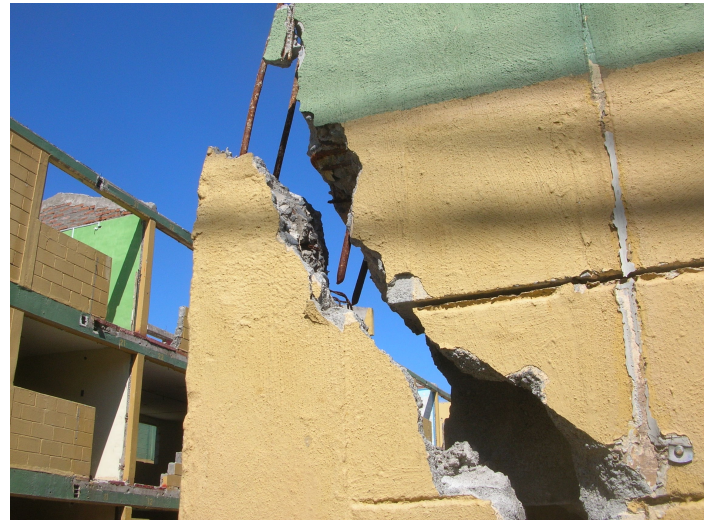
Shear failure of tie-column

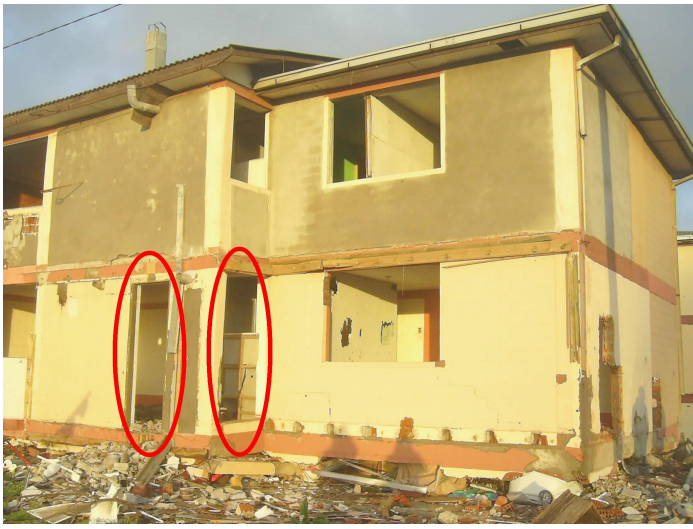
Collapse of building in construction, door opening at the second floor

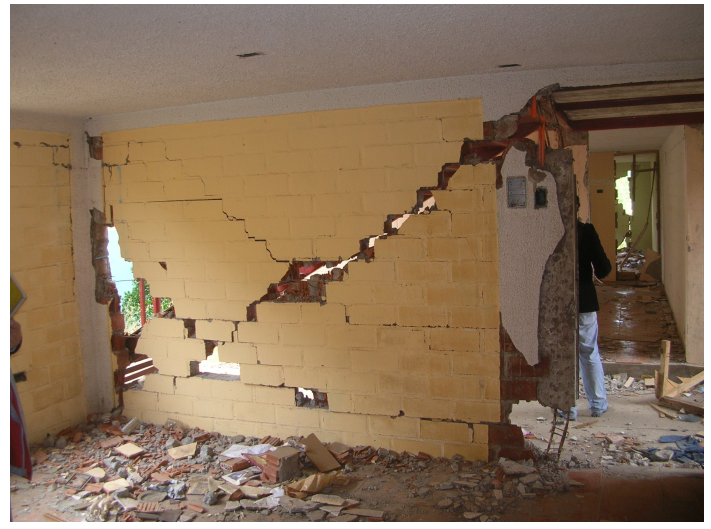
In-plane shear failure

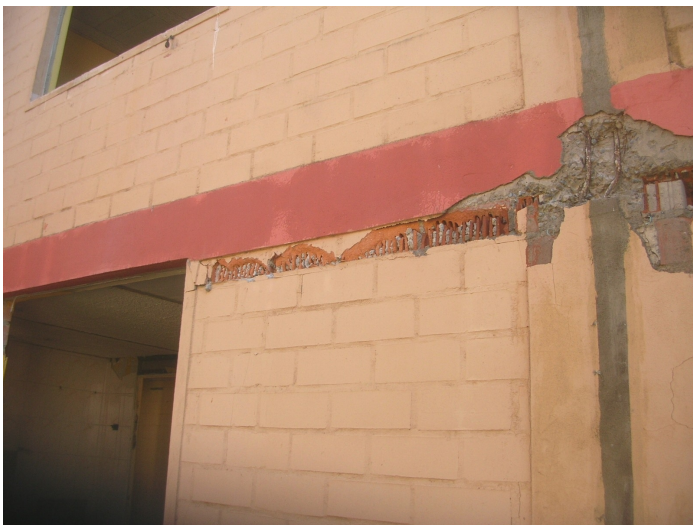
Out of plane cracking in the longitudinal wall

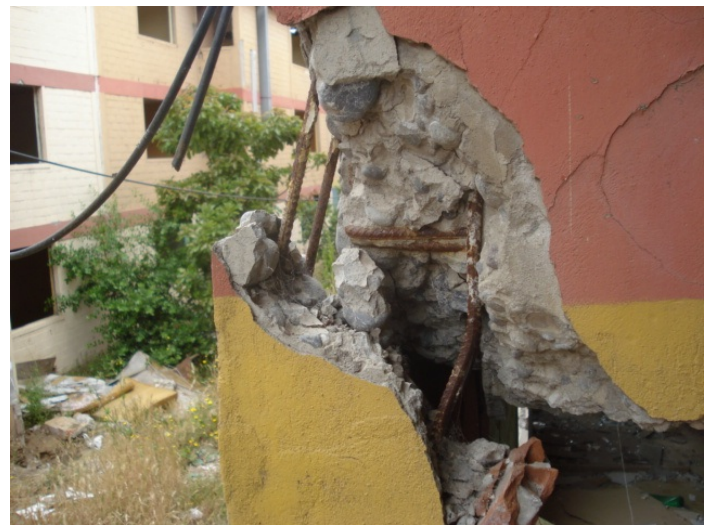
Absence of ties in the joint region
