# World Housing Encyclopedia

## HOUSING REPORT

### Low-strength dressed stone masonry buildings

<b>Report#</b>	80
<b>Last Updated</b>	
<b>Country</b>	India
<b>Author(s)</b>	Ravi Sinha, Vijaya R. Ambati,
<b>Reviewers</b>	Marjana Lutman ,

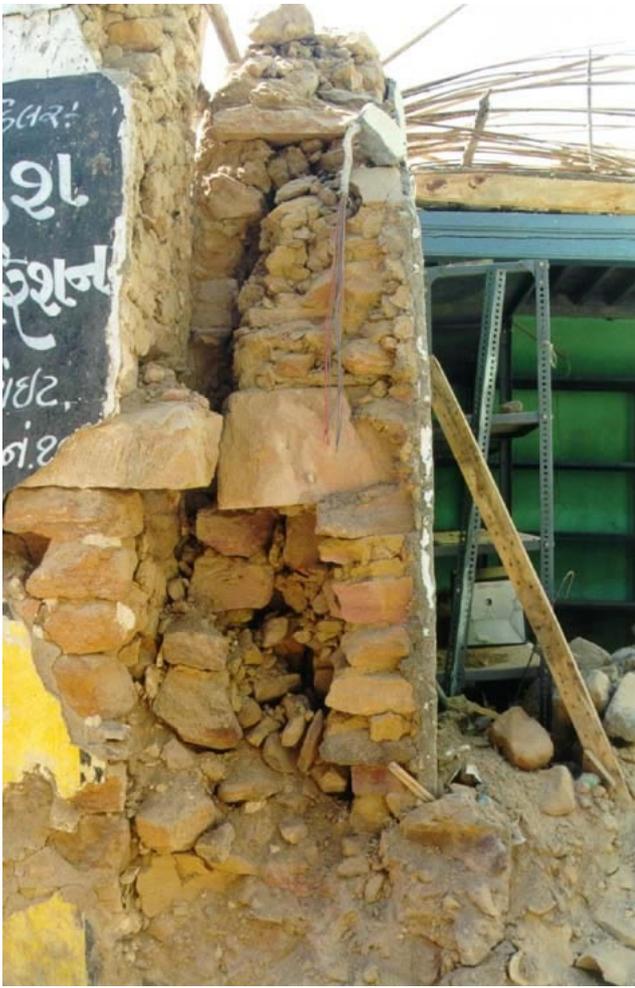
***Key details: multi-wythe wall construction***

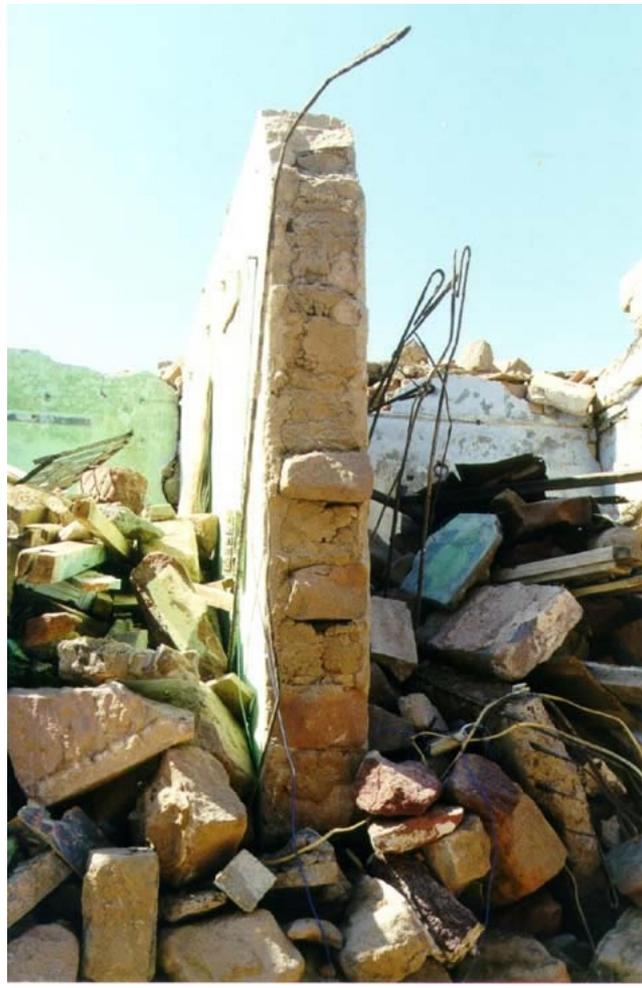
***Key details: section through a single-wythe wall***

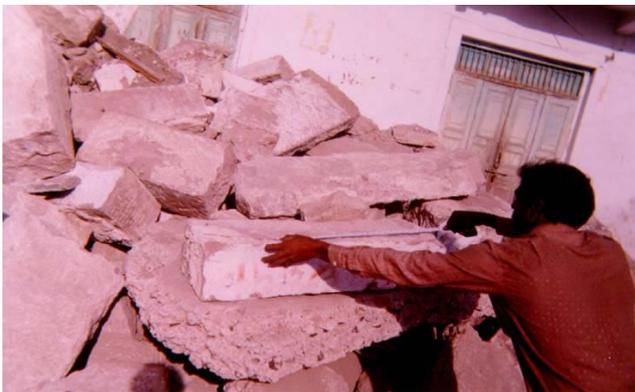
***Key details: stone lintels***

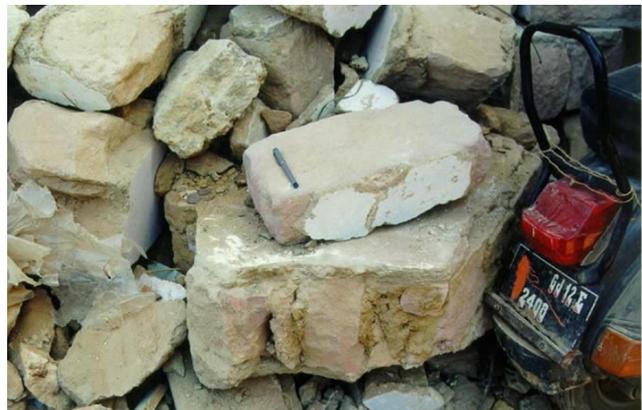
***Key details: size of stones used in construction***

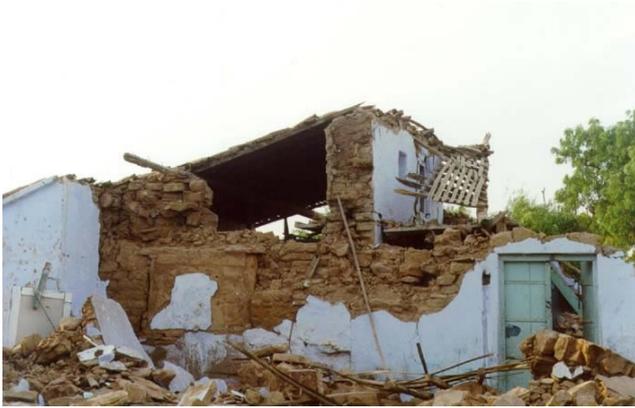
***Seismic deficiencies: collapse of stone masonry building due to inadequate wall connections (2001 Bhuj earthquake)***

Walls: -Out of plane wall failure; -Failure of wall corners and junctions; -Bulging type failure of the wall; -Vertical shearing of wall; -Shear failure of walls near openings. Roof/Floor: -Movement of roof relative to the wall causing sliding of roof structure and complete failure in some cases.

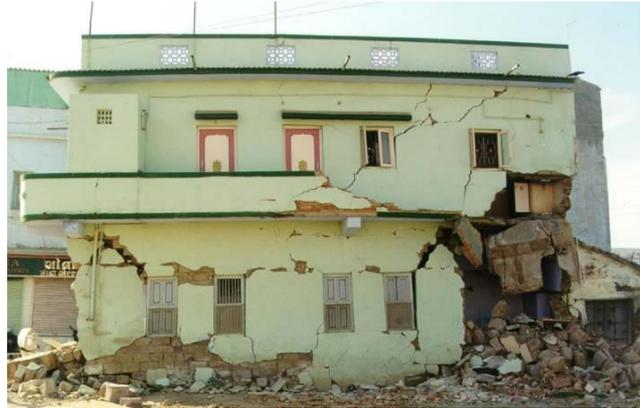
***Seismic deficiencies: in-plane shear wall failure (2001 Bhuj earthquake)***

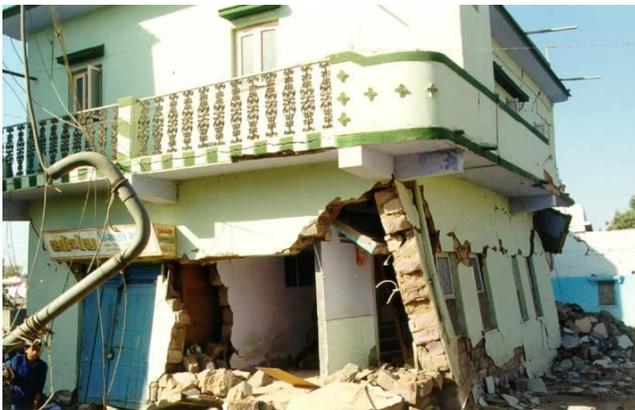
***Seismic deficiencies: improper wall-concrete floor slab connection resulting in the out-of-plane wall***

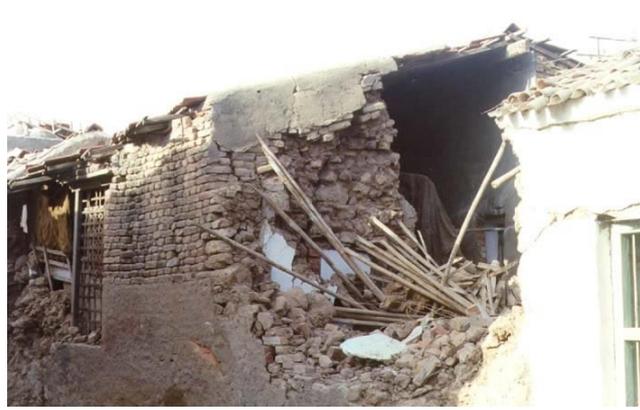
***Seismic deficiencies: separation of wall wythes due to absence of through-stones (2001 Bhuj earthquake)***

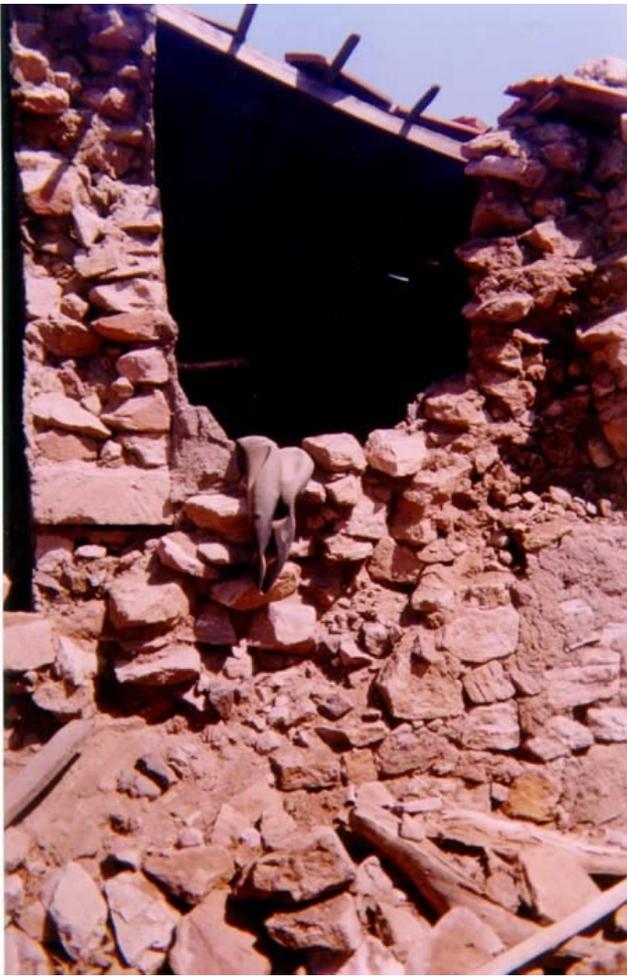
***Earthquake damage: complete collapse of a stone masonry building due to inadequate mortar strength (2001 Bhuj Earthquake)***

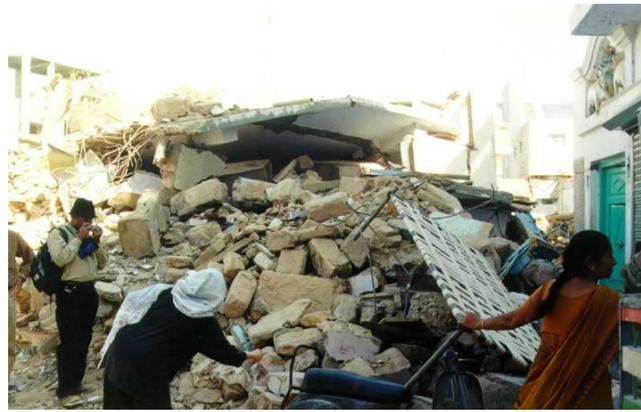
***Seismic deficiencies: poor mortar strength in stone masonry walls resulting in the wall collapse (2001 Bhuj Earthquake)***

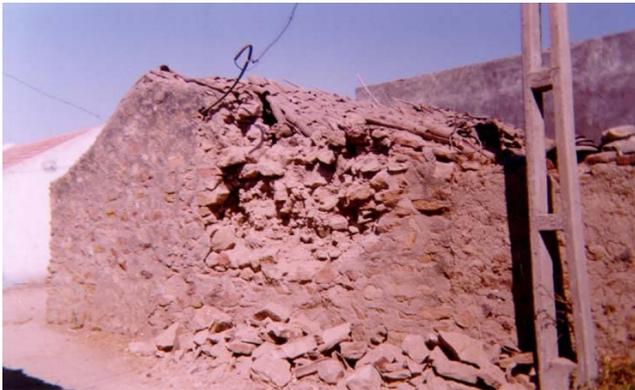
***Earthquake damage: out-of-plane wall corner failure (2001 Bhuj Earthquake)***

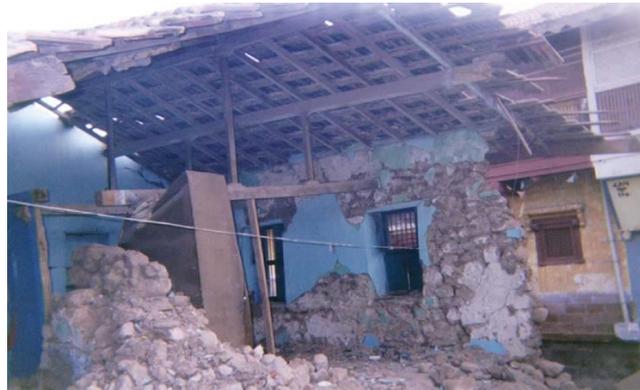
***Building Collapse due to Lack of Earthquake Resistant Features (2001 Bhuj Earthquake)***

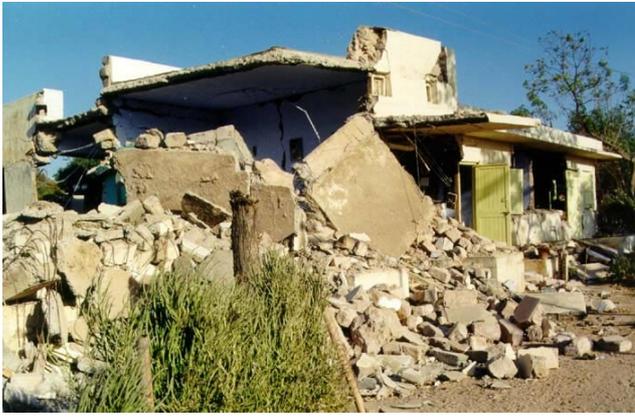
***Building Collapse due to the Torsional Motion of Reinforced Concrete (RCC) Roof Slab (2001 Bhuj Earthquake)***
