# World Housing Encyclopedia

## HOUSING REPORT

**EMSB1- single storied brick masonry house generally with GI roof**

<b>Report#</b>	91
<b>Last Updated</b>	
<b>Country</b>	Bangladesh
<b>Author(s)</b>	Mehedi Ansary,
<b>Reviewers</b>

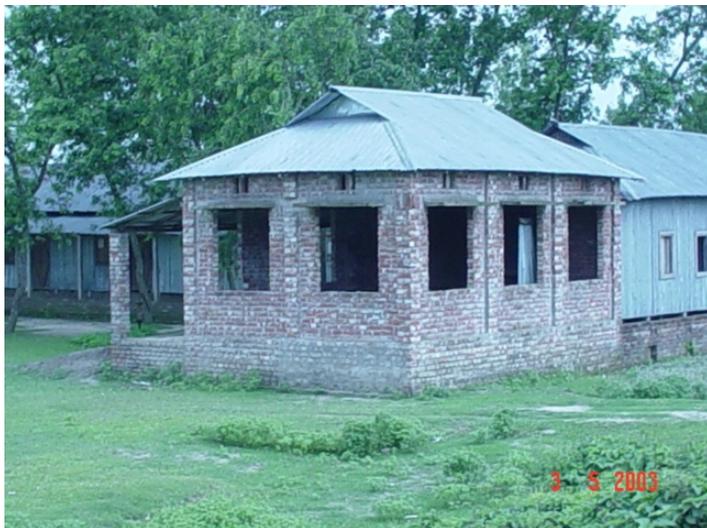
***Typical Construction***

<b>Involved in building process</b>	seniors.
<b>Construction process and phasing</b>	- trench line is planned - excavate 2 to 3 ft deep trench - 6 inch thick sand layer - lay brick and use cement mortar to join them The construction of this type of housing takes place in a single phase. Typically, the building is originally not design
<b>Construction issues</b>

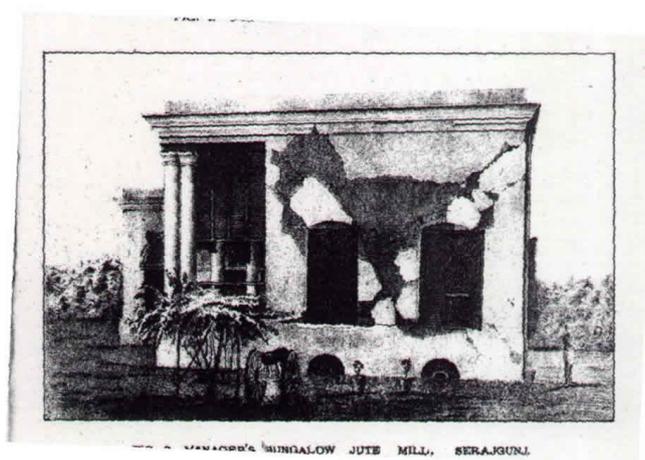
***Damage at Sirajganj, 1897 Earthquake***

<b>Damage patterns observed in past earthquakes for this construction type</b>	During the 1897 Assam earthquake, almost 90% of this type of structure suffered some kind of damage.
--	--

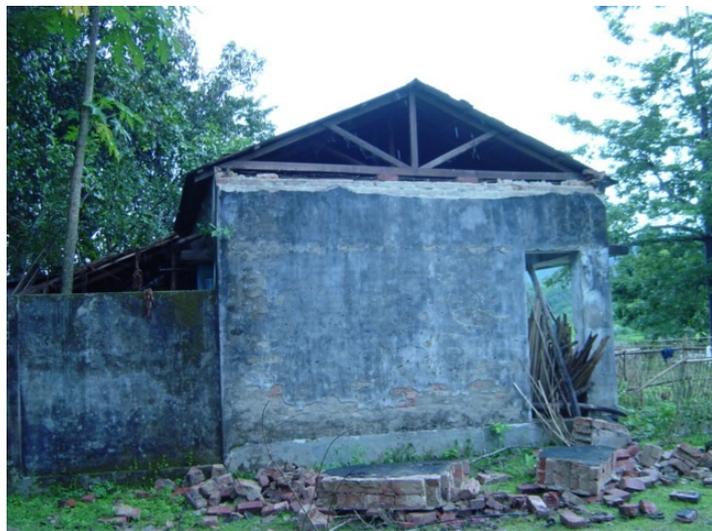
***Damage due to 2003 Rangamati Earthquake***

Proposed for the damaged buildings of 2003 Rangamati earthquake.
