World Housing Encyclopedia

HOUSING REPORT

Traditional Nawari house in Kathmandu Valley

Report#	99
Last Updated	
Country	Nepal
Author(s)	Dina D'Ayala, Samanta S. R. Bajracharya,
Reviewers	Svetlana N. Brzev,

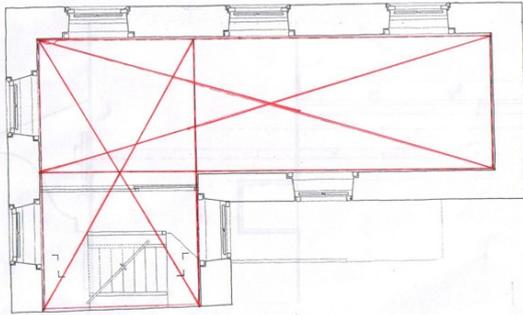
First Floor Plan
 Typical Steel Diagonal Bracing
 on All Floor Levels & along the Wall

Proposed strengthening for stiffening of diaphragm and connection of bearing walls. (courtesy of Ing. Rohit K. Ranjiktar of the Kathmandu Valley Preservation Trust)

Structural Deficiency	Seismic Strengthening
Connection between walls	Use of steel ties at floor levels to connect front and back walls has been proposed.
Flexible diaphragm	Inclusion of diagonal ties within the interior floor structure to stiffen the floor structure and create a more rigid diaphragm has been proposed.

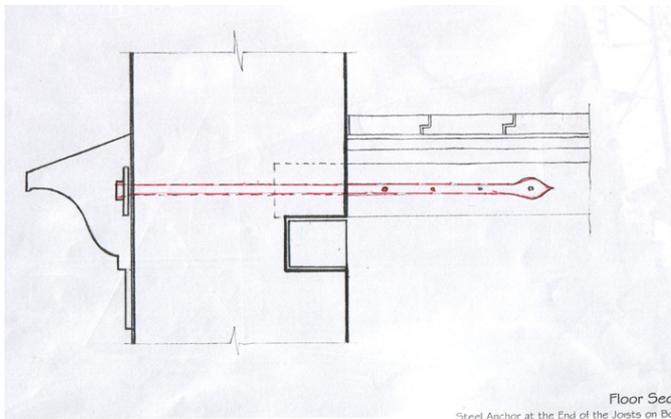
Detail of anchor key to be hidden behind floor band. (courtesy of Ing. Rohit K. Ranjiktar of Kathmandu Valley Preservation Trust)

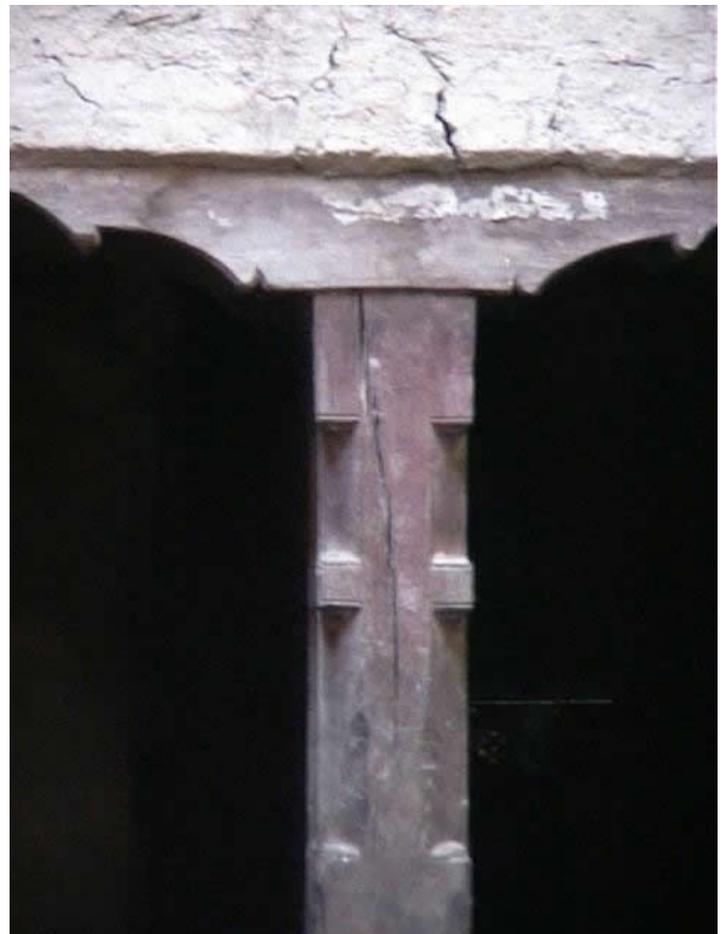
Detail of timber post in the dalan

structure.

chirpat are covered by compressed mud.	
Roof	Timber joists (dimensions 100 x 70 mm) run from wall to wall at closely spaced intervals of 150 to 200 mm. Above the joists either planks or a bamboo chirpat are covered by compressed mud.	
Other	The timber frame (dalan) is made of twin columns, surmounted by a capital upon which sits a double beam. Adjacent timber frames are usually connected only at the level of the beam. The columns usually have a square cross section (about 100 x 100 mm minimum and 150 x 150 mm maximum) and are pinned to the ground, 100 to 150 mm apart.

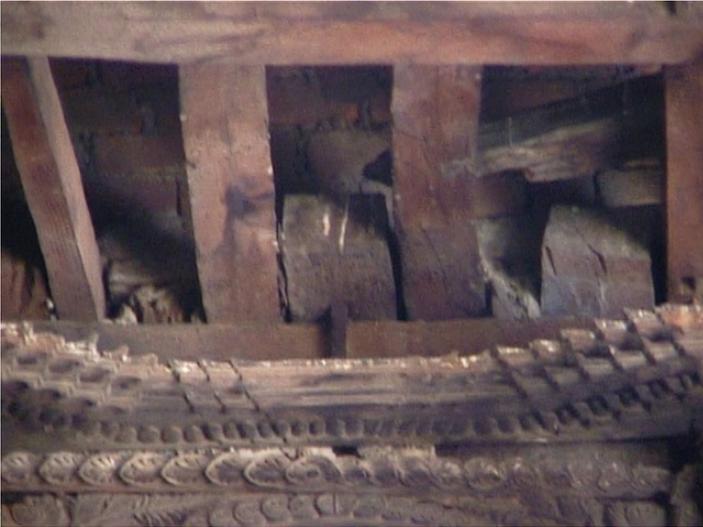
Detail of timber peg connecting joists to walls or transversal beam to limit lateral relative sliding

The applicability of some of the statements above is limited due to a construction philosophy completely different from the modern earthquake proof approach. For instance, although the floor structures are not rigid diaphragms, the closely spaced joists and their connection to the walls by timber pegs ensure uniform redistribution of lateral loads, 3D behavior and the continuity of load paths for lateral loads.

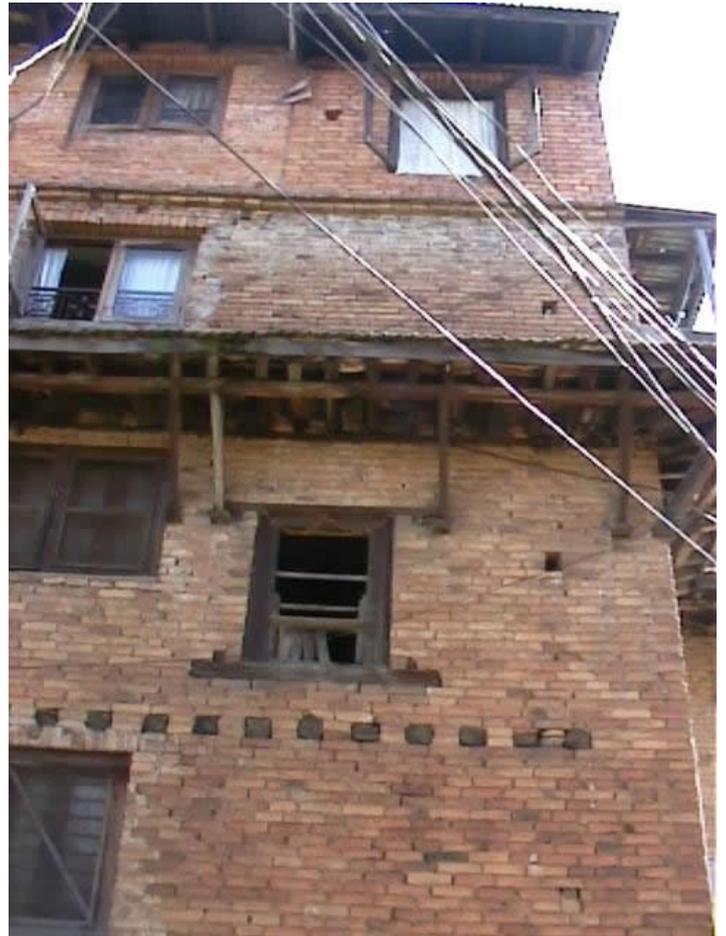
Typical elevation with joists coming through the wall, different window sizes, jetting at third floor level and overhanging of roof. This is sometimes supported by struts.

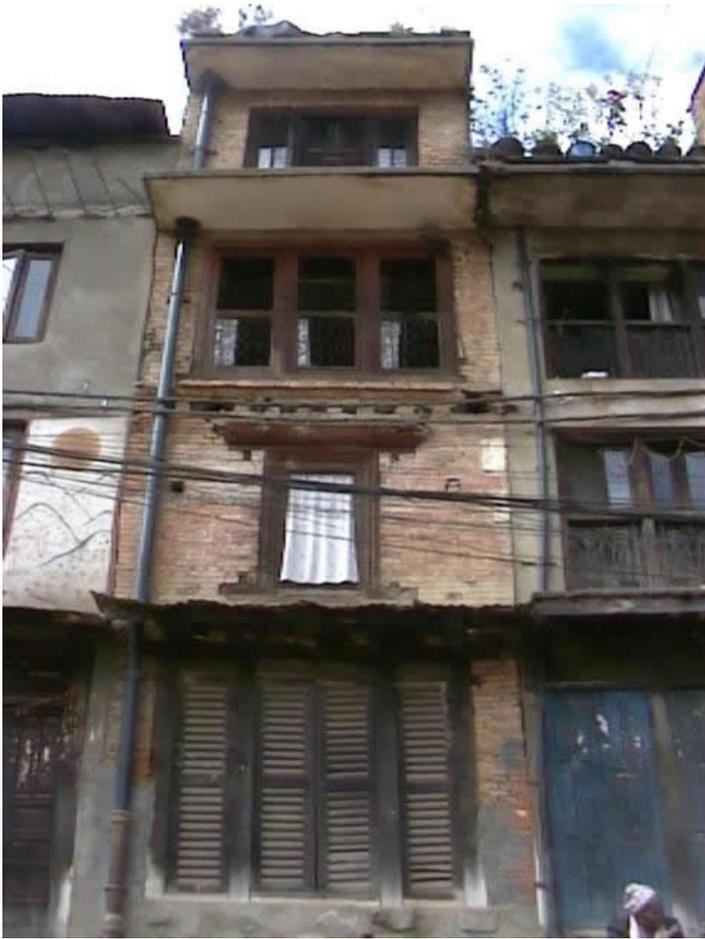
Alteration of original layout. Note vertical division of property, addition of one story and replacement of timber floors with concrete flat slab.

The major modification consist of: updating of hygienic facilities, introduction of running water and toilets. replacement of traditional timber floor structure with concrete slab. vertical division of units. Vertical extension of units of one or more storeys with concrete frames above original masonry structure. Horizontal extension by means of lightweight structure jetties made of timber and corrugated metal sheets for one or two storeys.

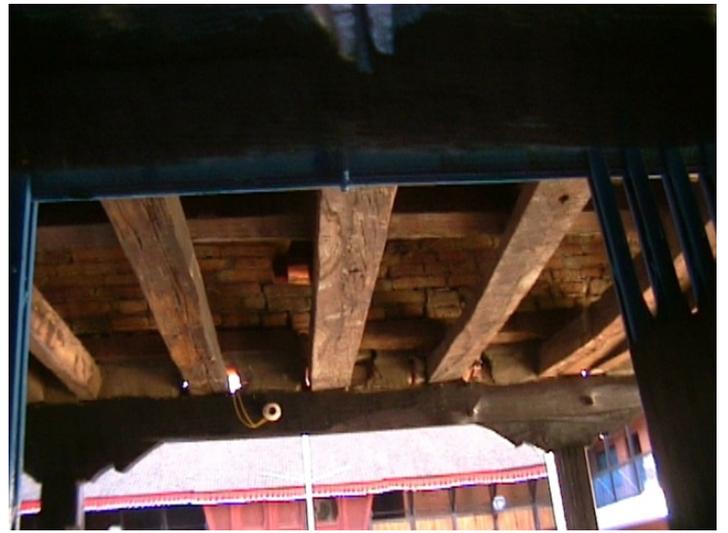
Typical floor structure.

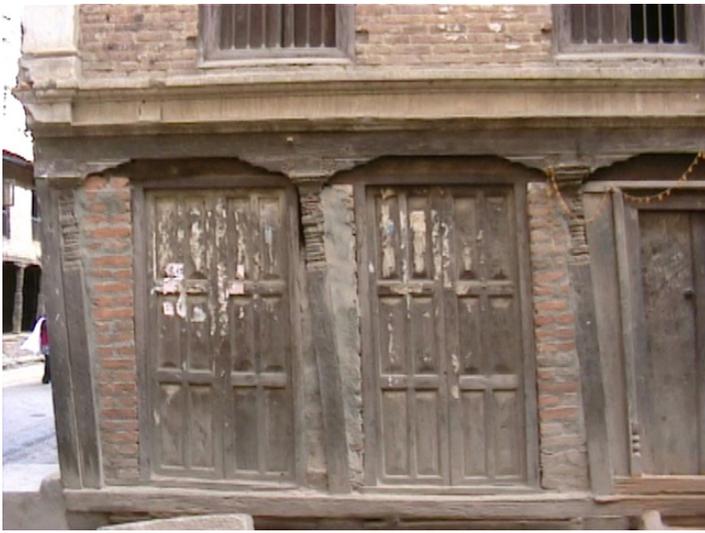
Lean out of dalan structure after the earthquake in 1980.

showed damage following the 1988 earthquake, specifically in plane distortion following the failure of the dalan (see figure).

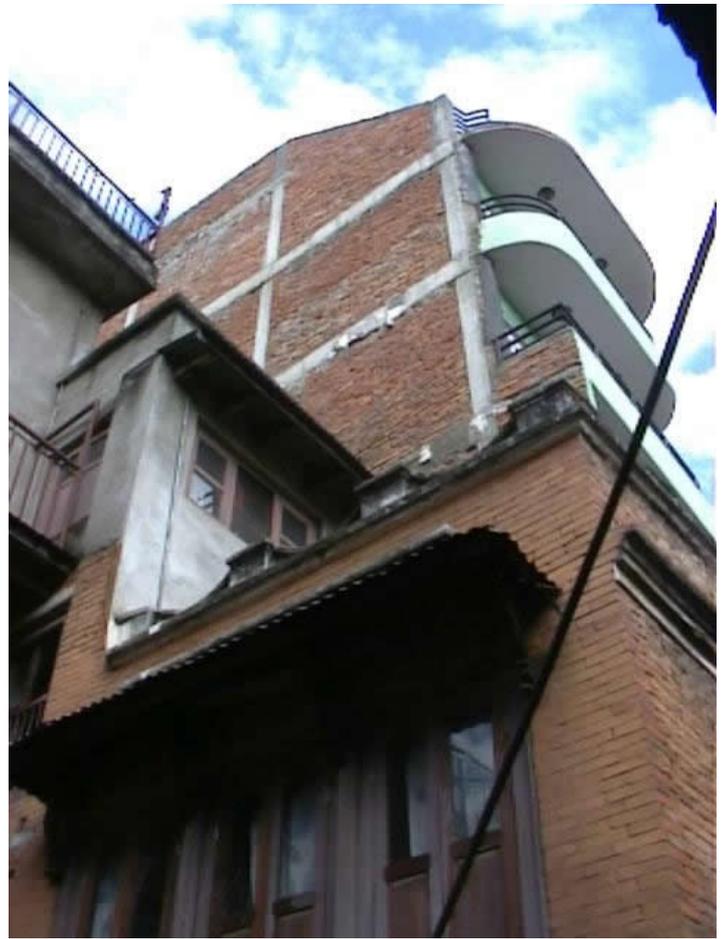
Construction of 5-story concrete frame above a ground floor masonry building

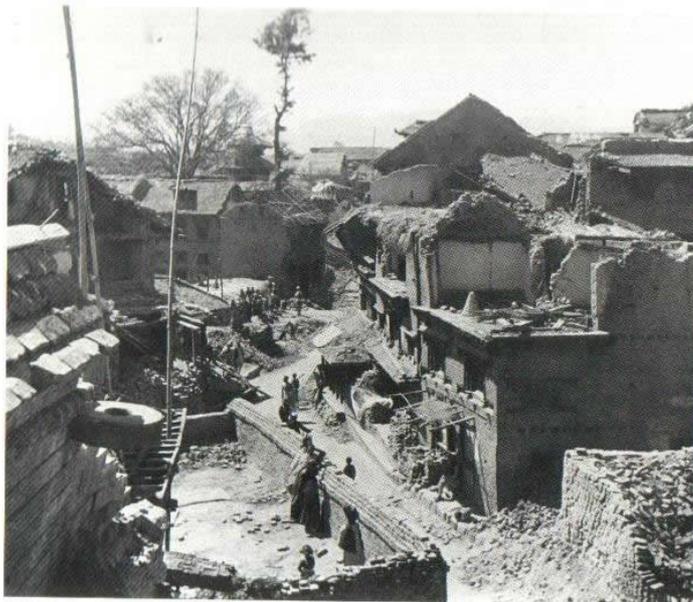
Photograph of a residential street in Lalitpur after the 1934 earthquake.

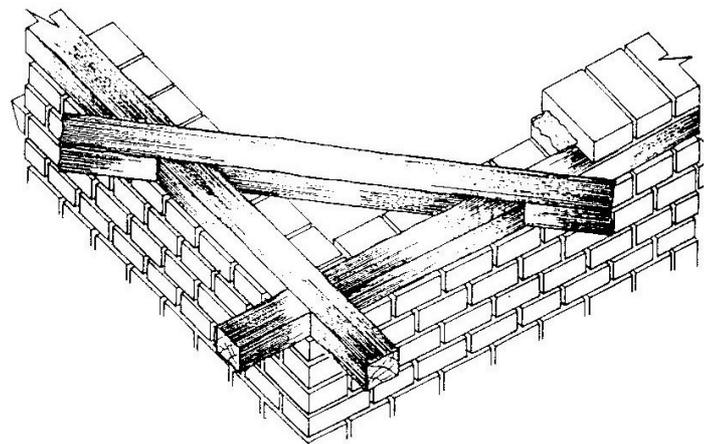
Example of single Band and diagonal element (Nepal National Building Code NBC 202 1994)

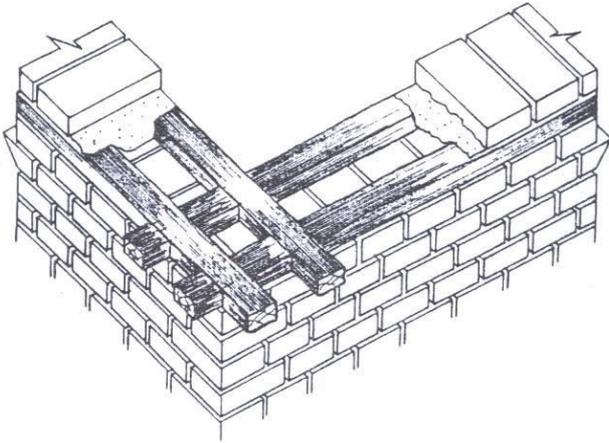
Collar band in wall at lintel level with rough cut timbers in parallel (NBC 202)

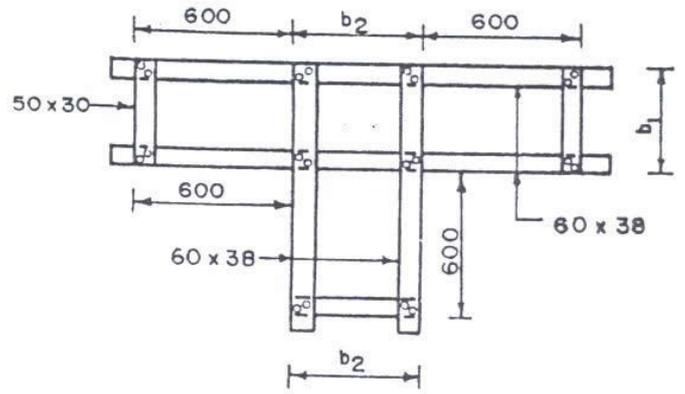
(ii) WOOD DOWEL AT T-JUNCTION OF WALL AT ABOUT 900 ABOVE FLOOR LEVEL.

Detail of timber reinforcing at T junction (NBC 202)

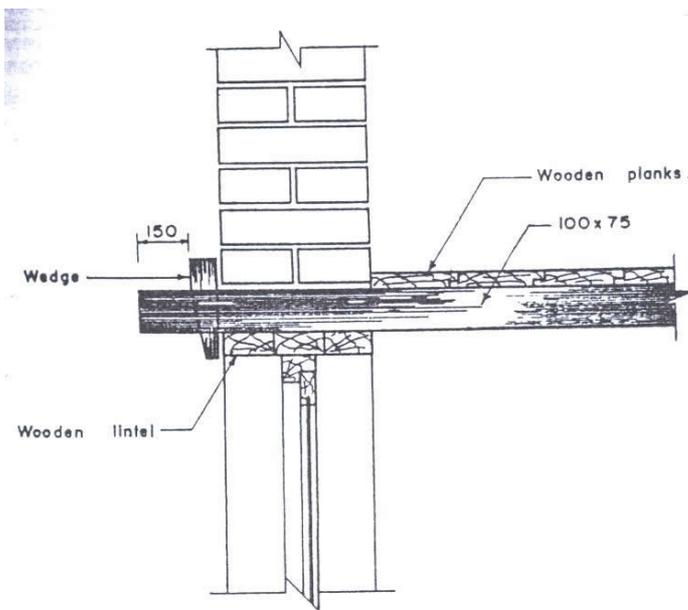
Figure 25.3 : Lintel and Floor Joint Detail

Example of use of wedge to anchor floor joist over lintel

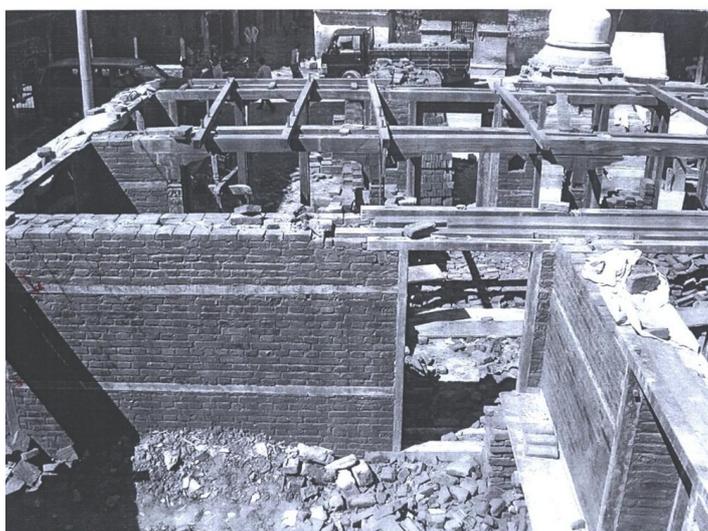
Khokana VDC Office building- New construction with traditional technology - Pilot project for the "Urban Management and economic diversification project (UMEDP)". General view of construction in progress. Note horizontal bands at 1/3 and 2/3 of wall's hei

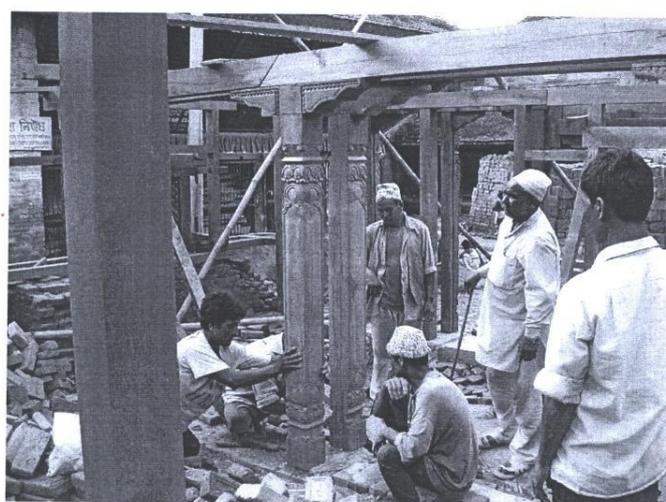
Khokana VDC Office. Detail of positioning of the internal dalan columns. Vertical pins connect the columns to the lower and upper beam. (courtesy of UMEDP)

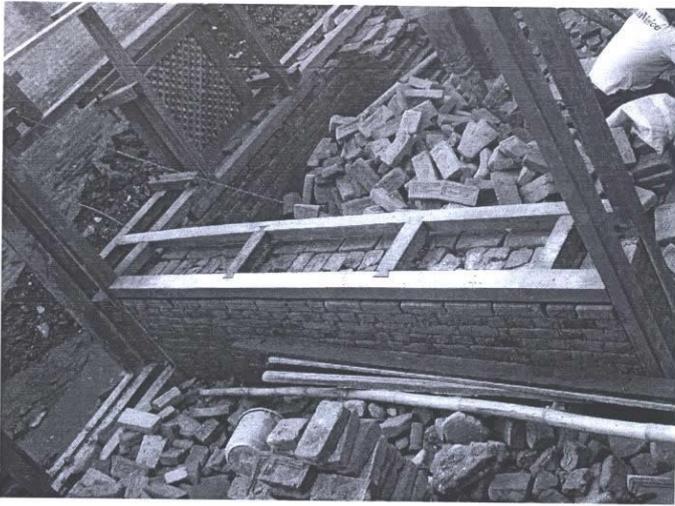
Detail of strengthening timber band. Note the dove-tailing connection rather than the use of pins. (courtesy UMEDP)
