# Housing Report Blast: Afghanistan

M. Numan Aloko, PhD, University of Bristol, UK  
Shahzade Ulfat, Asst. Prof., University of Kandahar, Afghanistan

## Common Housing Typologies in Afghanistan

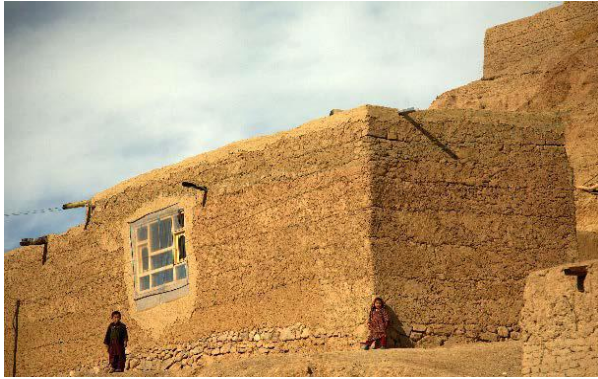
Fig. 1: Mud House with rubble stone foundation (Sultani, 2016).

Generally, wall foundations are excavated to a depth of approximately 30–50 cm. In some cases, stone masonry or rubble stone is used for the foundation, while the walls are constructed using mud, adobe (mud bricks), rubble stone, or fired bricks. Fig. 1 shows a typical mud house constructed with earthen walls supported by a rubble stone foundation, which helps improve stability and resistance against

ground moisture (Sultani, 2016). Fig. 2 illustrates a mud-brick (adobe) wall, one of the most widely used wall systems due to the availability of local soil and low construction costs. Fig. 3 presents a burned brick wall supported by a stone masonry foundation. This type of construction generally provides greater durability and strength than traditional mud-based systems. Fig. 4 shows a rubble stone wall combined with wooden logs in the structural system, where timber elements help support roof loads.

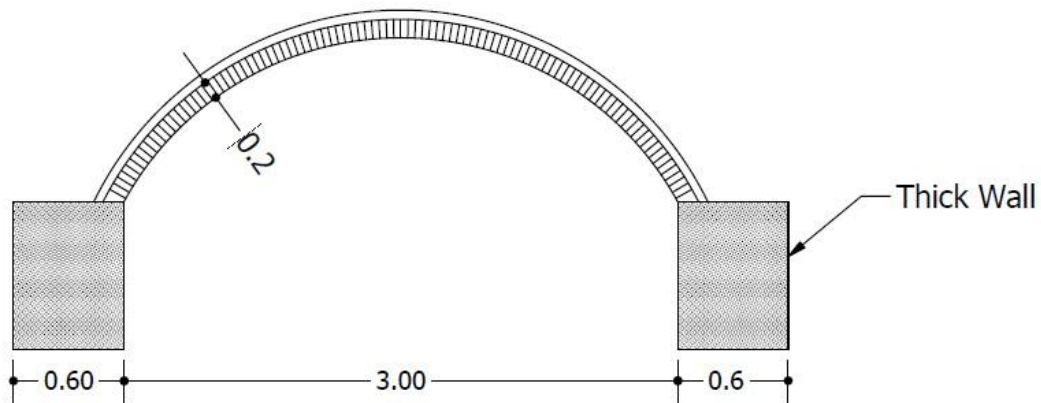
**a) Vault (Pooshesh)**

The *Pooshesh* vault is a traditional masonry structure constructed over substantial load-bearing walls. It generally spans 3.0 meters between walls, each measuring approximately 0.60 meters in thickness. The vault shell, typically 0.20 meters thick, is built from mud bricks or rubble masonry bonded with mud mortar. This system relies on masonry's compressive strength and transfers structural loads to the supporting walls through arch action.

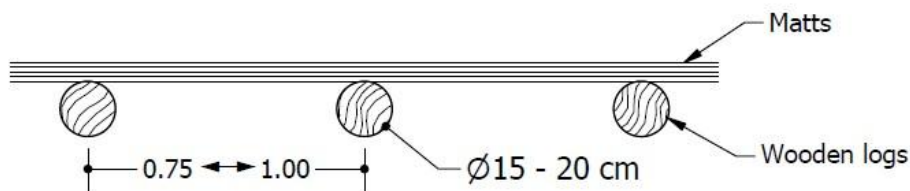
**b) Wooden Roof**

The wooden roof system comprises timber logs positioned horizontally across the supporting walls. These logs typically have diameters ranging from 15 to 20 centimetres and are spaced 0.75 to 1.00 meters apart. Woven mats are placed above the logs to support layers of soil or clay, which provide waterproofing and thermal insulation. The assembly is finished with a protective plaster of mud and straw, known locally as *kahgel*. This roofing method is prevalent in areas with readily available timber and is widely used in rural housing.

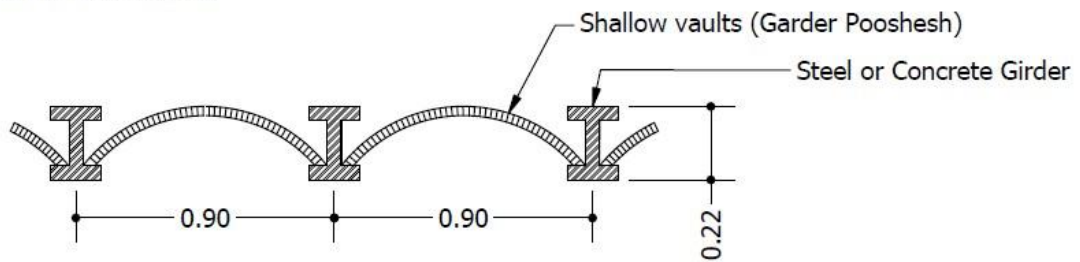
**c) Garder E Pooshesh**

The *Garder-e-Pooshesh* system is a hybrid roofing method that integrates steel or reinforced concrete girders with shallow masonry vaults. The girders are generally spaced 0.90 meters apart, with shallow vaults constructed between them to a depth of approximately 0.22 meters. These vaults, typically made of brick or masonry, transfer loads to the girders, which subsequently convey them to the supporting walls. Steel girders are typically available as I-sections, whereas concrete girders are commonly supplied as precast beams from local markets. Mud mortar is typically used for Pooshesh vaults and mud-brick masonry, while lime mortar or cement mortar is commonly used in shallow vault roof systems.

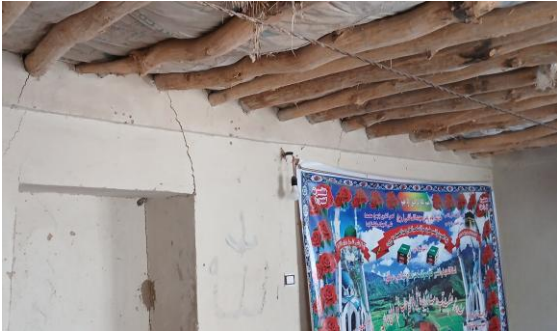
a) Diagonal cracking in an adobe masonry wall caused by lateral stresses and weak roof-wall connections in a traditional timber log roof system during the 2023 Herat earthquake.

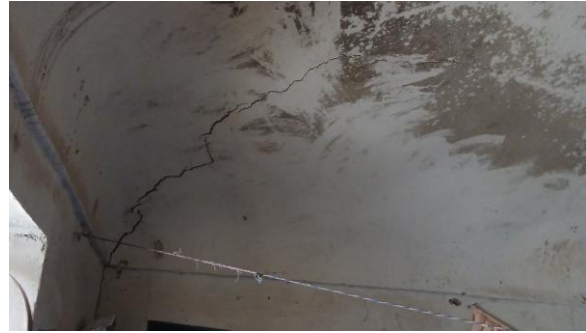
b) Vertical crack that separates the in-plane and out-of-plane walls at the corner, which also extends to the vault roof during the 2023 Herat earthquake.

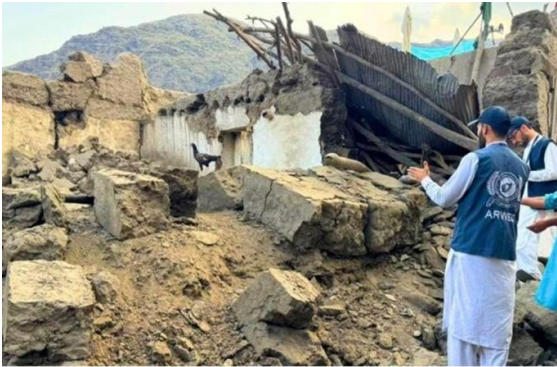
c) The mud wall and wooden roof collapsed during the 31 August 2025 earthquake in eastern Afghanistan<sup>1</sup>.

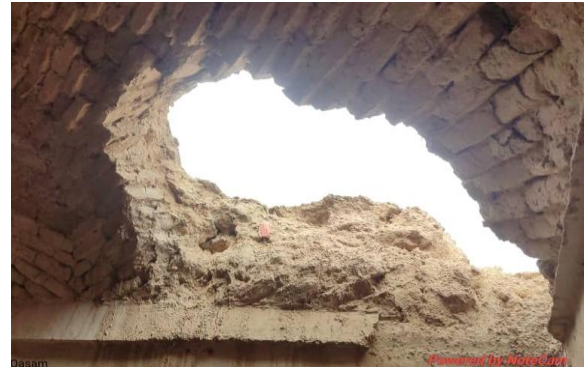
d) Partial damage to the thick vault roof made of mud bricks during the 2023 Herat earthquake<sup>2</sup>.

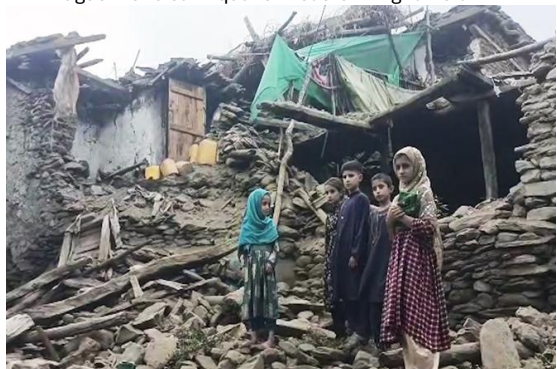
e) Dry stone walls collapsed in the 31 August 2025 earthquake in Kunar Province, eastern Afghanistan<sup>3</sup>.

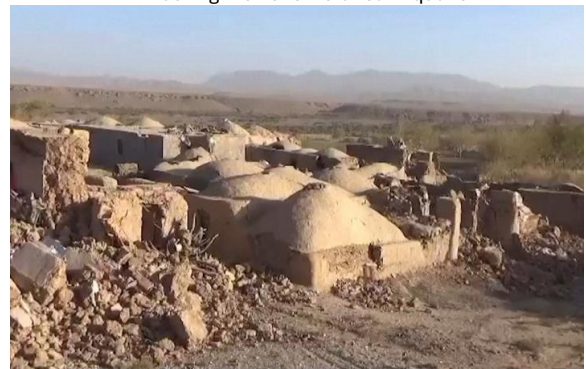
f) Arch ceiling damage caused by the 7 October 2023 earthquake in Herat Province, Afghanistan<sup>4</sup>.

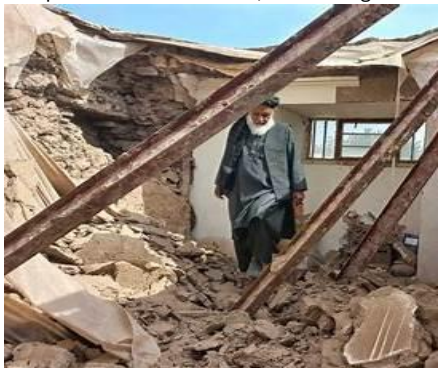
g) Collapse of a house with steel roof girders in Herat Province following the October 2023 earthquake<sup>5</sup>.

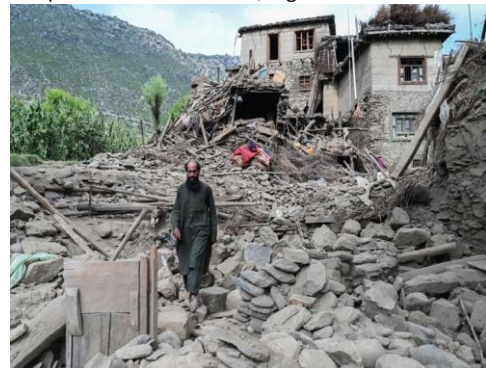
h) Destroyed houses in mountainous terrain after the August 2025 earthquake in eastern Afghanistan<sup>6</sup>.
